Dampness Report

Old City Hall

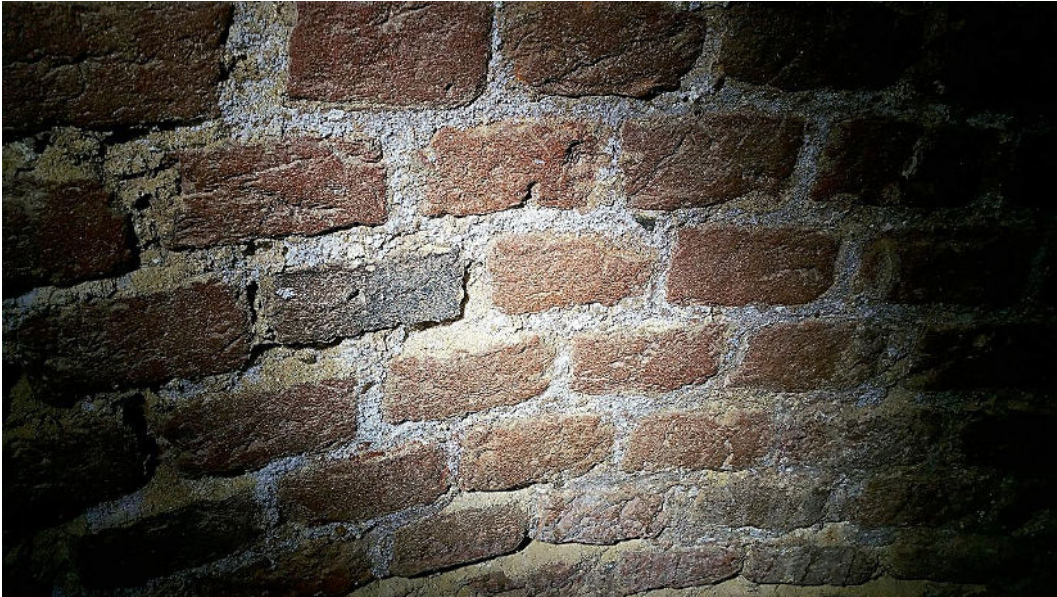
The mortar bed has a very high concentration of ground salts. The white salt deposits on the mortar bed very clearly indicate that the capillary action is more prevalent in mortar.

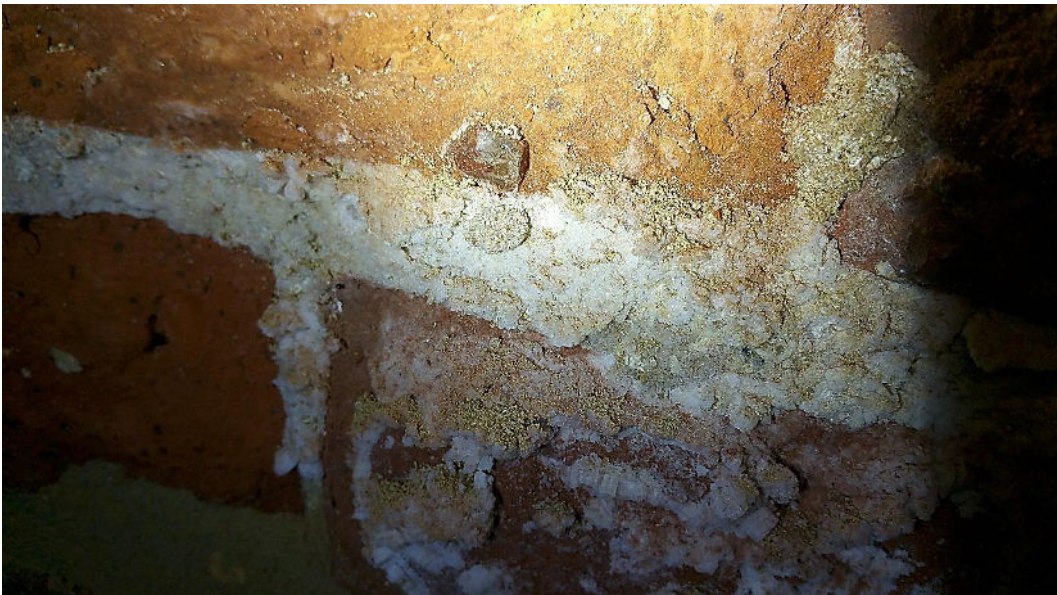
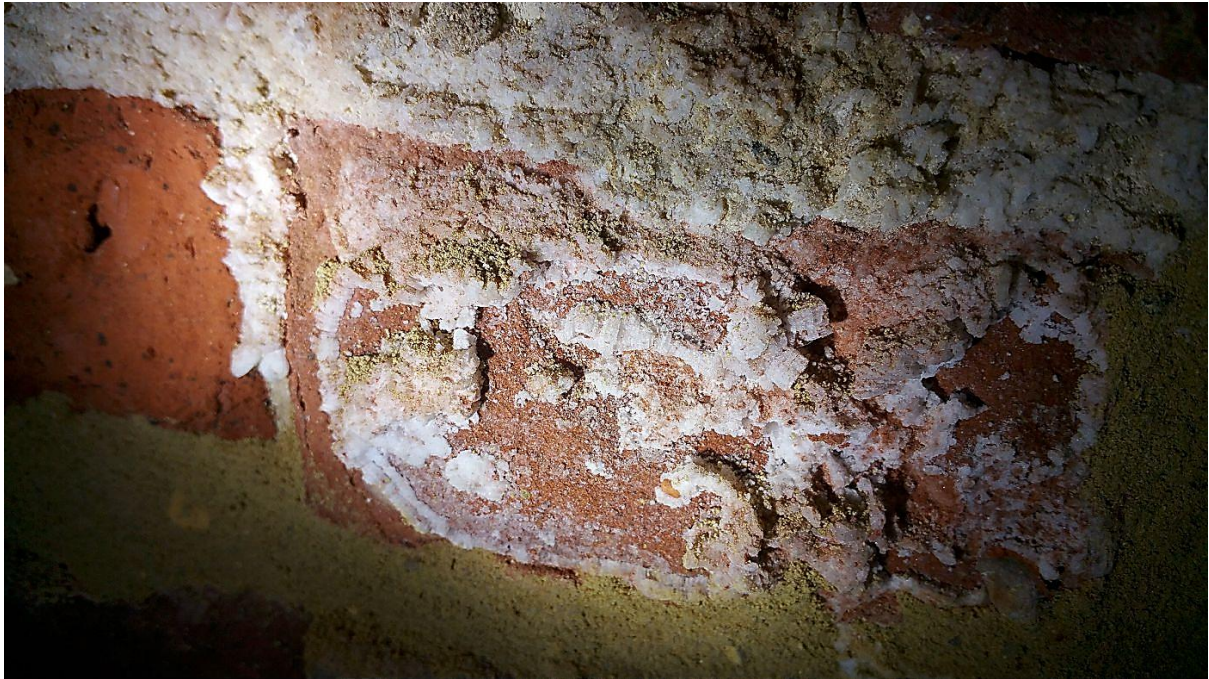
Some areas of the mortar bed and bricks are extremely salty.

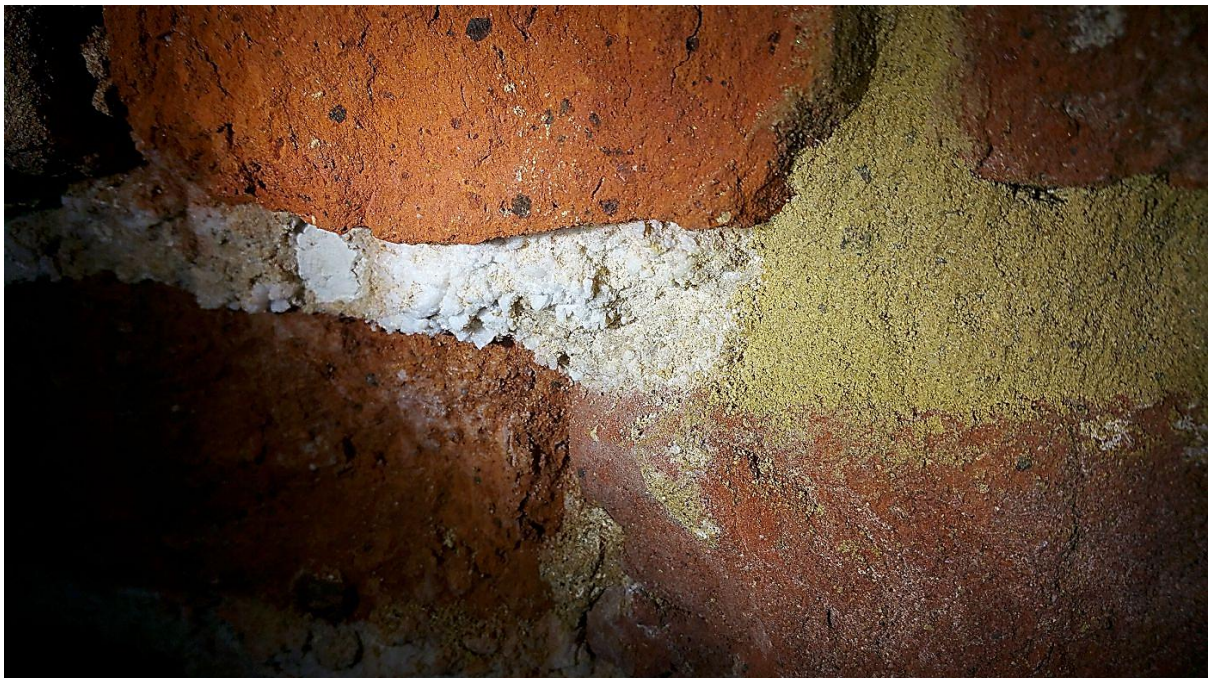
Some areas have been recently repointed with a lime based mortar. In some areas the fresh lime has been applied on top of the salts, which will result in the gradual contamination of the fresh plaster with salts.

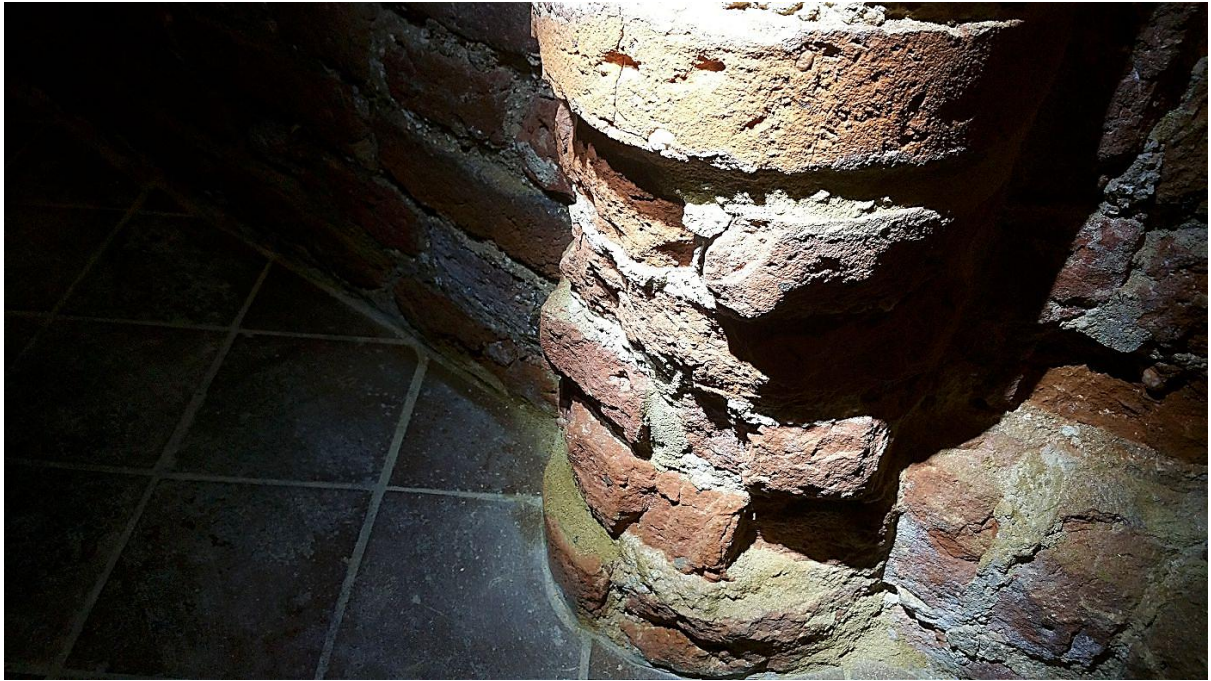
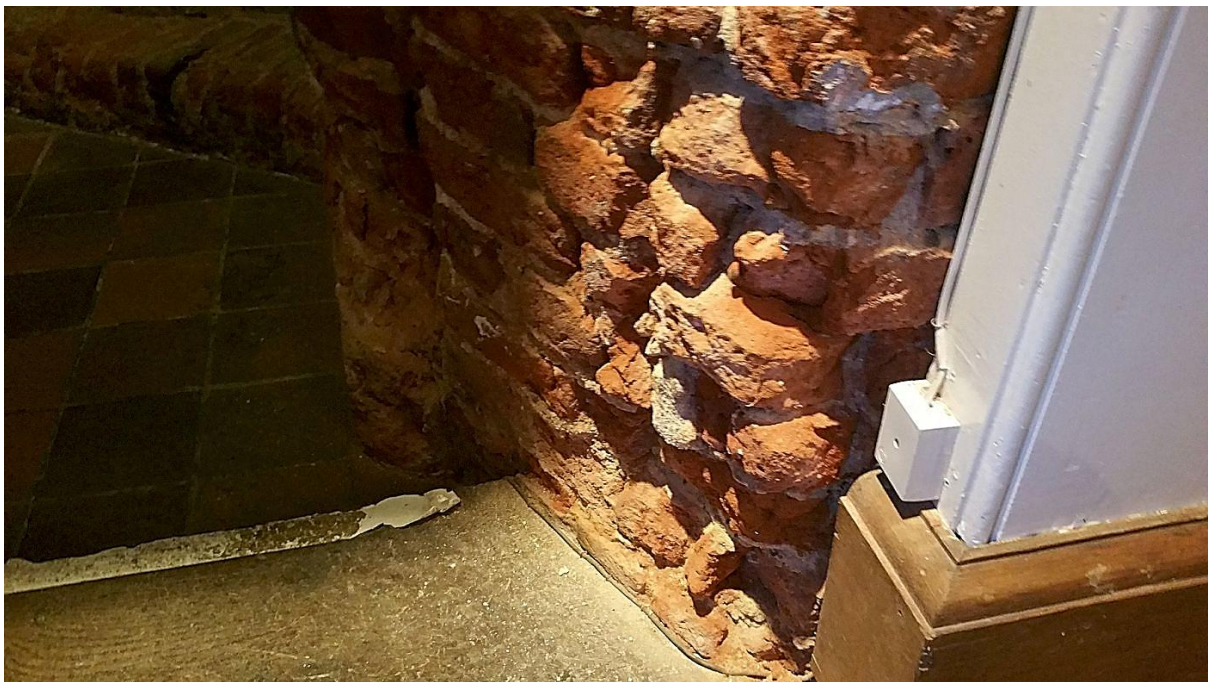
The long-term exposure to salts has damaged the building fabric, a typical sign of rising damp.

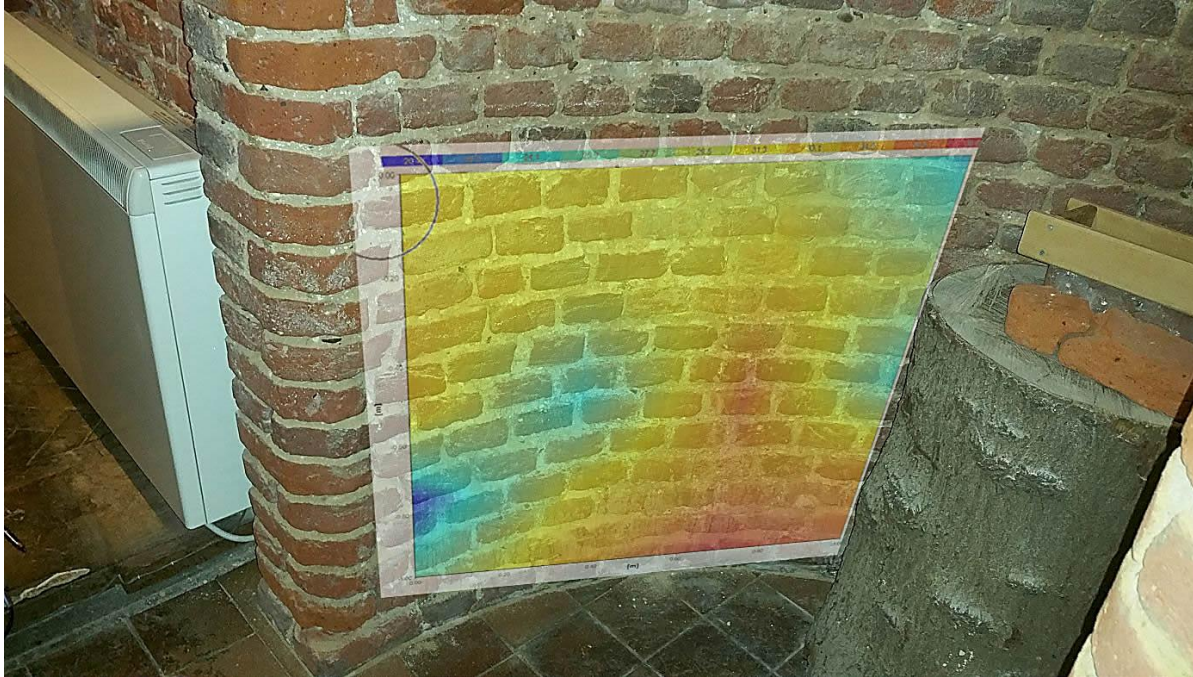
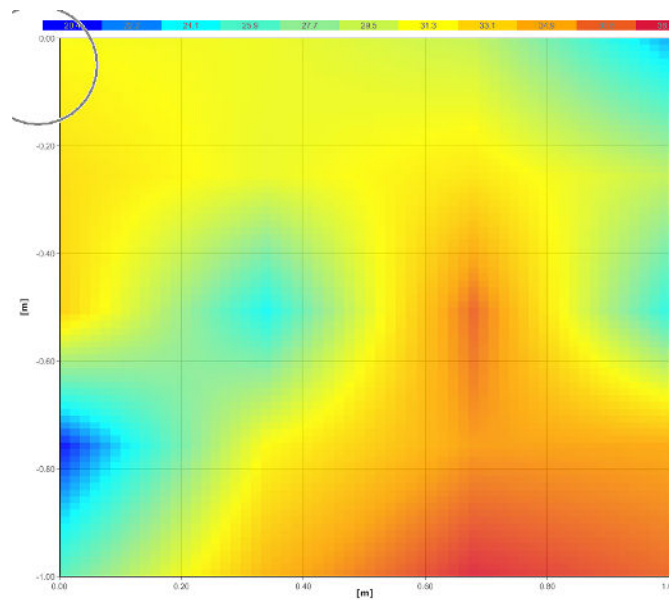
Brick Wall no.1

Red / orange / yellow areas are very damp, light blue moderately damp which need attention, while dark blue areas are normal.

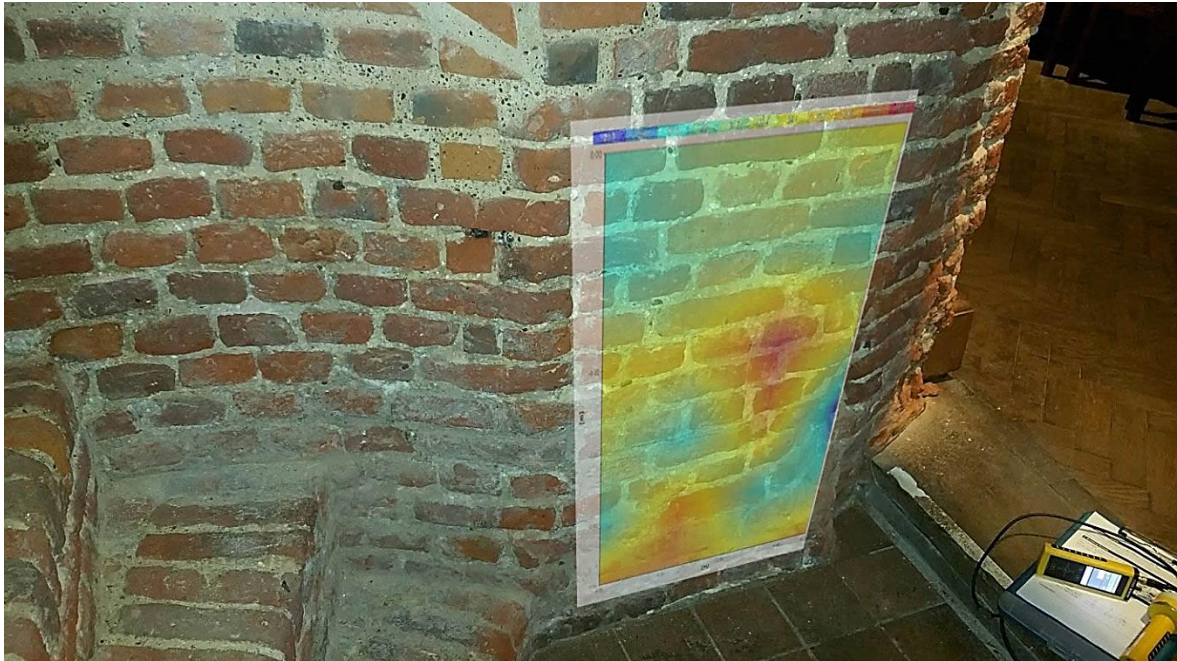
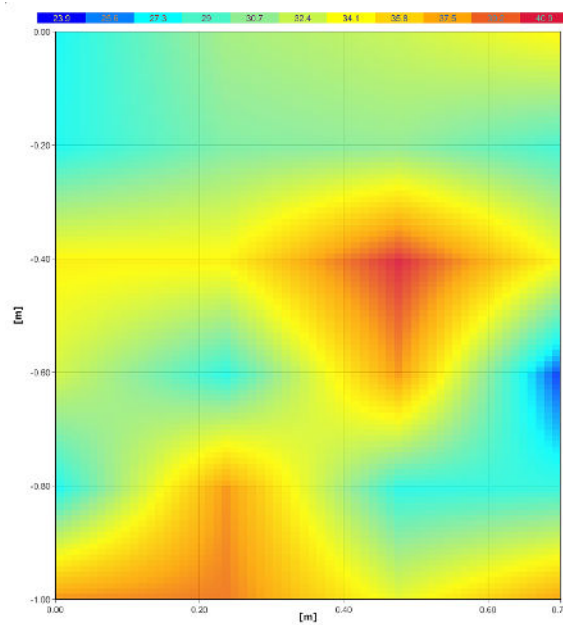
Brick Wall no.2

Red / orange / yellow areas are very damp, light blue moderately damp which need attention, while dark blue areas are normal.

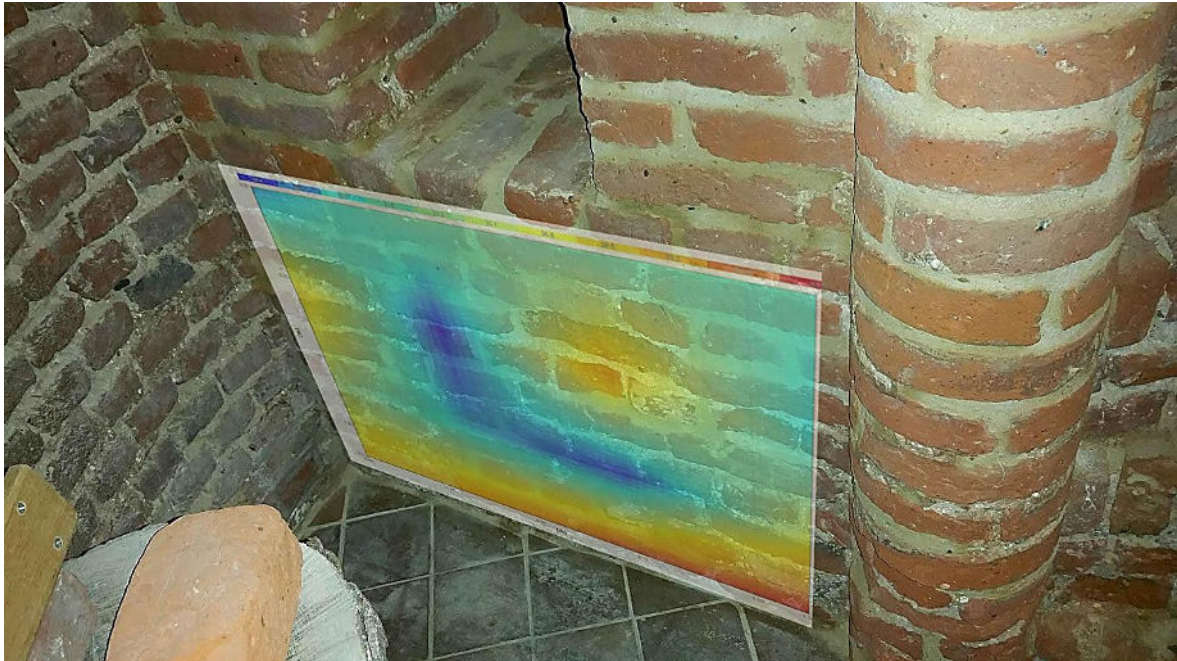
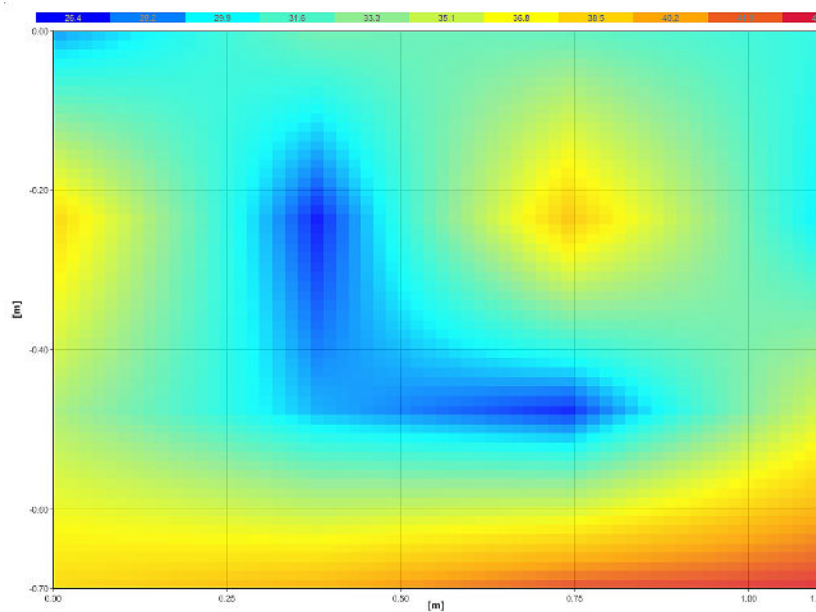
Brick Wall no.3

Red / orange / yellow areas are very damp, light blue moderately damp which need attention, while dark blue areas are normal.

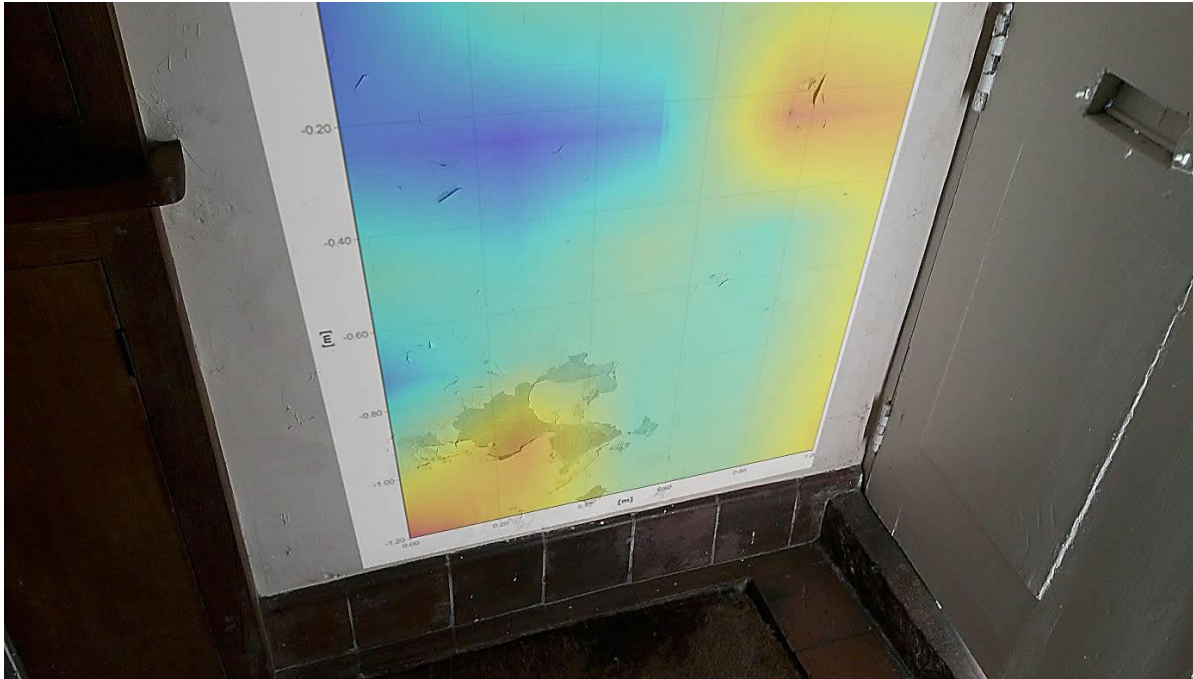
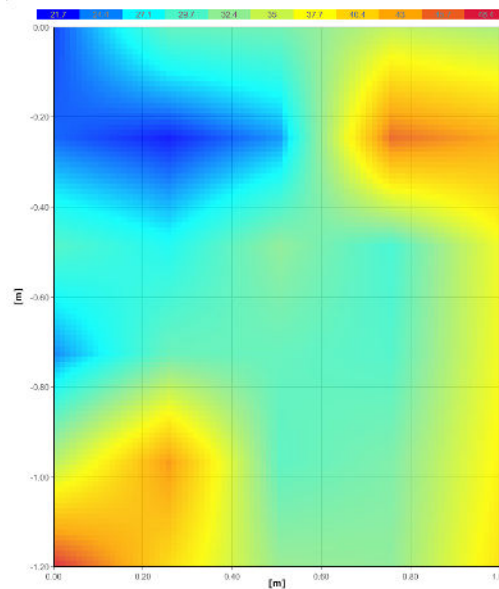
Entrance

Red / orange / yellow areas are very damp, light blue moderately damp which need attention, while dark blue areas are normal.

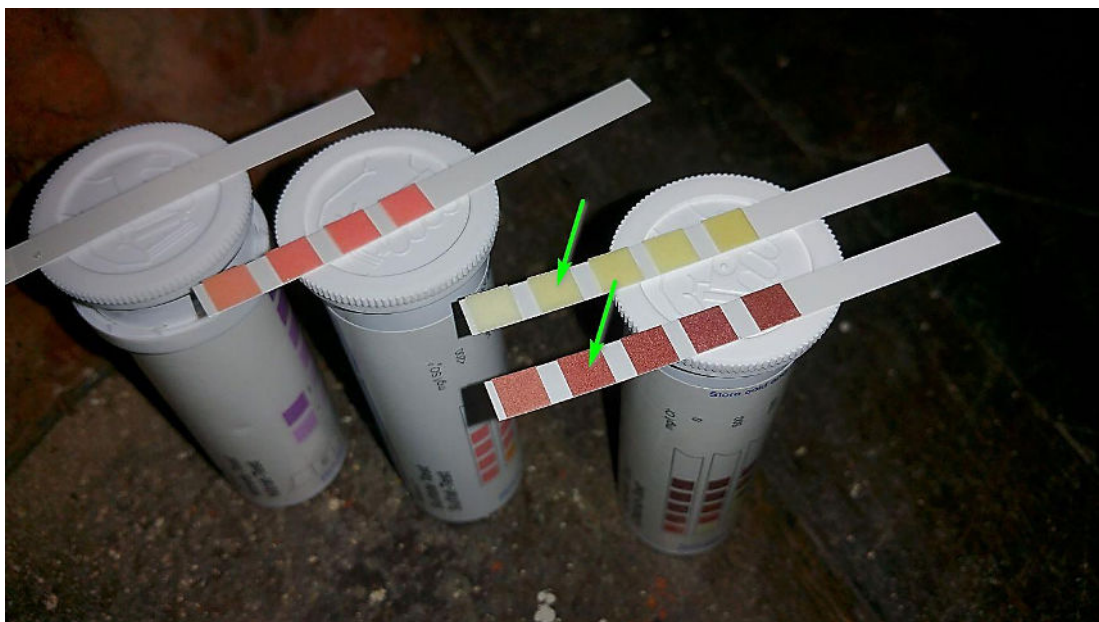
It can be seen on this last picture, that the test strip has changed its colour from dark brown to white, indicating an extremely **high concentration of chlorides**.

The main source of chlorides are sea salts, which indicates that it is possible that the sand used in the mortar is originating from a nearby beach, as well as the ground is permeated with sea salts, which gradually have migrated into the brickwork due to capillary action.
