Dampness Report

Clock Tower – Arts Centre

23 February 2025

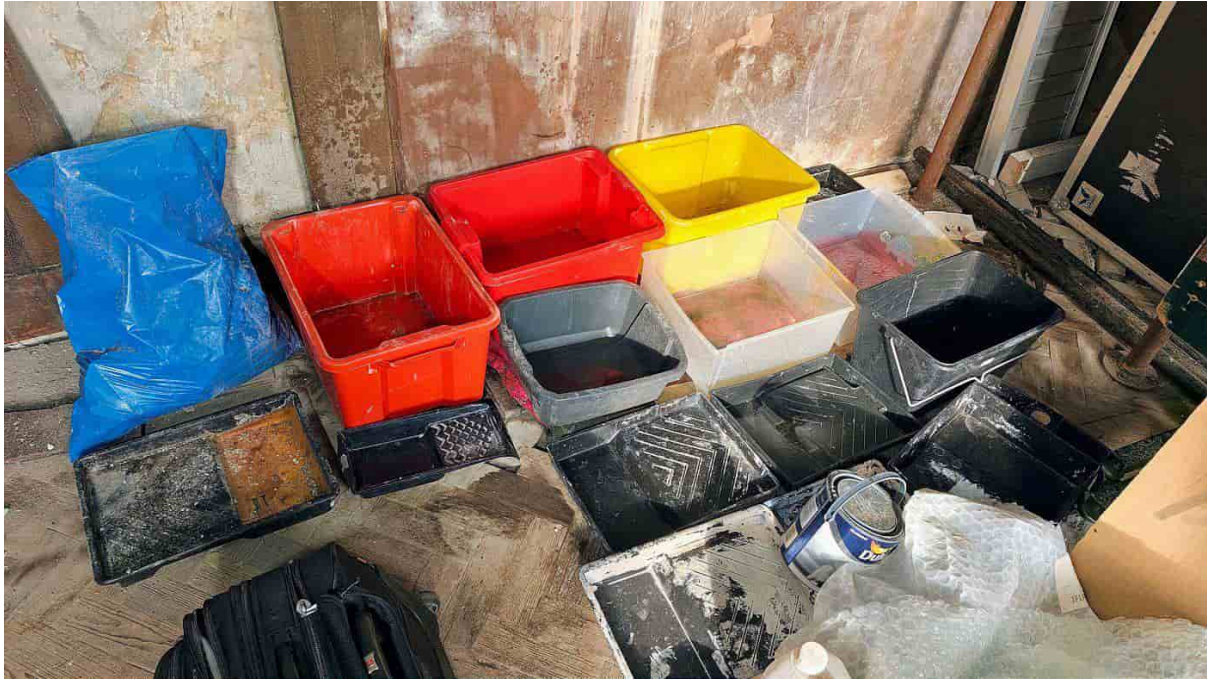
Increasing water ingress has been reported from the storage room, which significantly worsened from November 2024 with the onset of the cold and rainy season. Water catching trays and buckets had to be put in place to deal with the ongoing dripping water into the storage area.

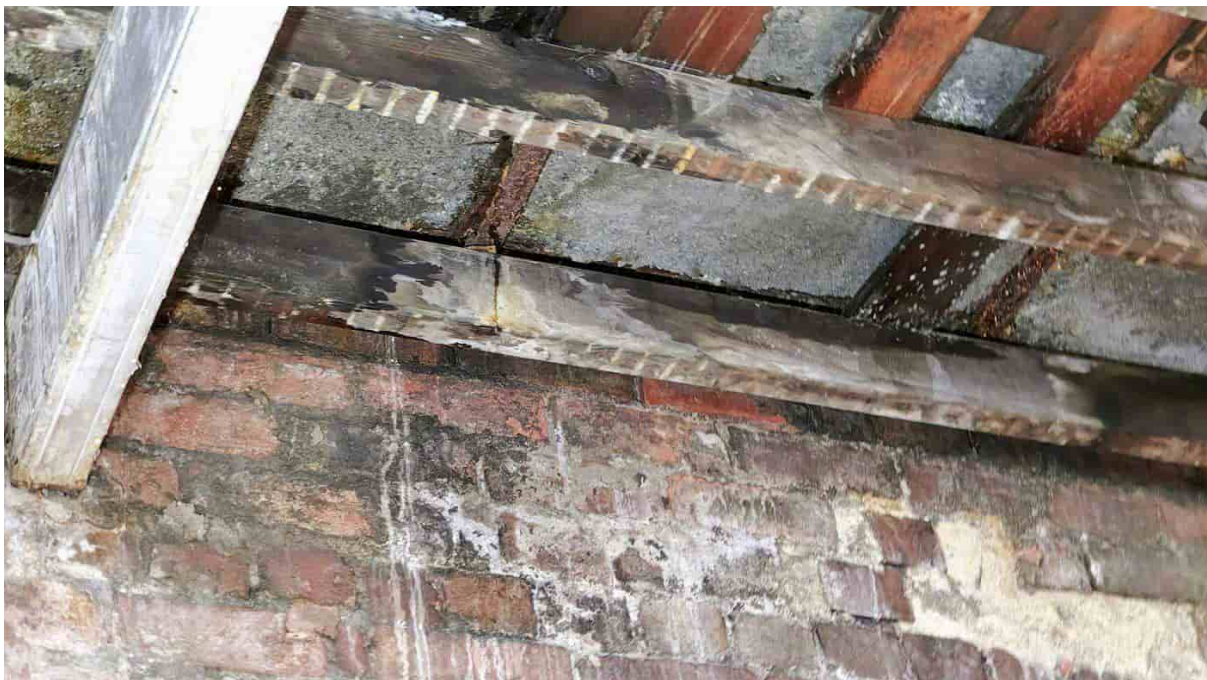
The worst affected area is the South facing wall with a concrete flat roof section above the dripping area.

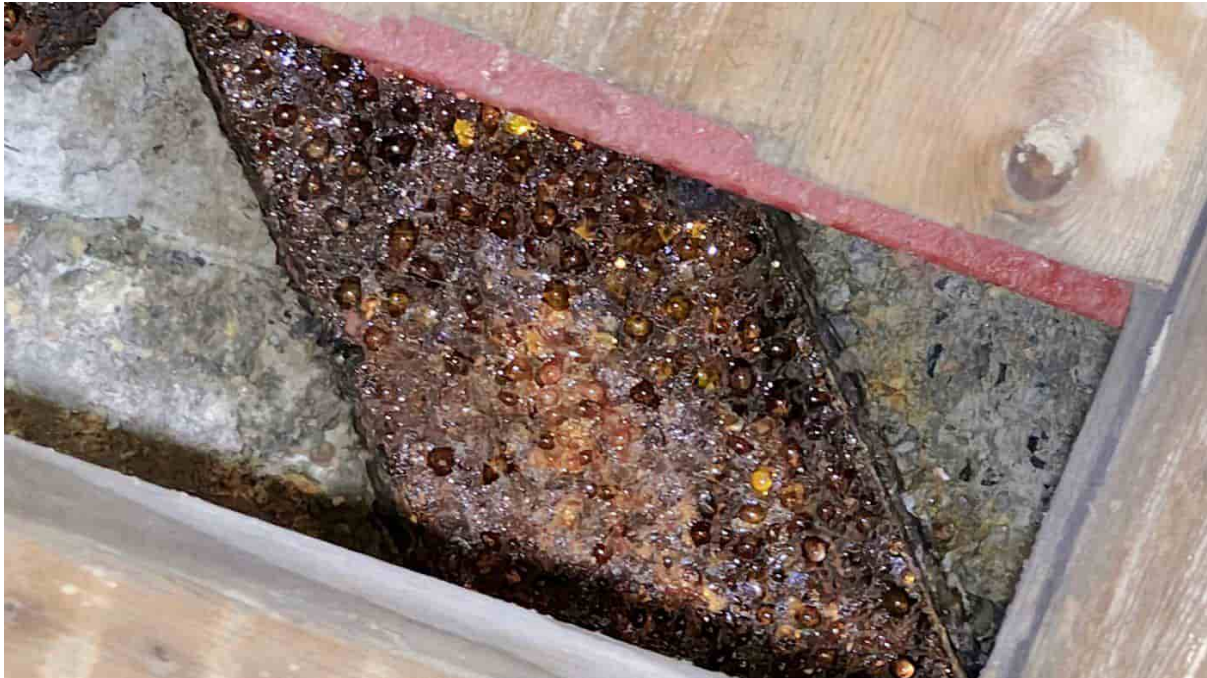
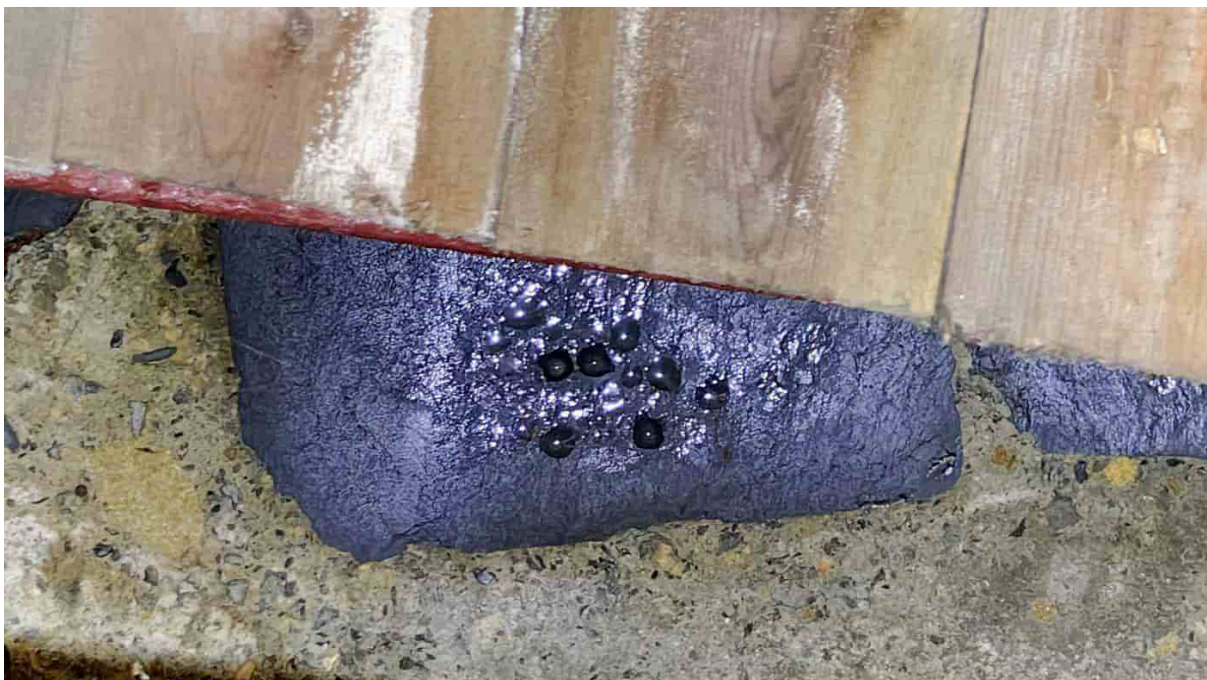
Due to the cold environment and lack of any thermal insulation in this area, condensation causes ongoing liquid water formation on the cold concrete and embedded metal beam surfaces. The condensation is so intense, that it causes similar manifestation to liquid water ingress, resulting in ongoing water dripping.

- **Fondo Pozzolanico MGN**: because the ceiling contains metal beams that can't be plastered on, it needs the application of a special waterproof lime coat, on the cement and metal beams to allow subsequent plaster coats to bond to it. So this coat is a lime-based bonding coat, that allows the application of any lime plaster onto the metal and cement.
- **Rinzaffo MGN** salt resistant, waterproof lime base coat: @10 mm thickness (15 mm included to allow for the repair and levelling of uneven surfaces).
- **Coccio term 2020 MGN** high quality lime-cocciopesto thermal insulating coat, breathable @60 mm. This material has high moisture tolerance and condensation regulating properties, while being very breathable, capable of dealing with the heavy condensation under the flat roof.
- **Rasacol MGN** high quality lime protective finish @4 mm

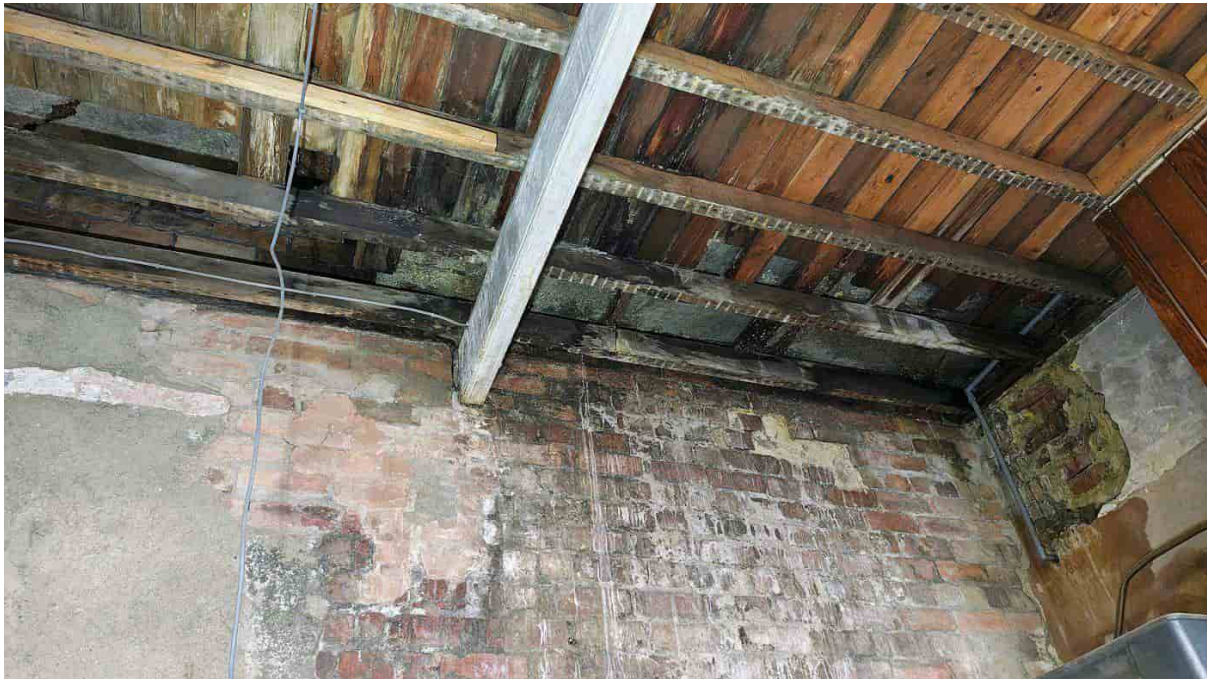
As this problem has been ongoing for years, it already caused some significant damages to the timber ceiling and joists, which are also the floor of the clock room situated above.

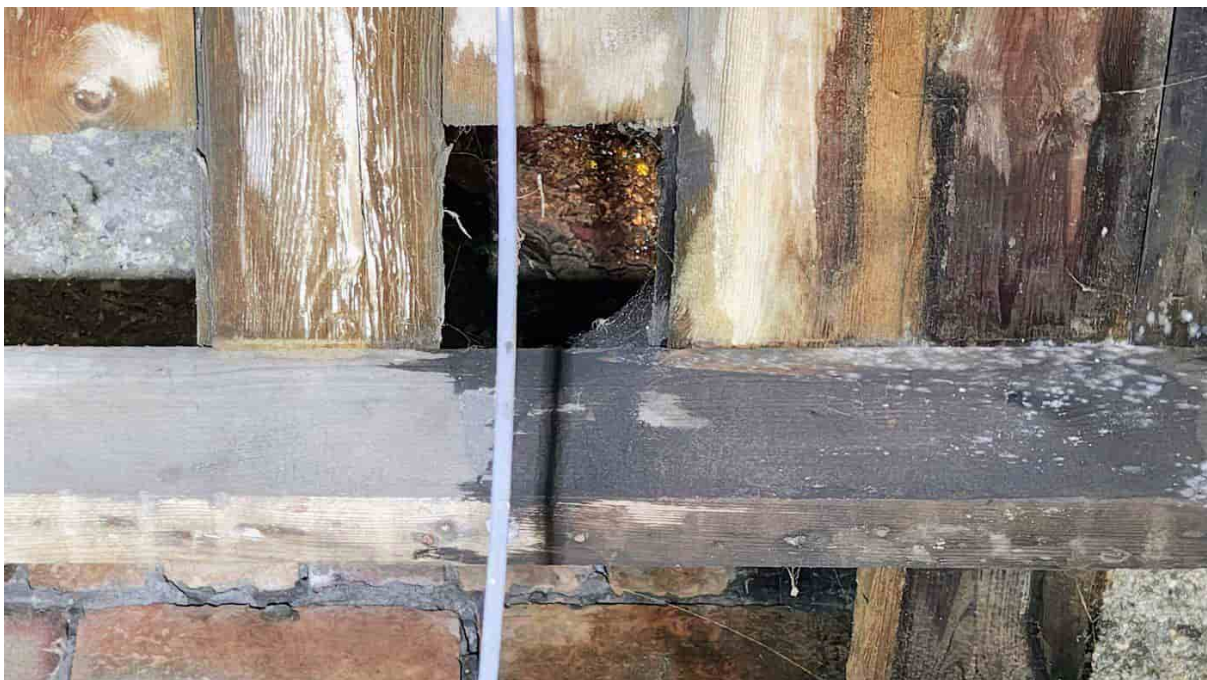
If not addressed, the water from the ongoing condensation could permanently damage the historic timber ceiling structure.

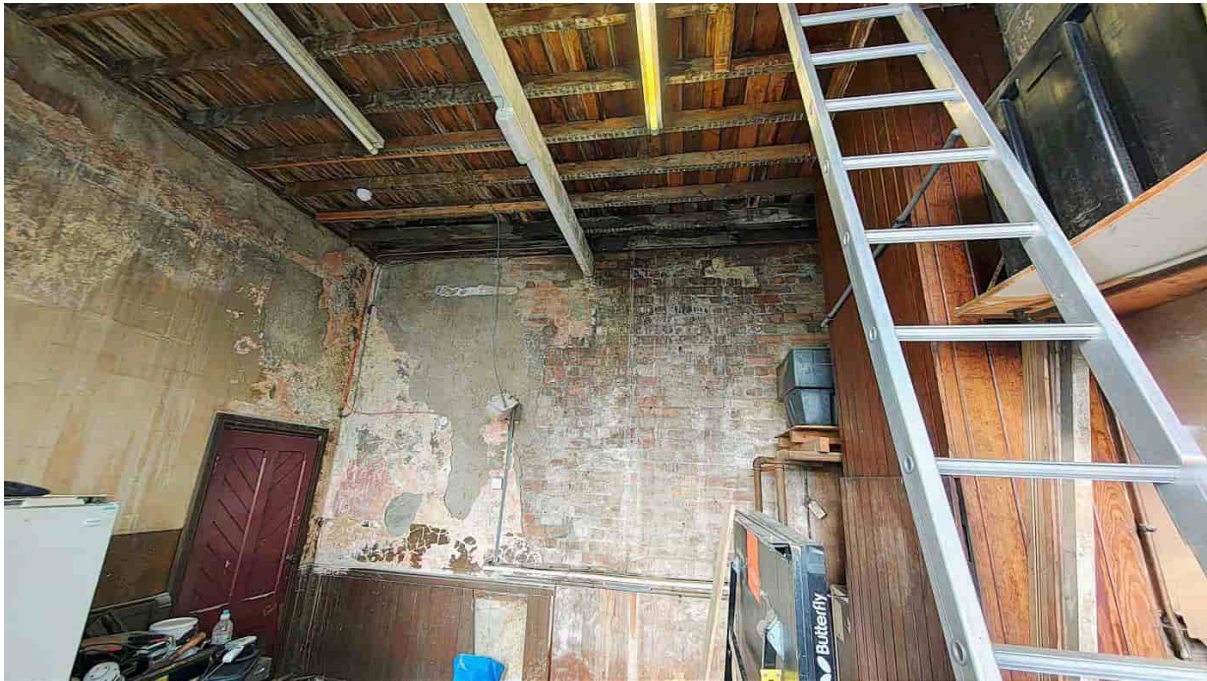
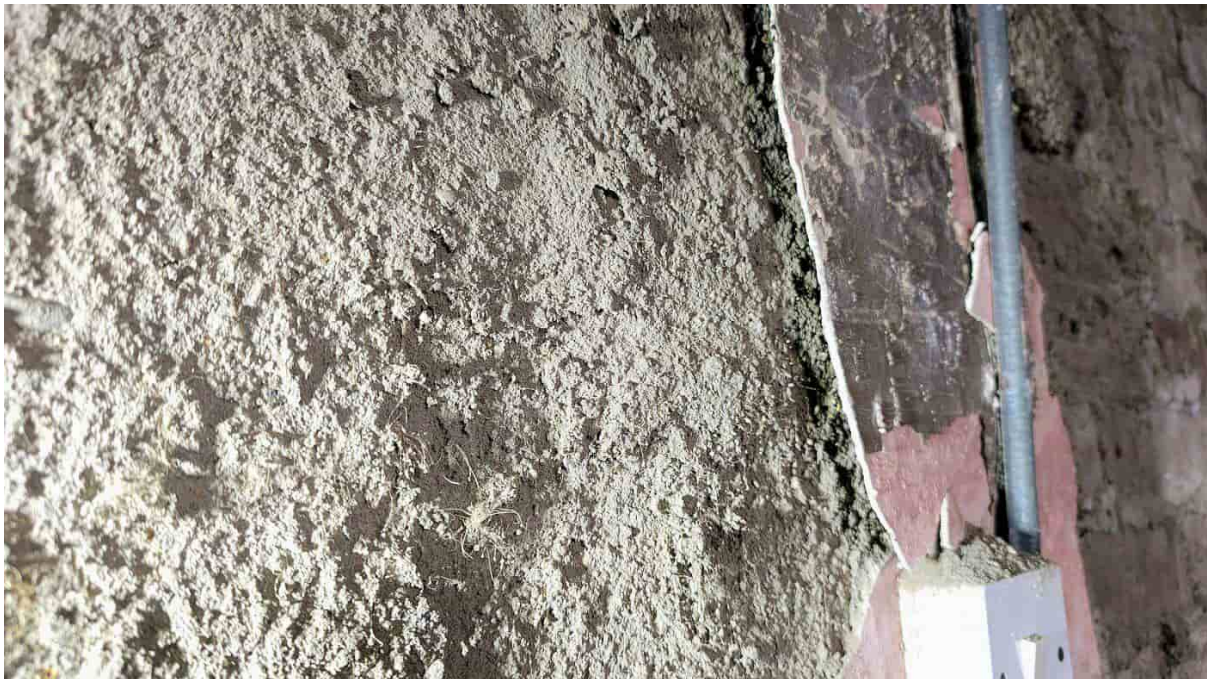
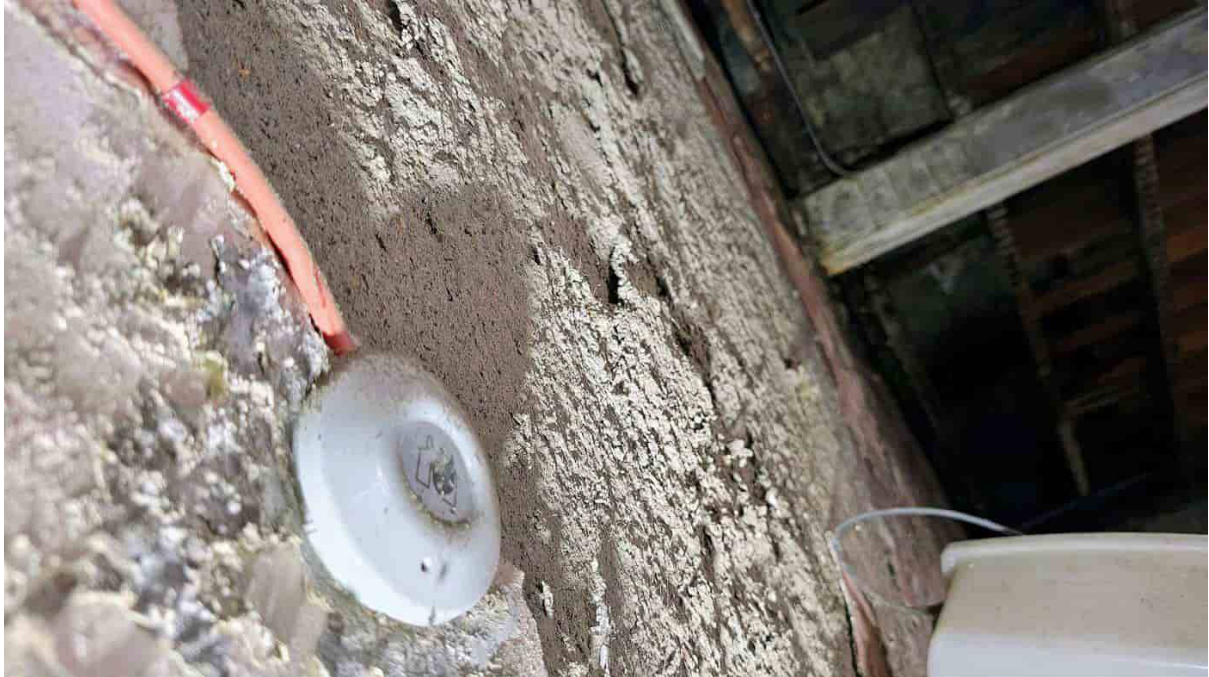
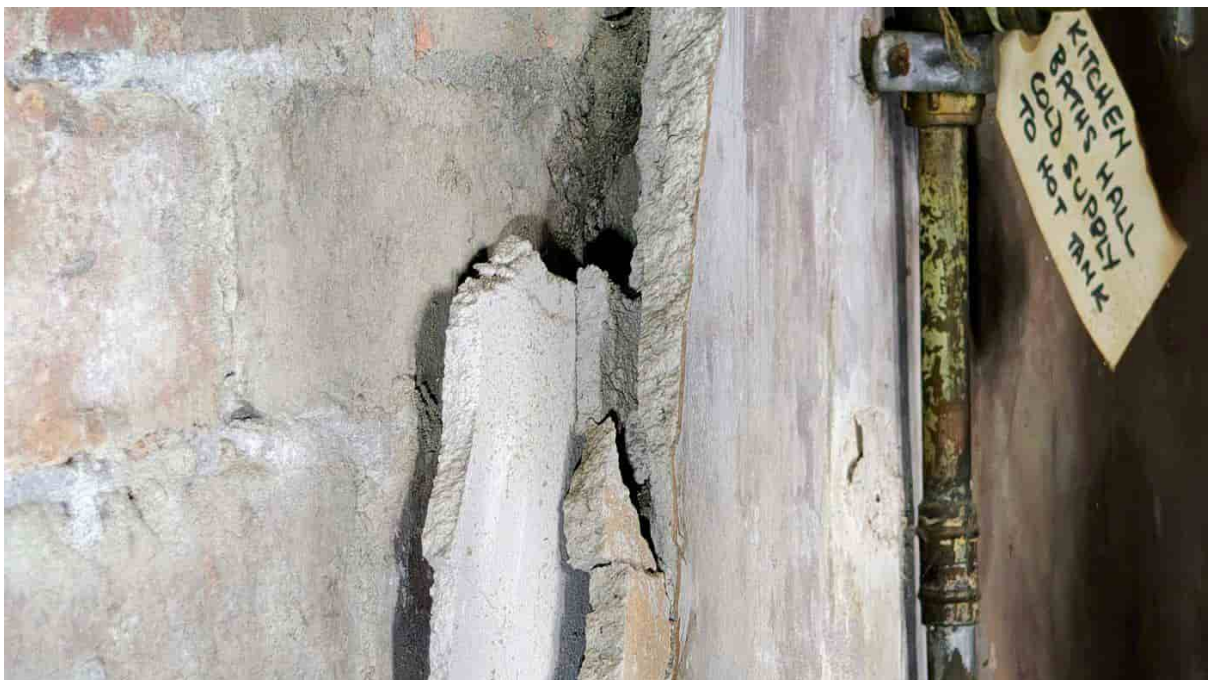
The plastering in the room is in generally poor condition. The lime plaster on the South facing wall, mostly affected by the dripping condensation, has almost completely decayed.

- **Rinzaffo MGN** salt resistant, waterproof lime base coat: @10 mm thickness (15 mm included to allow for the repair and levelling of uneven surfaces).
- **Calce Fondo 2020 MGN** high quality lime coat, breathable @20 mm. This material has high moisture tolerance while being very breathable.
- **Rasacol MGN** high quality lime protective finish @4 mm

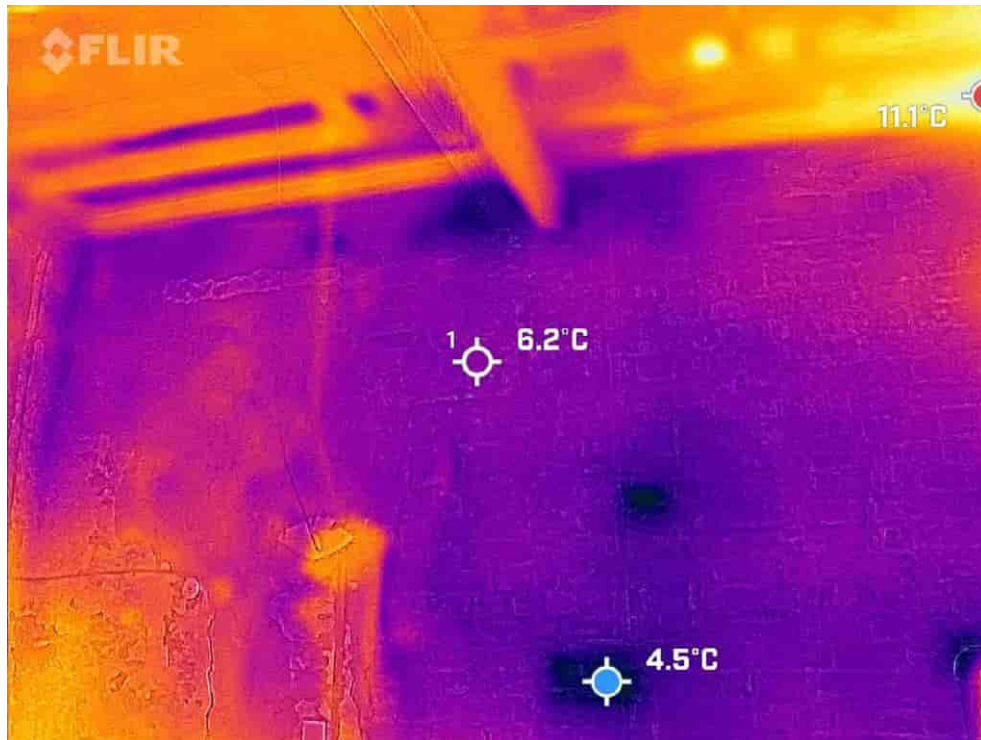
Soth Wall, the most affected by condensation. Fully external wall, very cold.

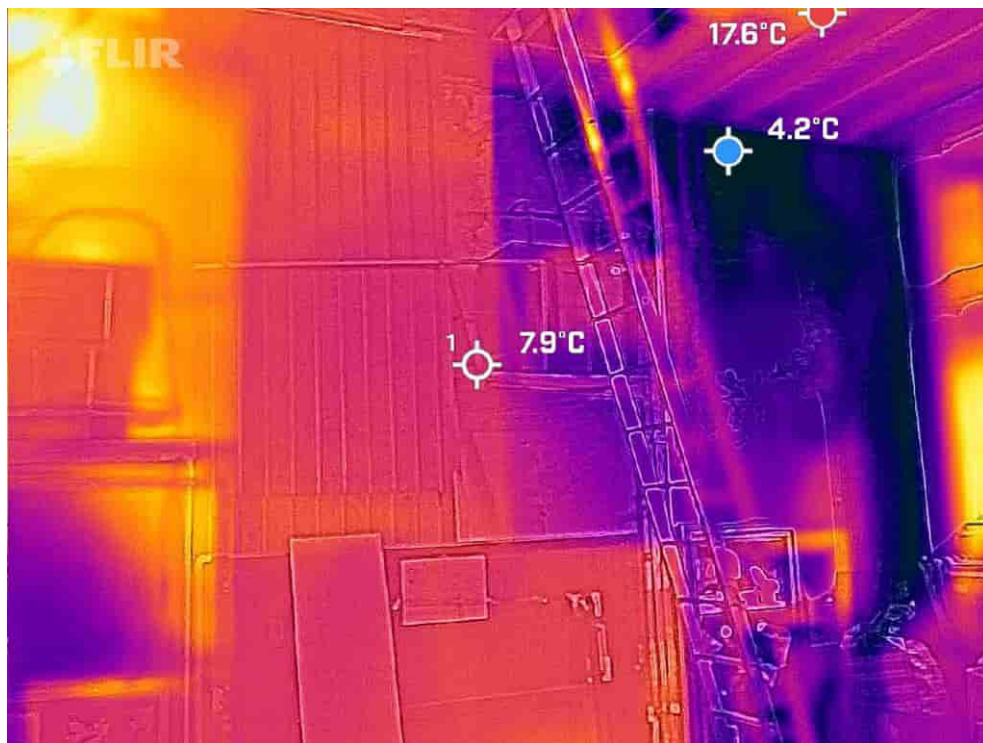
West Wall, with the ladder. Mostly external wall.

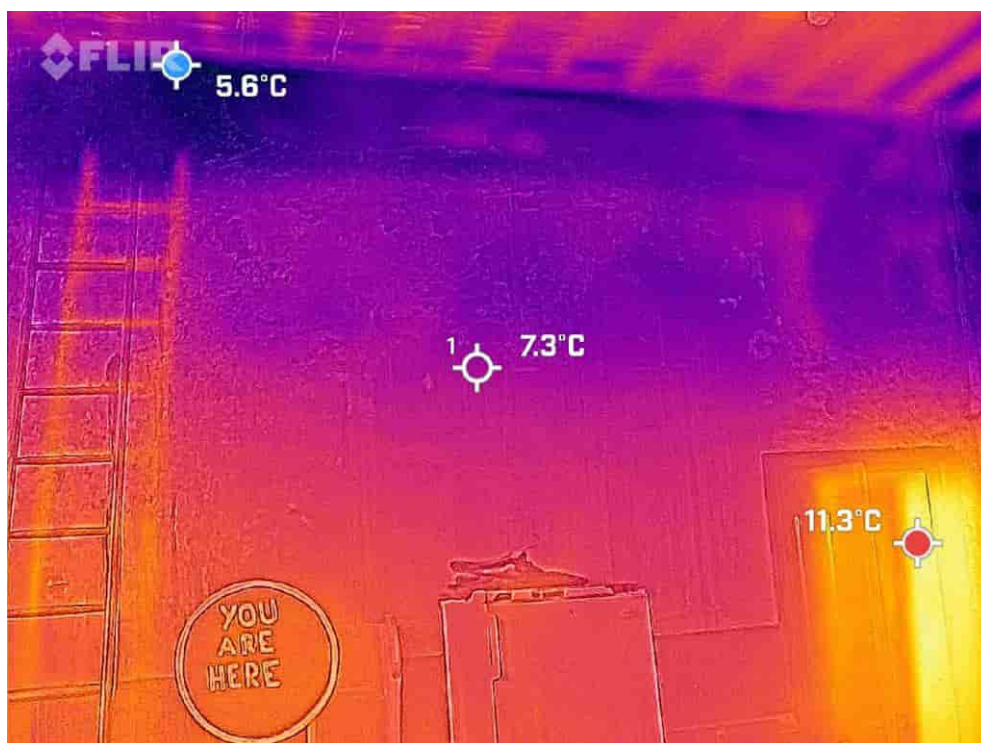
East Wall, mostly internal, except the upper third which is external.

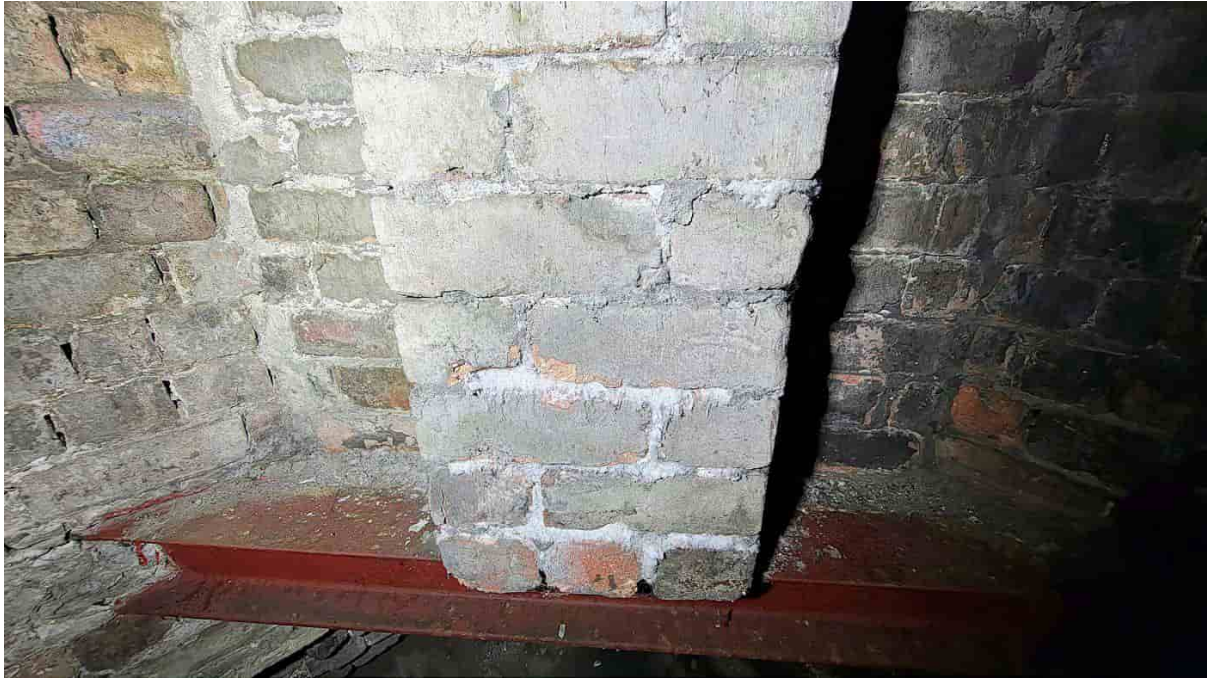
This room has been most probably the subject of some major structural work in the past. Some parts of the tower have been reinforced with steel beams, adding brick reinforcement piers to better support the weight of the cupola.

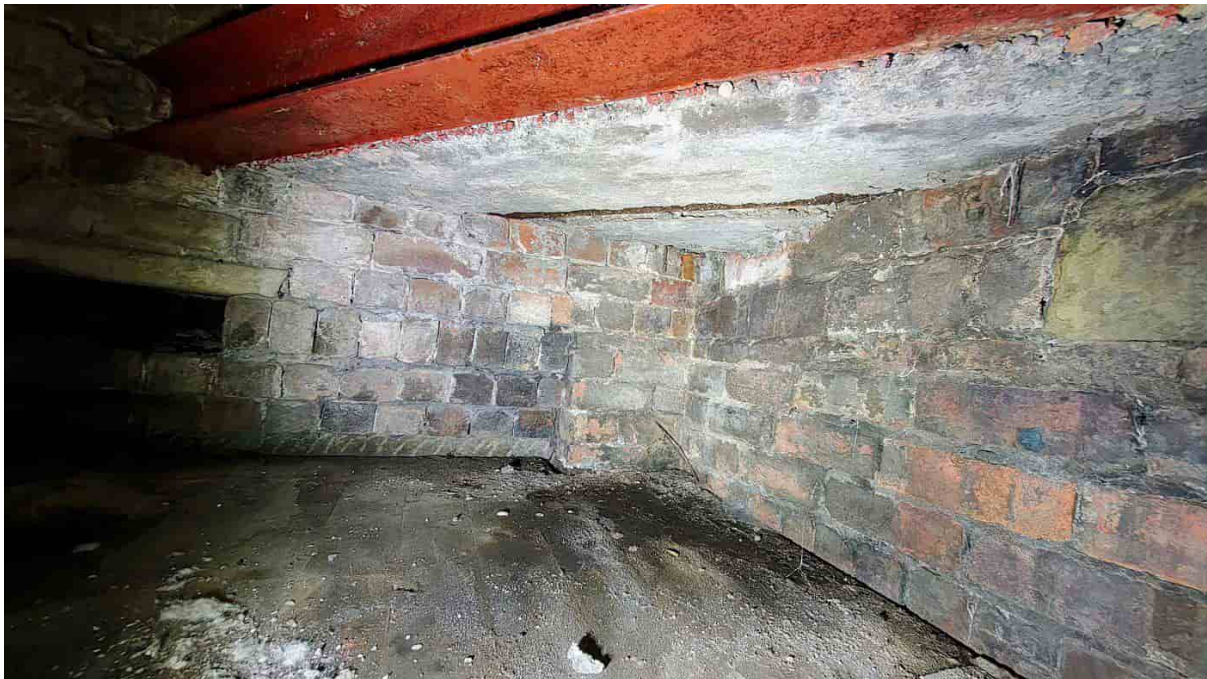
The reinforcement steel beams have also been encased in modern Portland cement, indicating that this most likely has been a later modification.

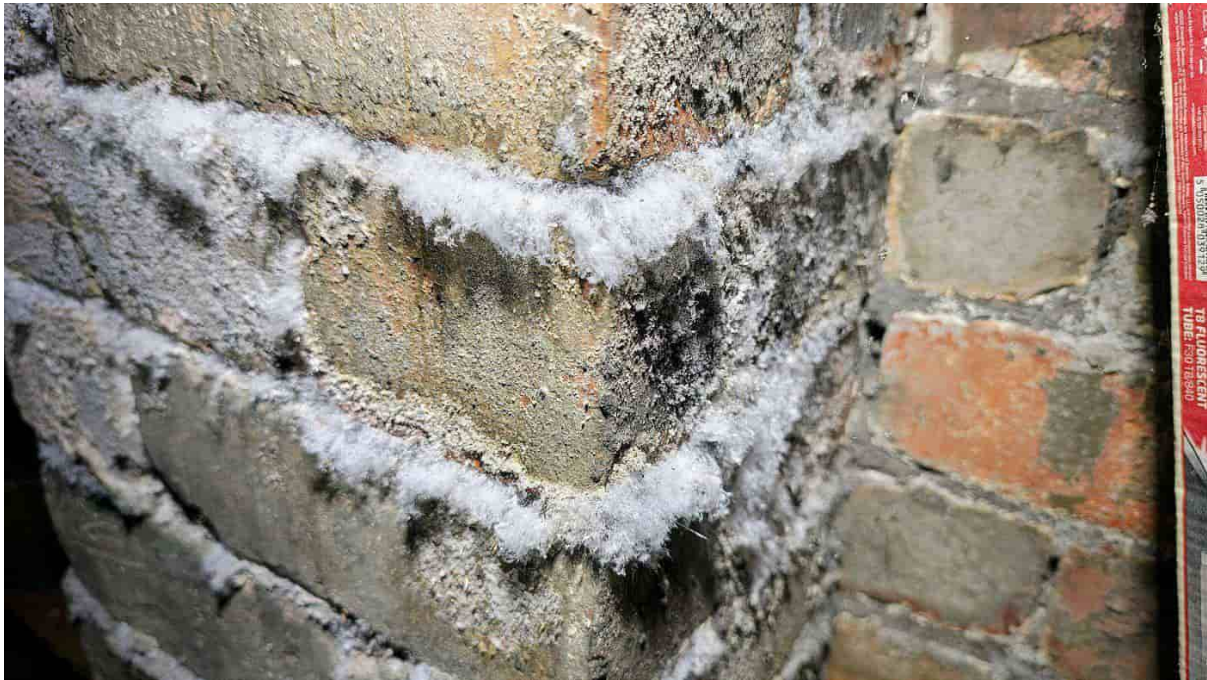
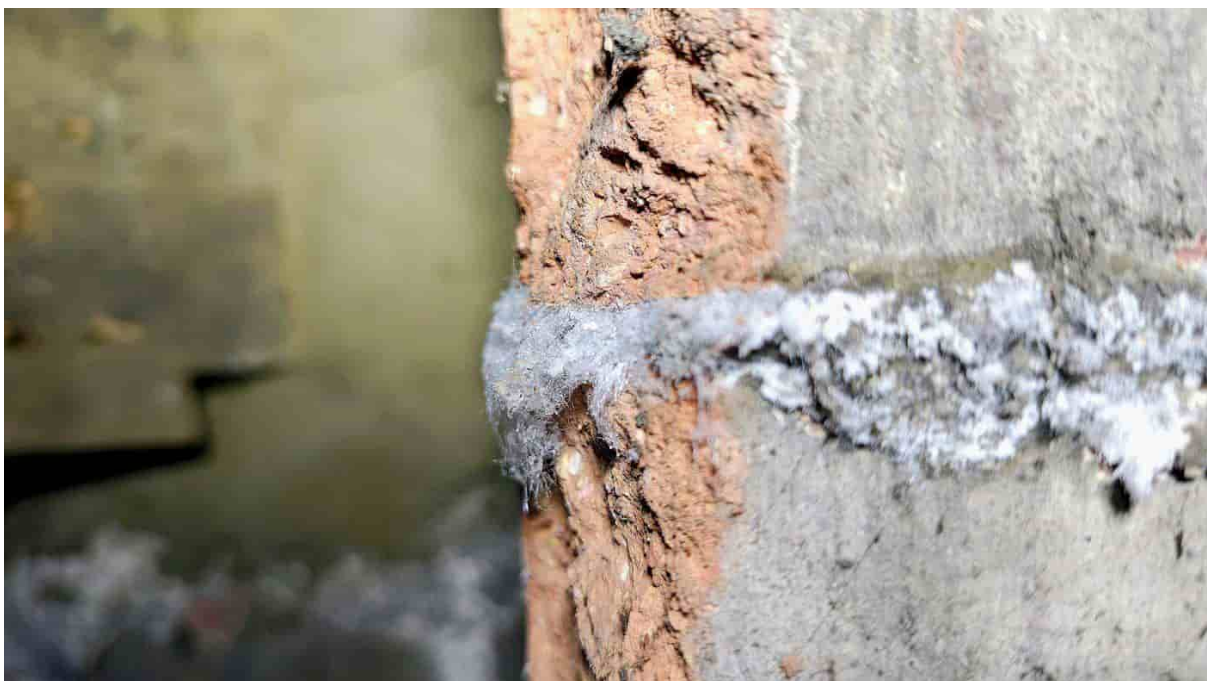
There is **heavy salt crystallization** through the mortar bed of the reinforcement piers. This, on the surface, looks like a small cosmetic issue, however long-term it can cause or contribute to structural problems.

In the presence of humidity changes salts get damp then crystallize, expanding 5-10 times in volume, leading to the spalling and cracking of bricks, as well as historic masonry decay.

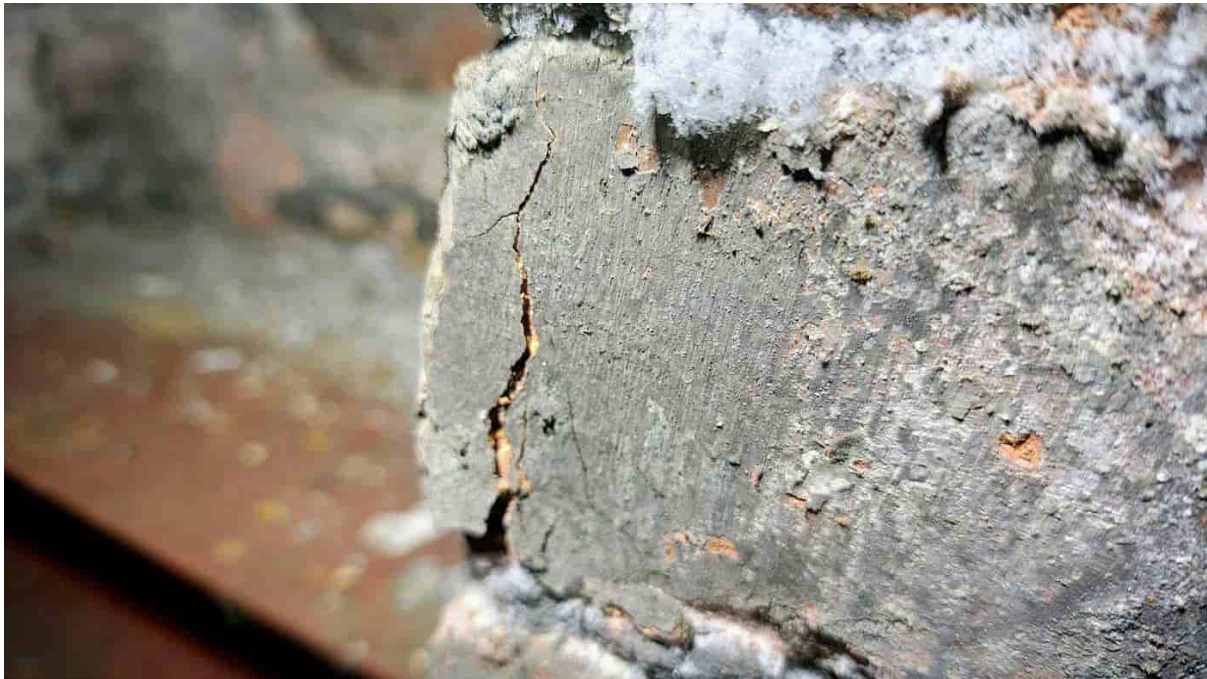
Salt-induced cracks are already visible on some bricks, leading to permanent fabric loss and structural weakening over time.

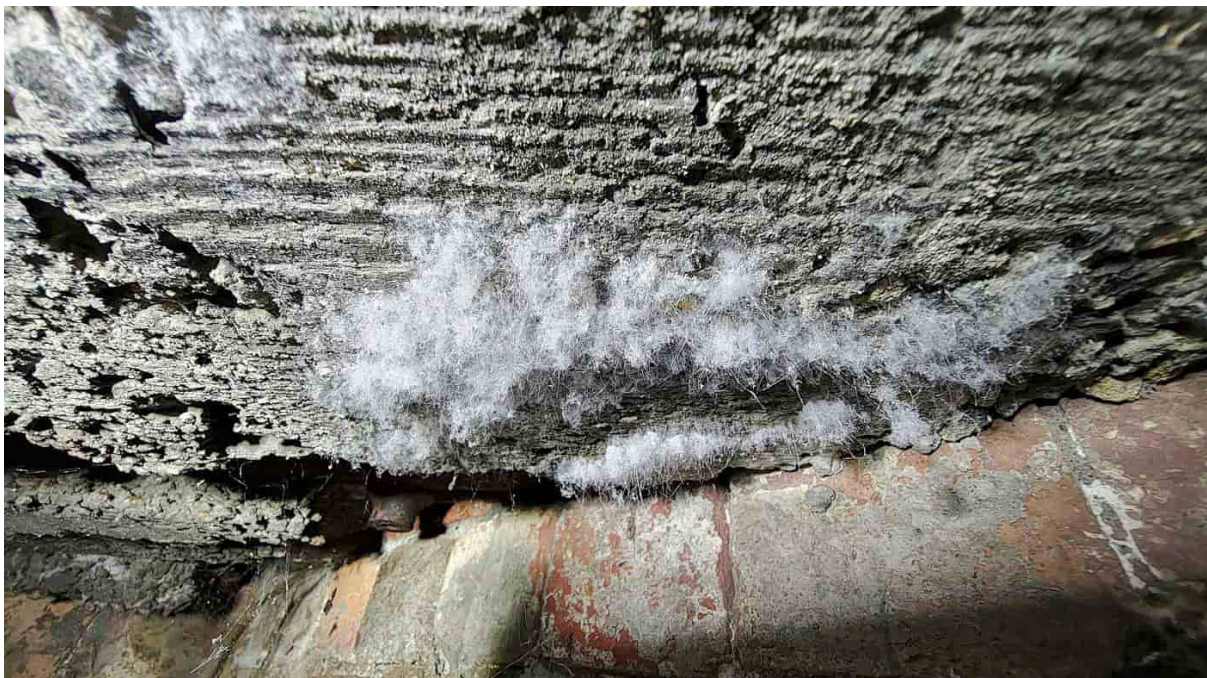
The cement blocks reinforcing the steel beams contain salts. In the presence of moisture this leads to significant salt crystallization on the surface of cement.

- **Rinzaffo MGN** salt resistant, waterproof lime base coat: @15 mm thickness (20 mm included to allow for the levelling of uneven surfaces).
- **Coccio term 2020 MGN** high quality lime-cocciopesto thermal insulating coat, breathable @20 mm. This material has high moisture tolerance and condensation regulating properties, while being very breathable.

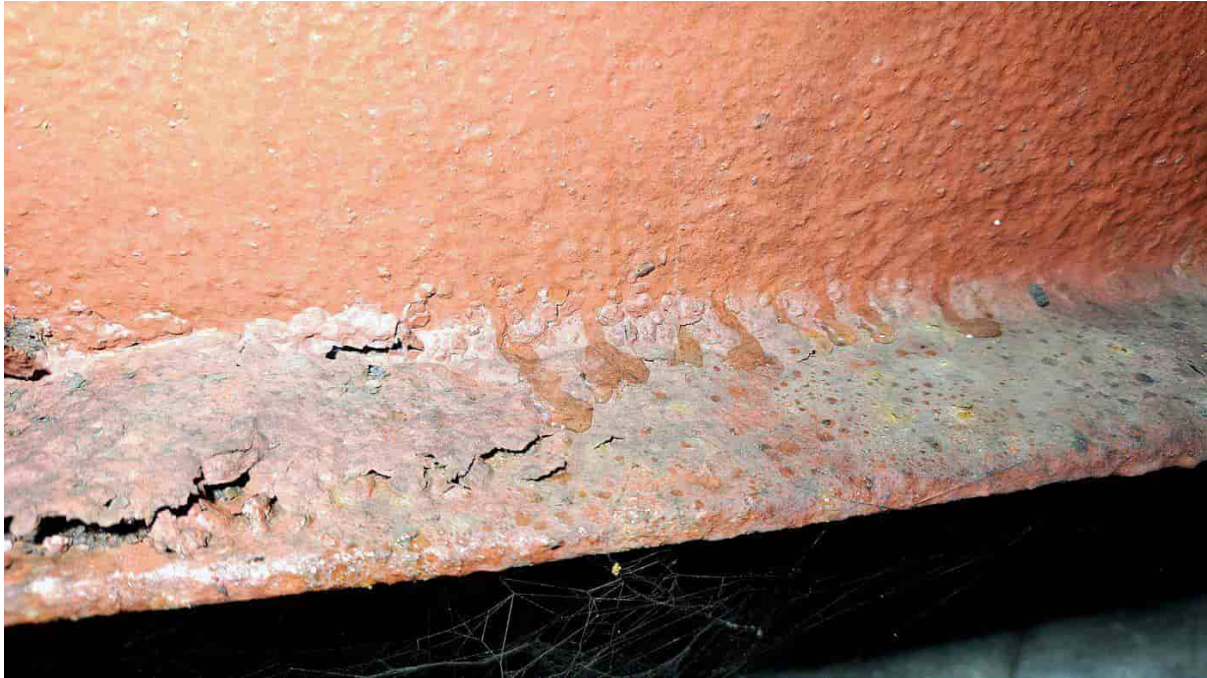
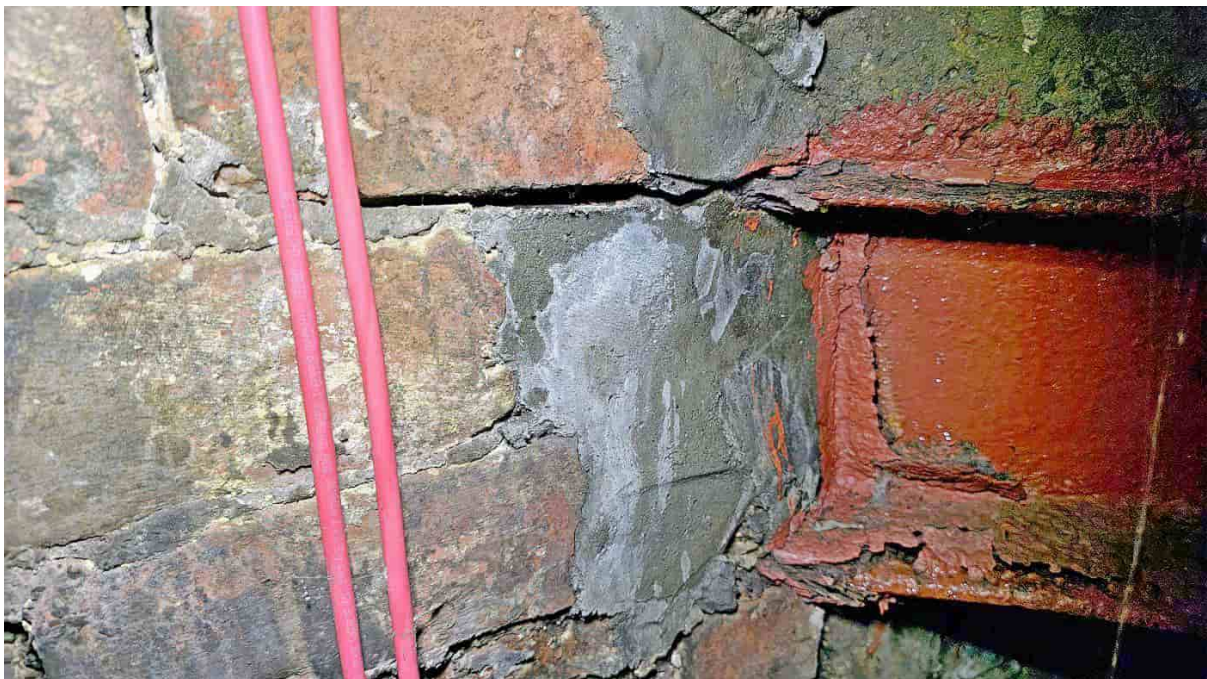
Condensation and rust on the steel and cement surfaces.

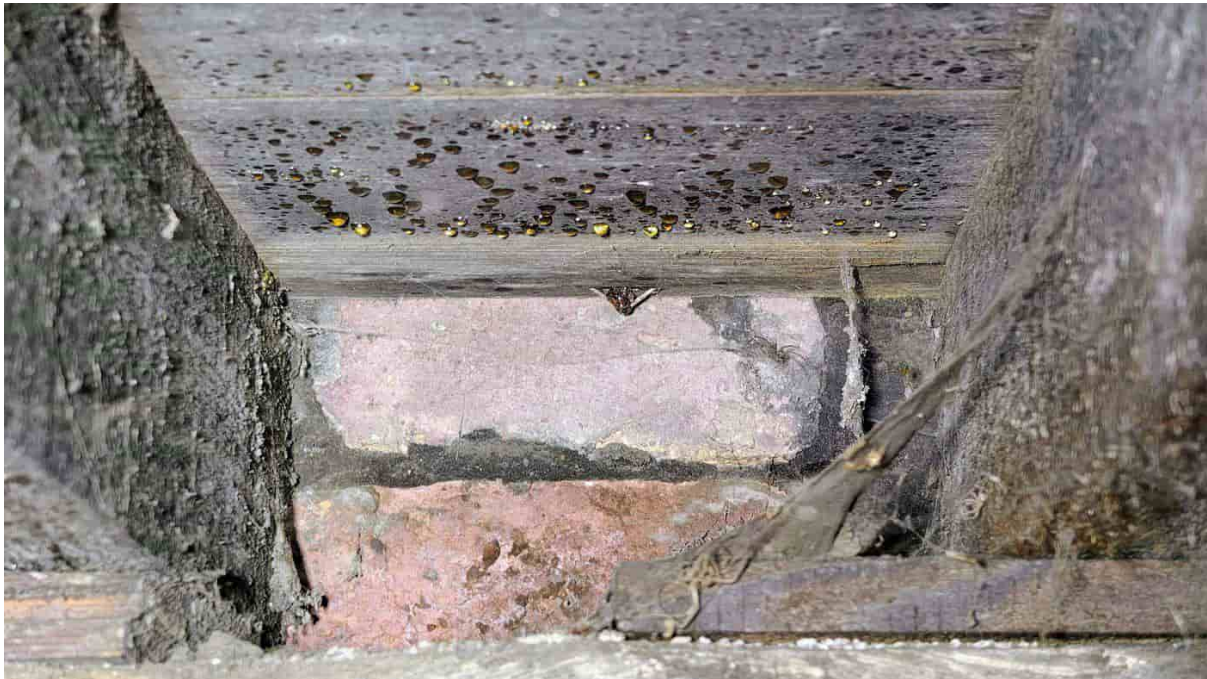
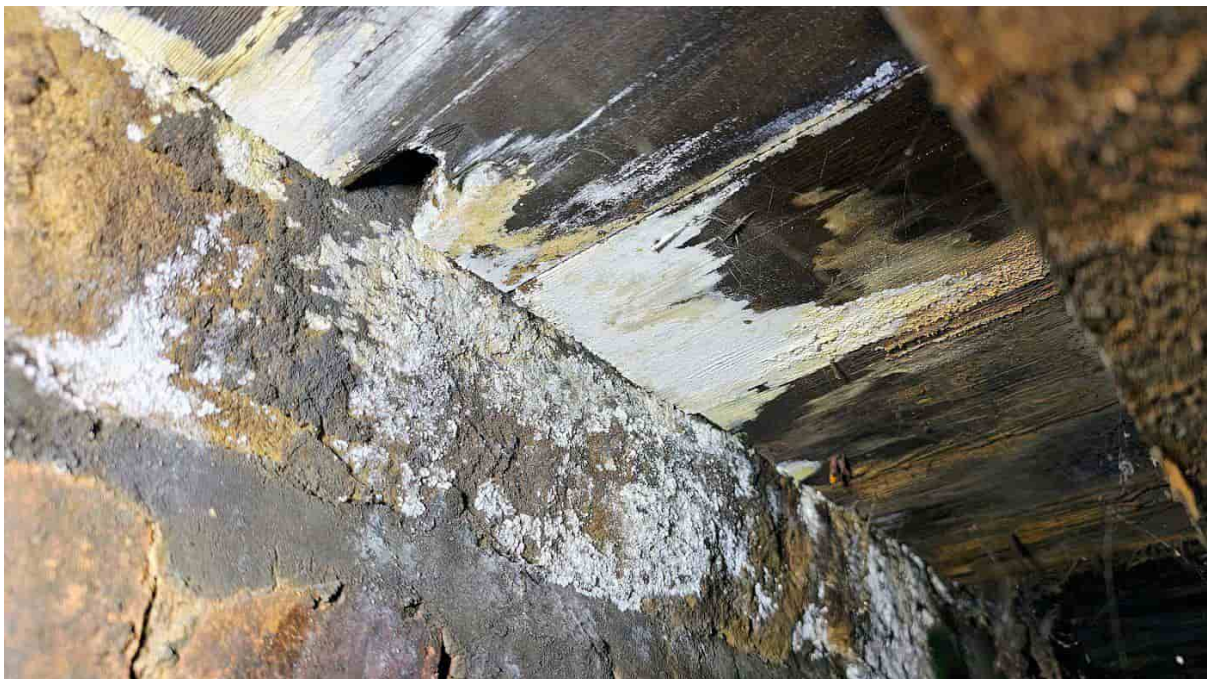
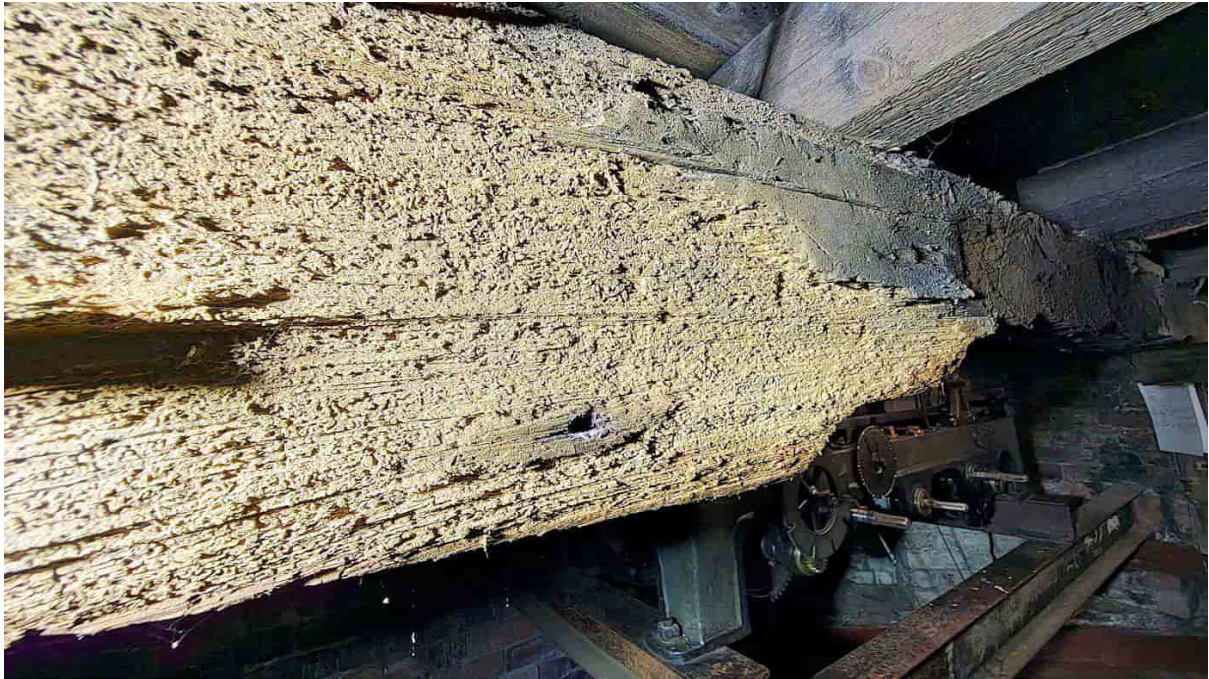
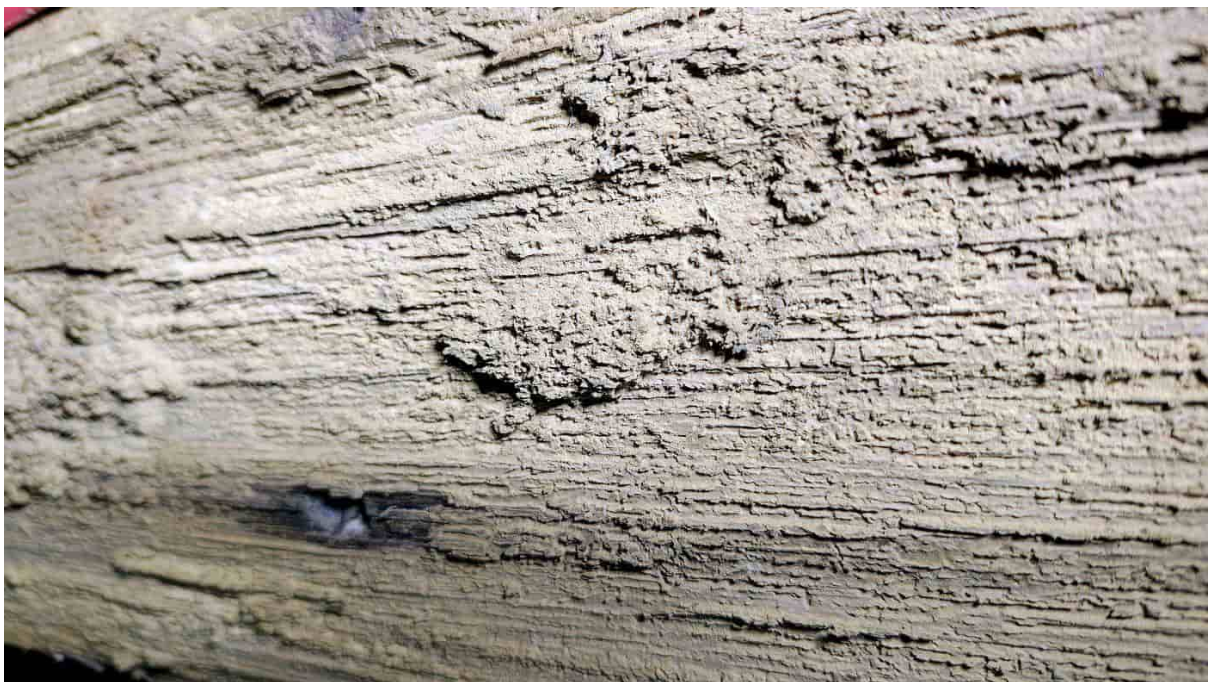
Condensation on timber elements and subsequent rot of beams and joists:

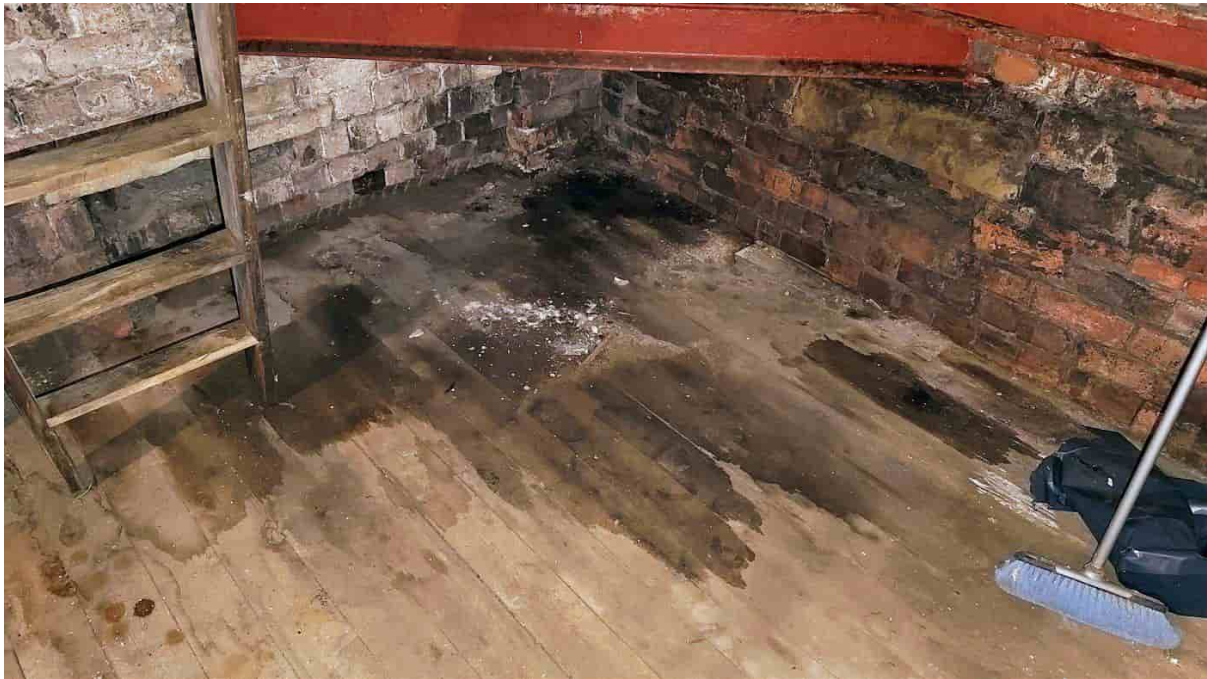
The high humidity and resulting condensation in the Clock Room results in **ongoing liquid water drips** from the underside of the piers and metal beams onto the floor of the Clock Room, causing slow but sustained damages to the floor.

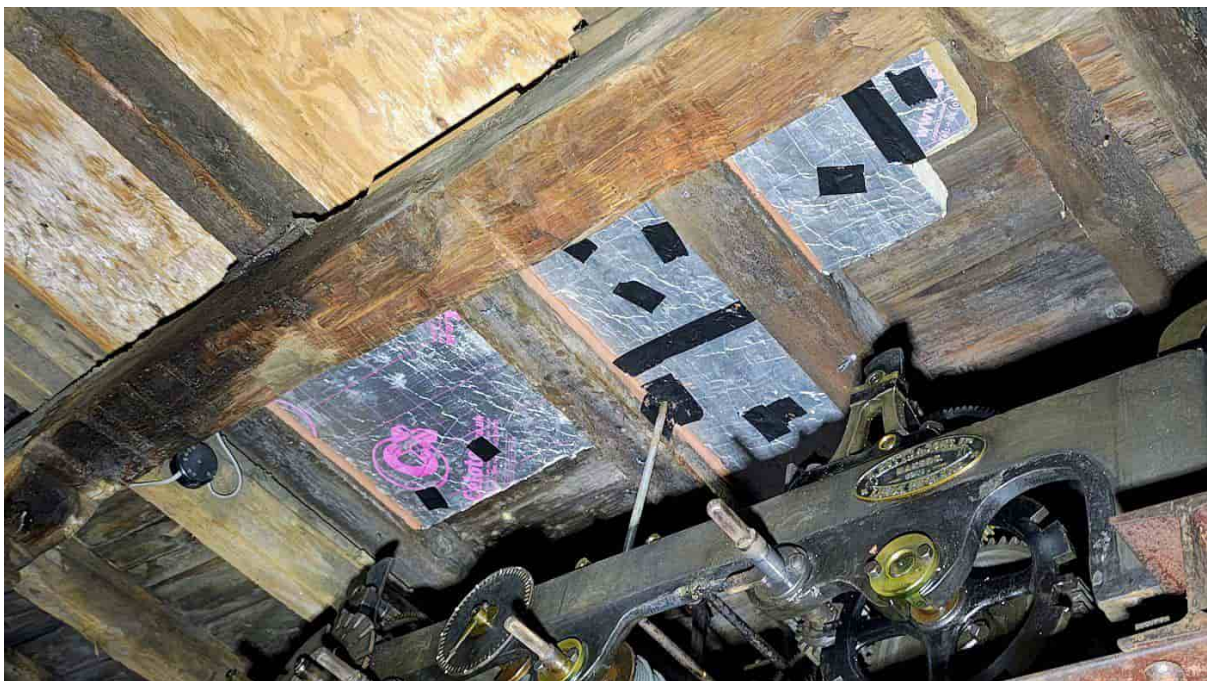
The dripping condensation water from the ceiling (which is also the underside of the cupola floor) cause the clock mechanism to stop. This has been partially mitigated by placing modern foam above the clock mechanism. This stops the dripping but leaves the timber in contact with the non-breathable foam subject to rot.
