Dampness Report

Clock Tower – Arts Centre

23 February 2025

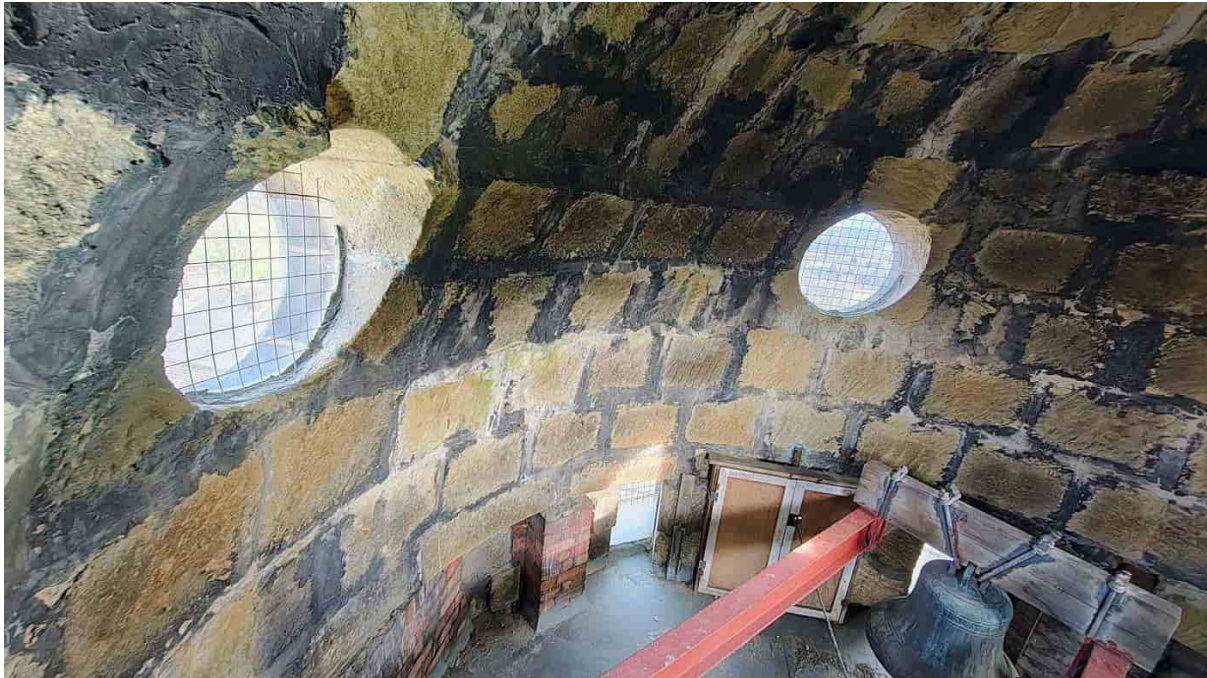
The cupola has 4 round openings. To reduce moisture ingress and to keep the inside of the cupola dry, the four openings are covered by a sheet of glass. Two of these **protective round glasses are missing**, resulting in water ingress on the North and East walls. The walls with water ingress have a distinct green colour as a result of moss growth.

To minimize the ongoing rainwater ingress and keep the inside of the Cupola drier, it is recommended to **refit the two missing glass panes** of the North and East Walls.

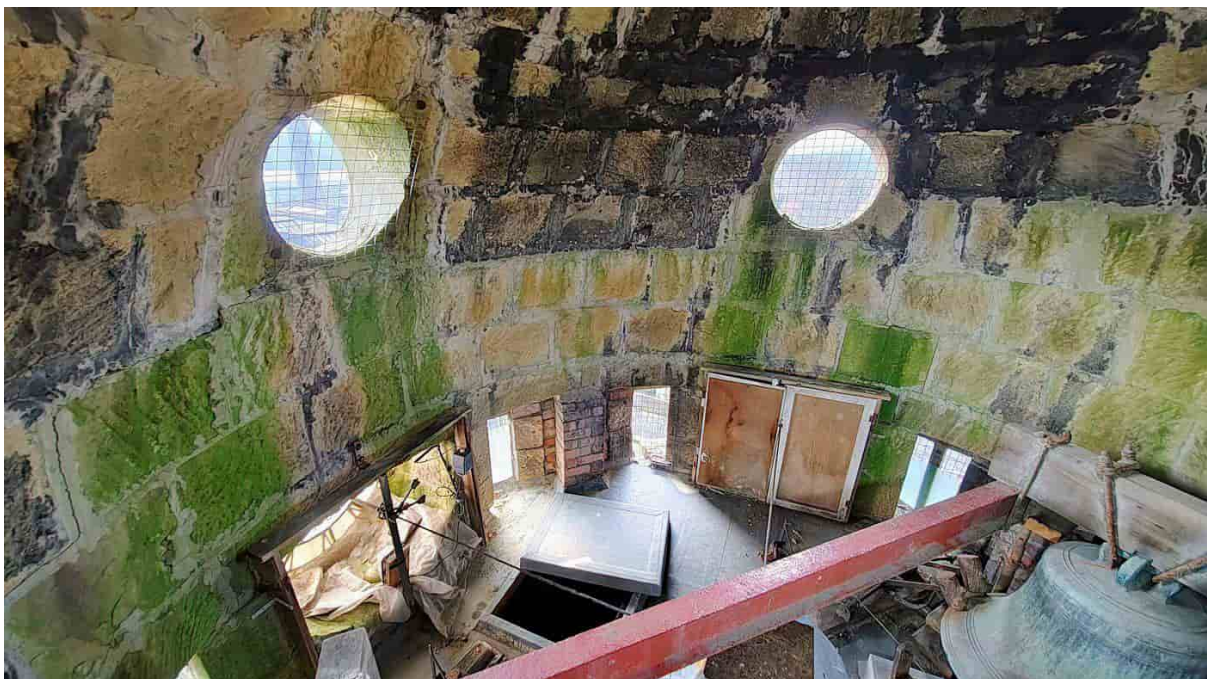
Water ingress and moss growth along two walls (North and East).

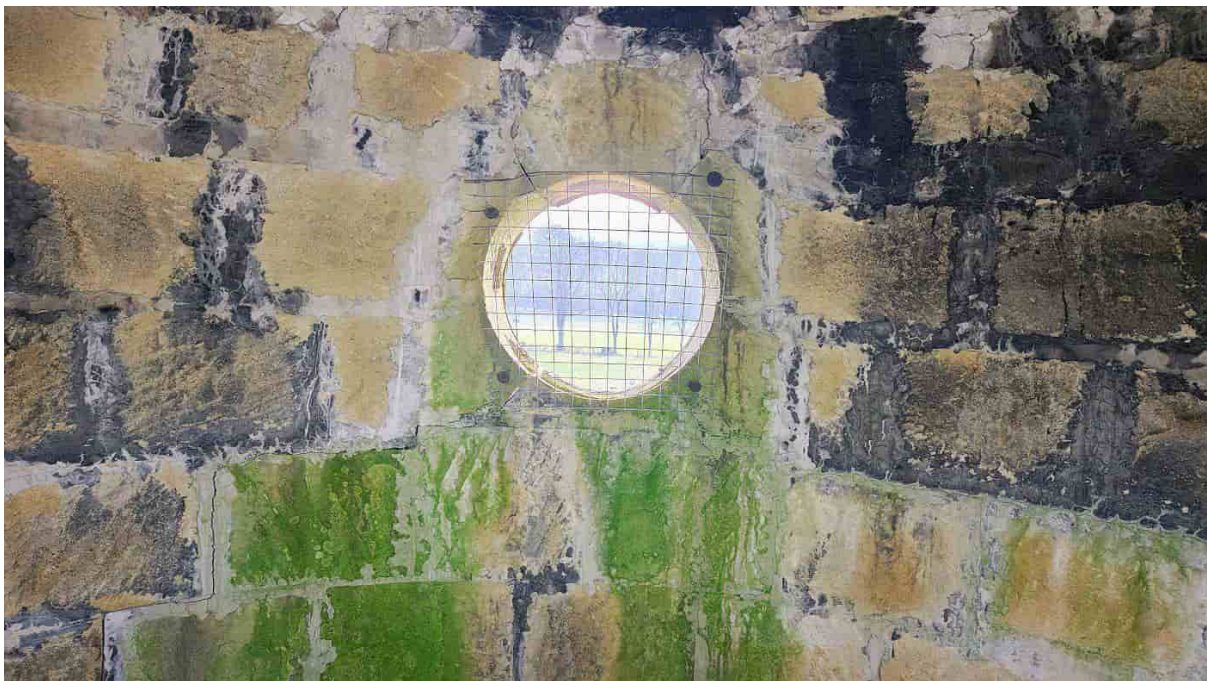
Missing glass along the North Wall – water ingress, green moss growth.

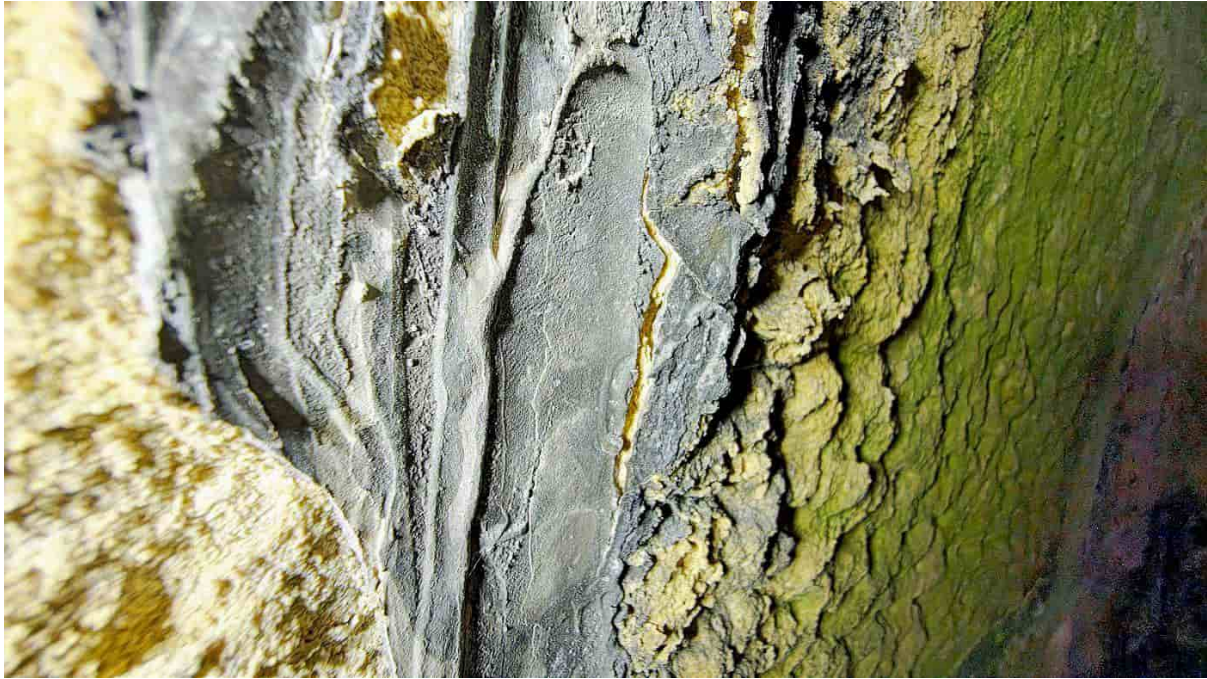
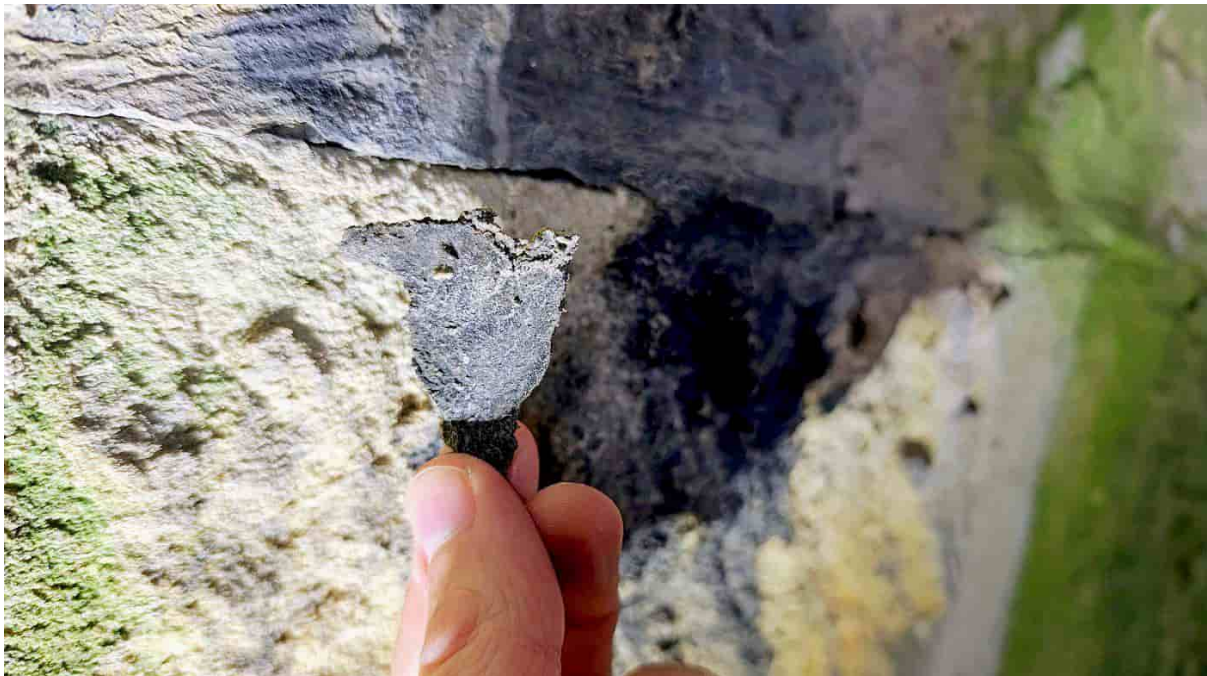
The **condition of the stone** is in fairly weathered condition. Acid rain, as a result of air pollution, reacts with the sand stone, resulting in the known black crust, leading to the gradual decomposition of the stone.

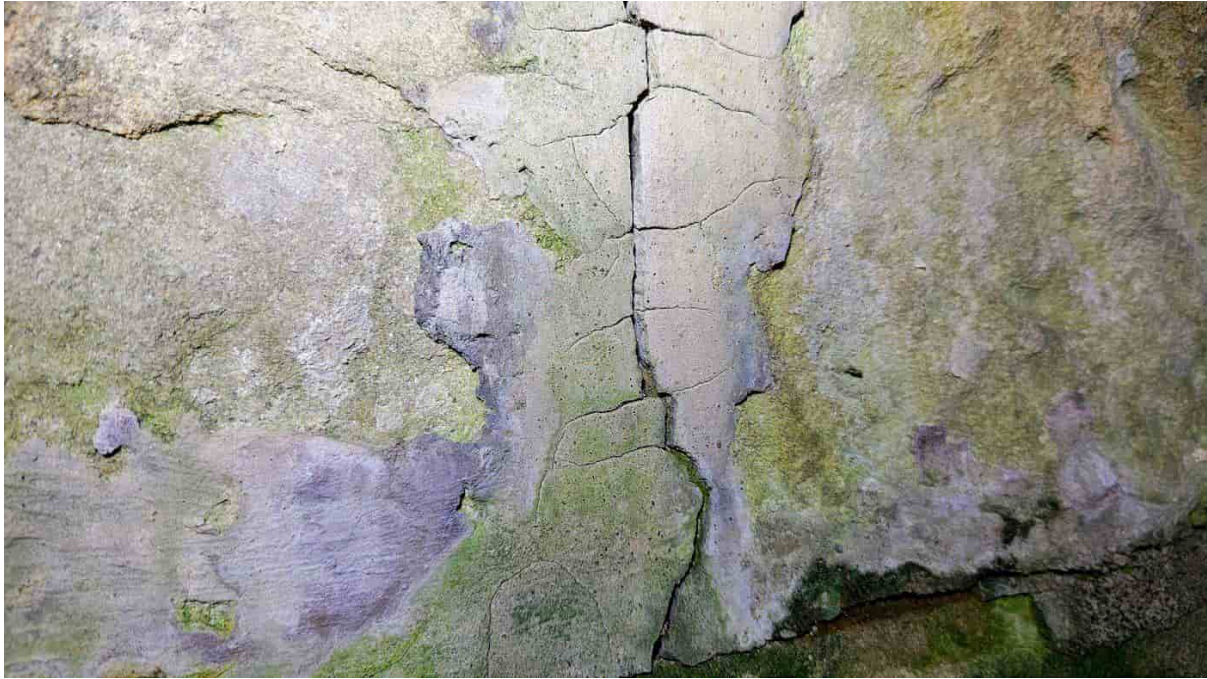
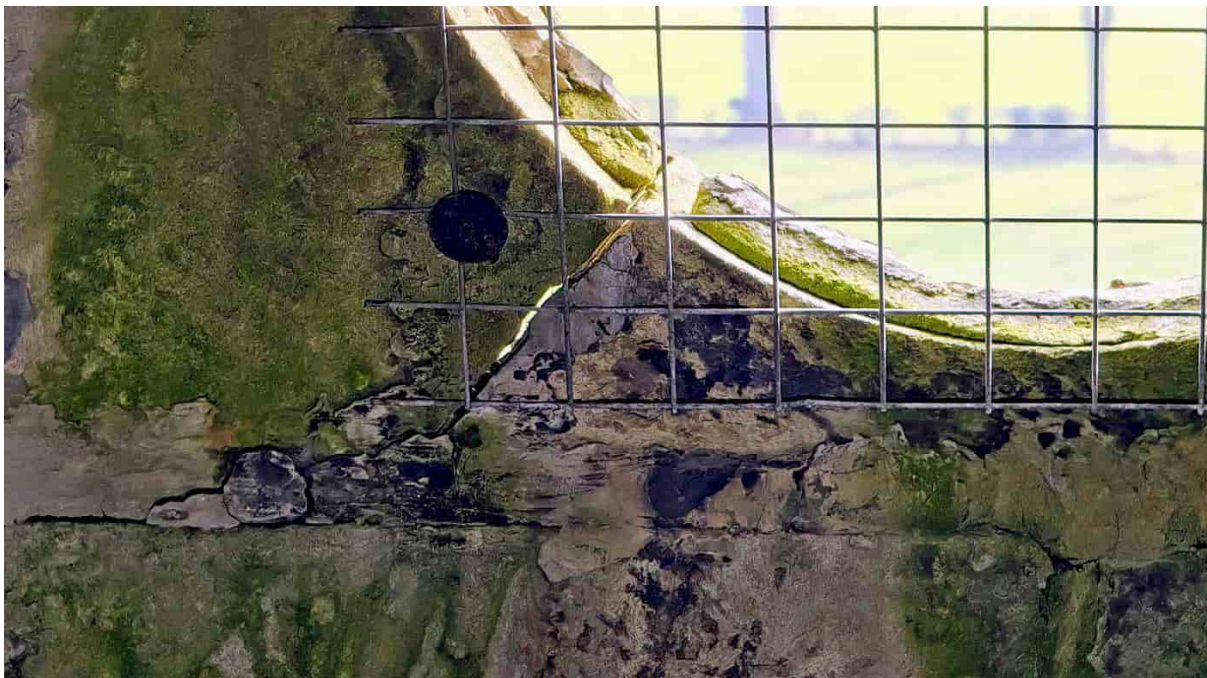
Some of the repointing of the cupola in the past has been done with cement, which in certain areas is cracking badly – partially also due to the traffic and vibration induced by the bells – letting rainwater in.

In case any repointing work is needed on the Cupola, the pointing should only be done with a traditional lime mortar. Cement mortars should be entirely avoided as they trap humidity, leading to future dampness problems.

Because the Cupola is subject to wind driven rain, vibrations and the mortar also has a structural reinforcement role, the Rinzafo MGN Roman mortar should be used for repointing. This breathable mortar:

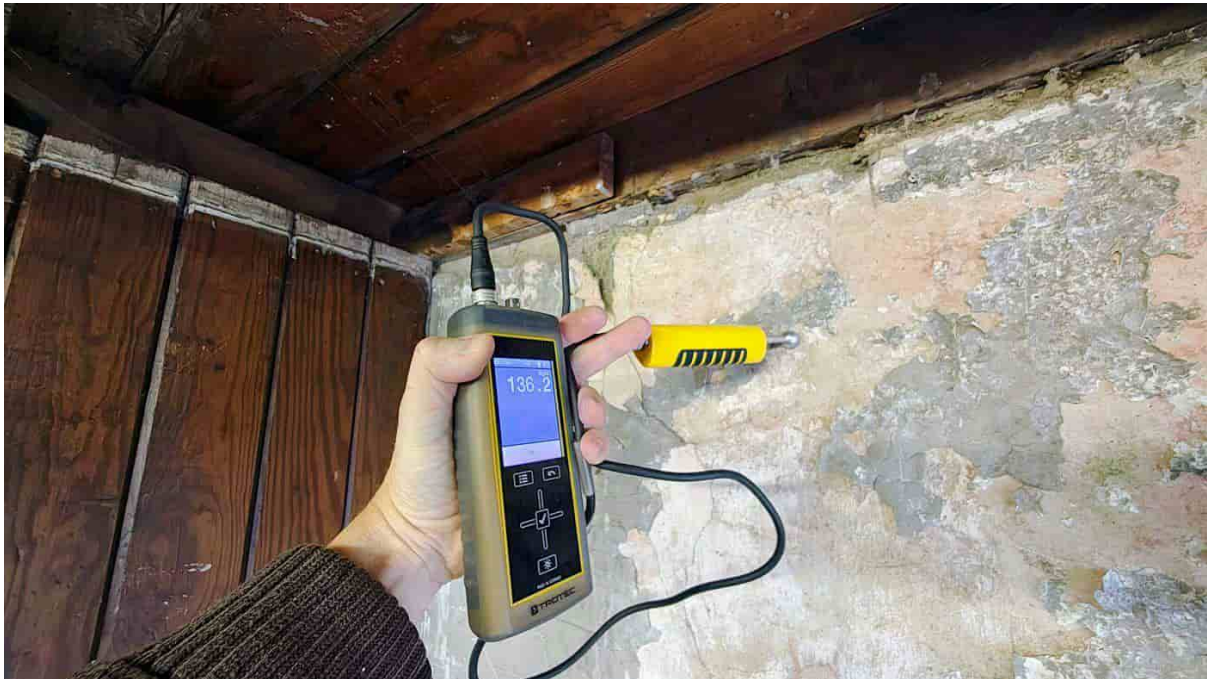
West Wall – plaster high elevation, high reading: 136

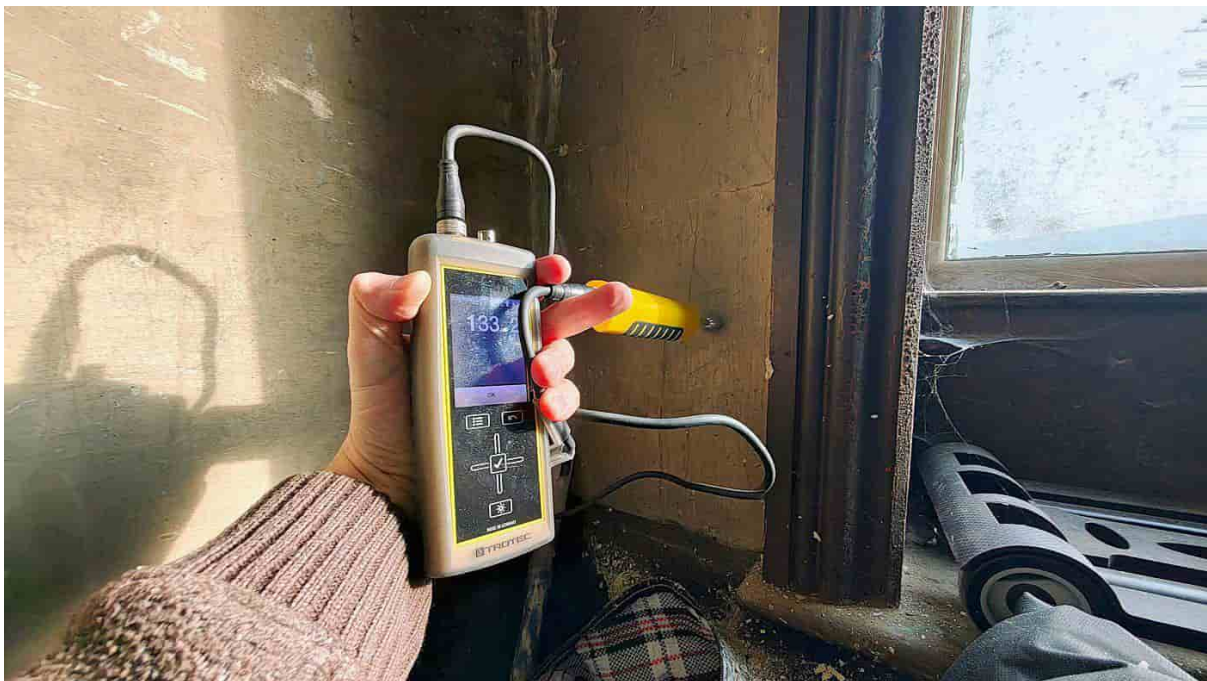
North Wall – plaster, high reading: 133

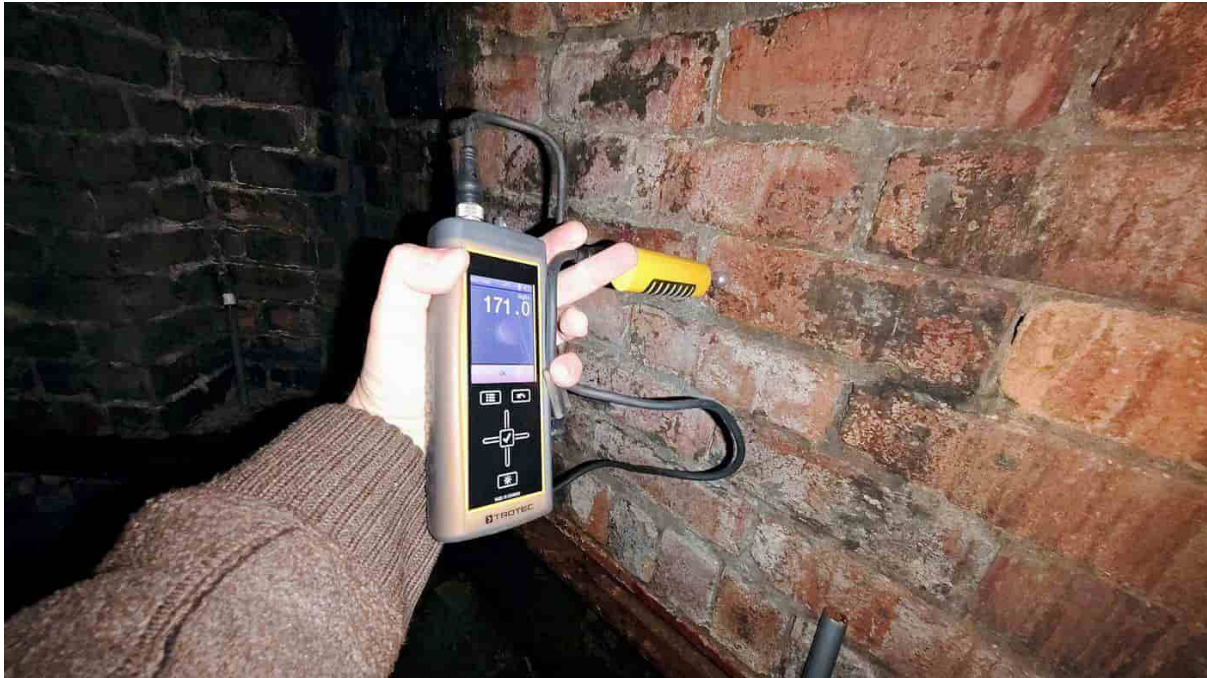
East Wall – external wall, very high reading: 171

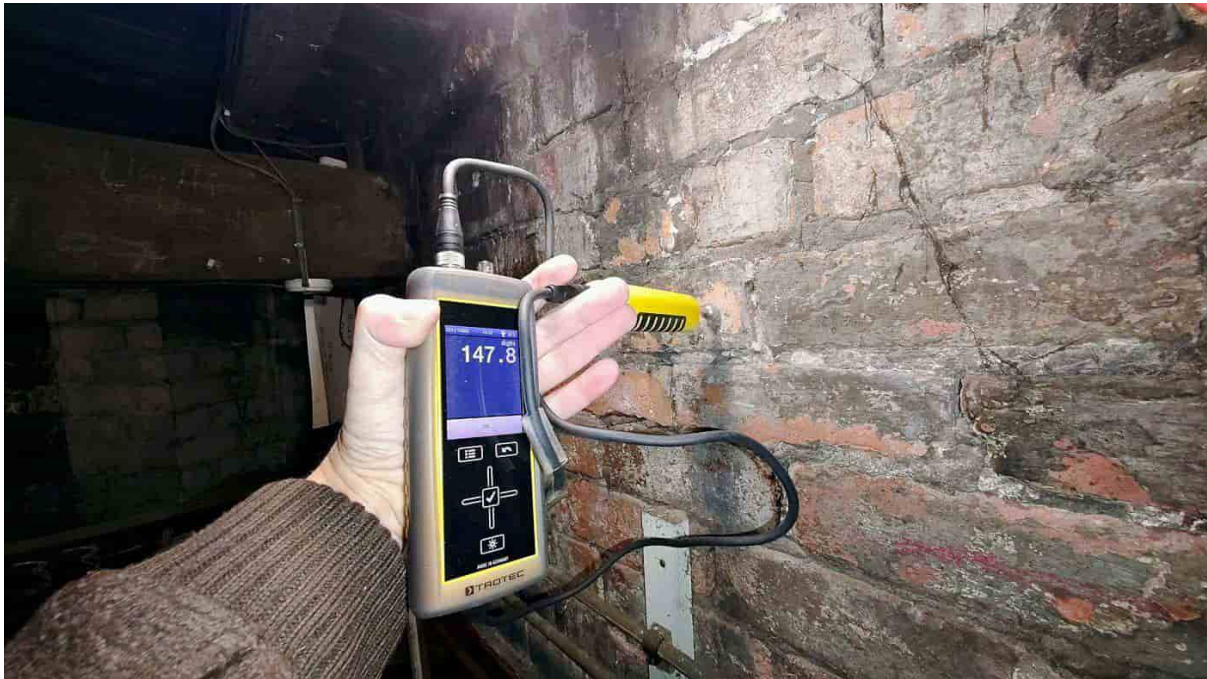
West Wall – external, high reading: 147

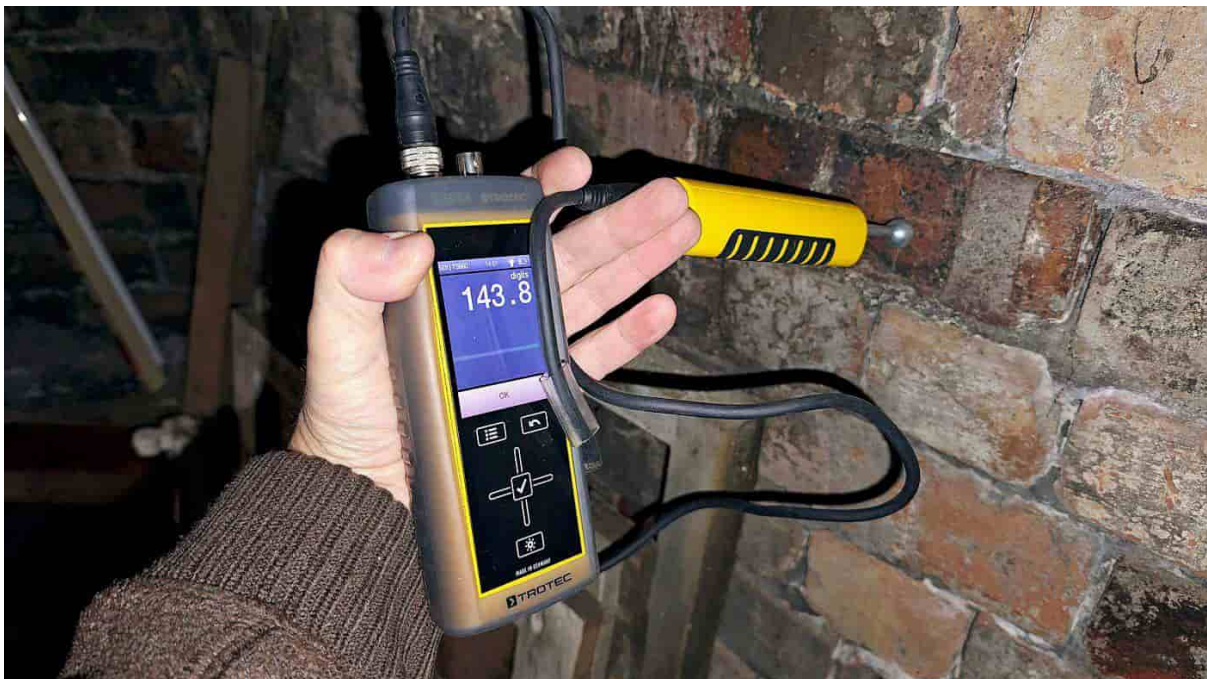
North Wall – external, high reading: 143

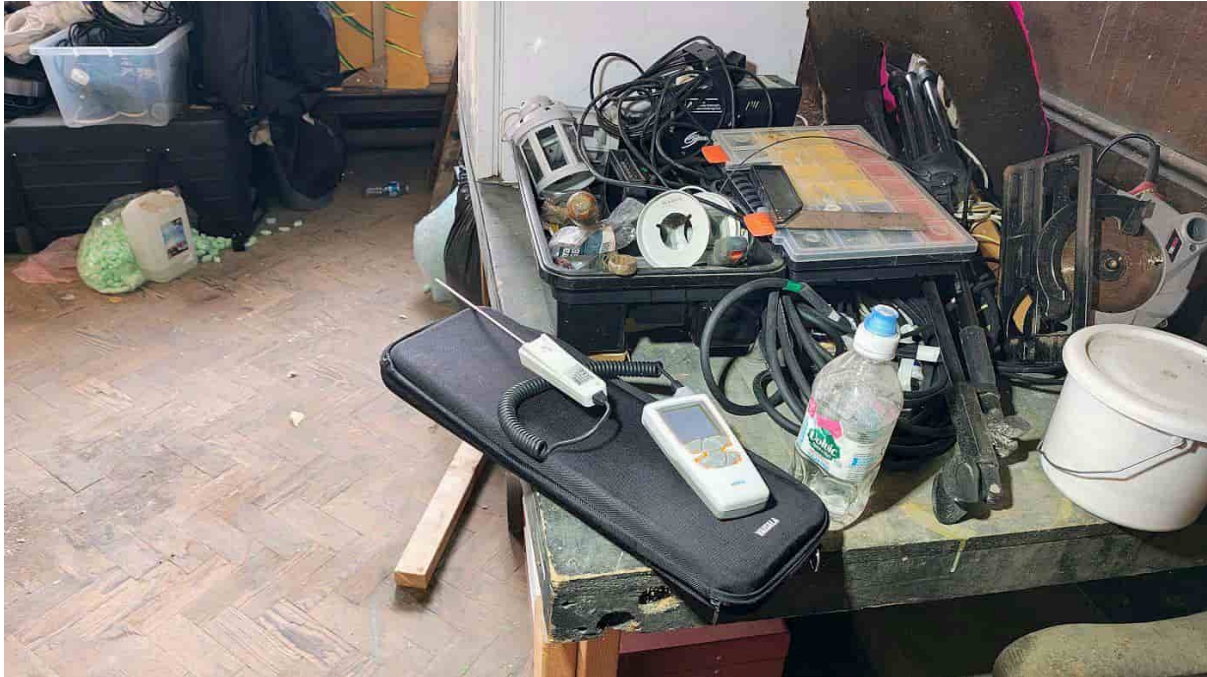
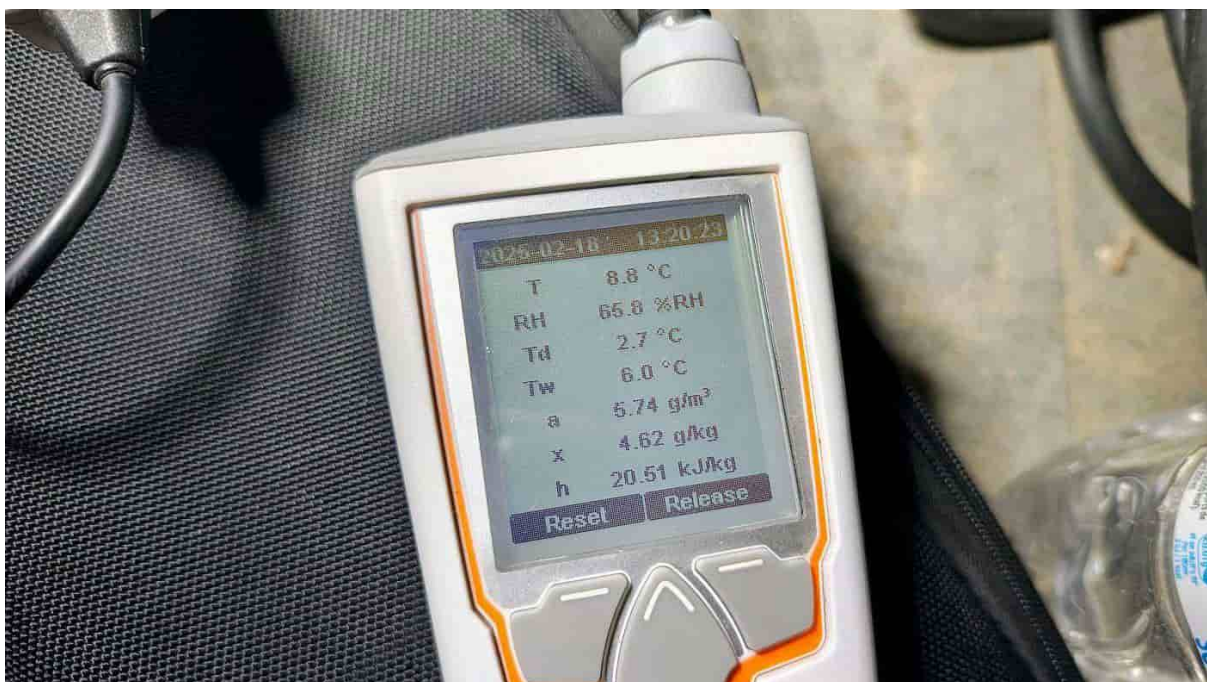
The Storage Room humidity was a = 5.74 g/m³.

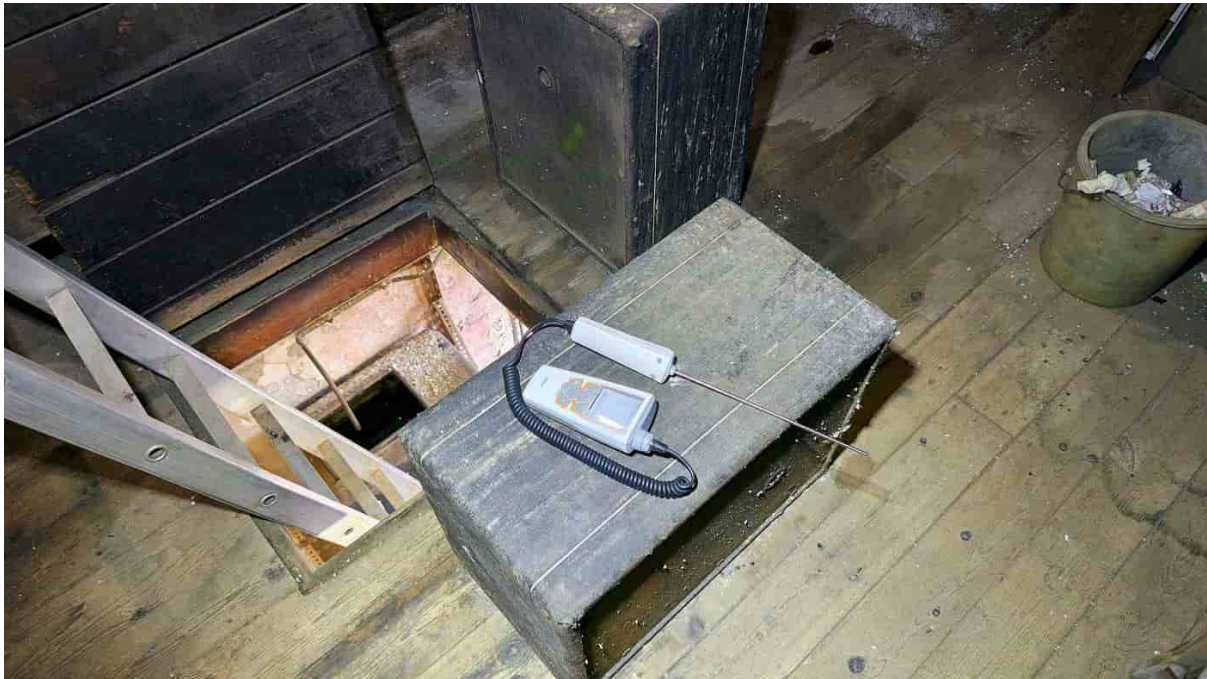
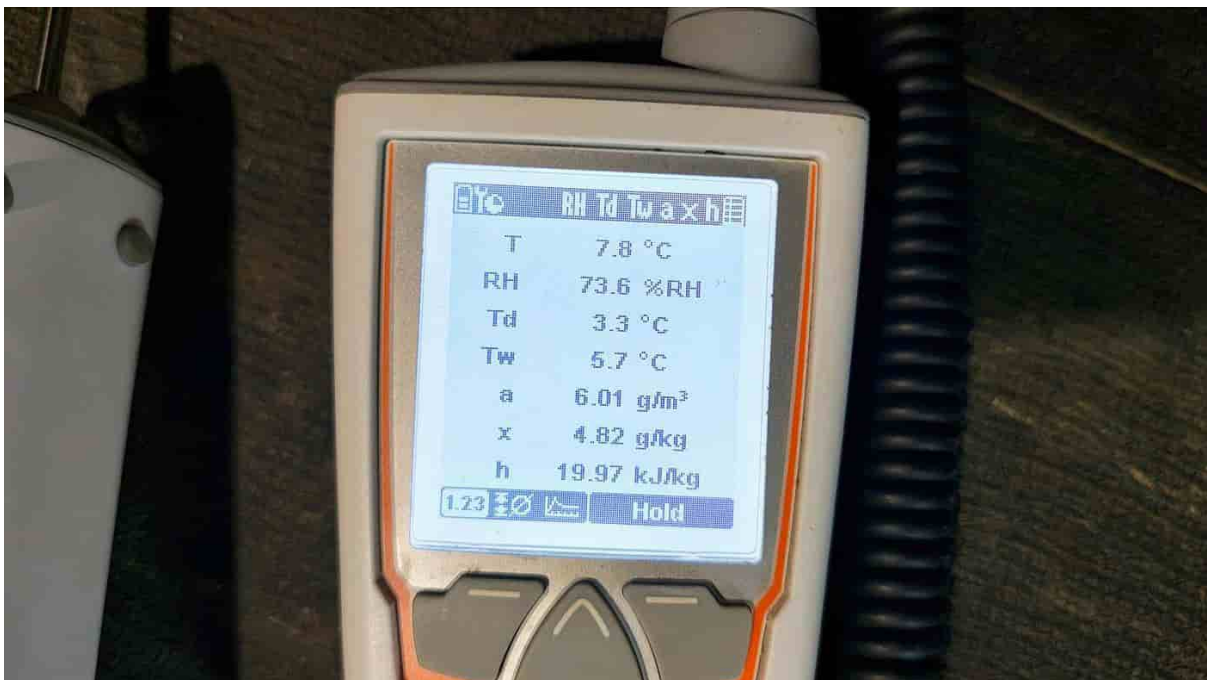
The Clock Room humidity was higher ($a = 6.01 \text{ g/m}^3$) as a result of the evaporative effect of the damper walls higher up in the Clock Room.

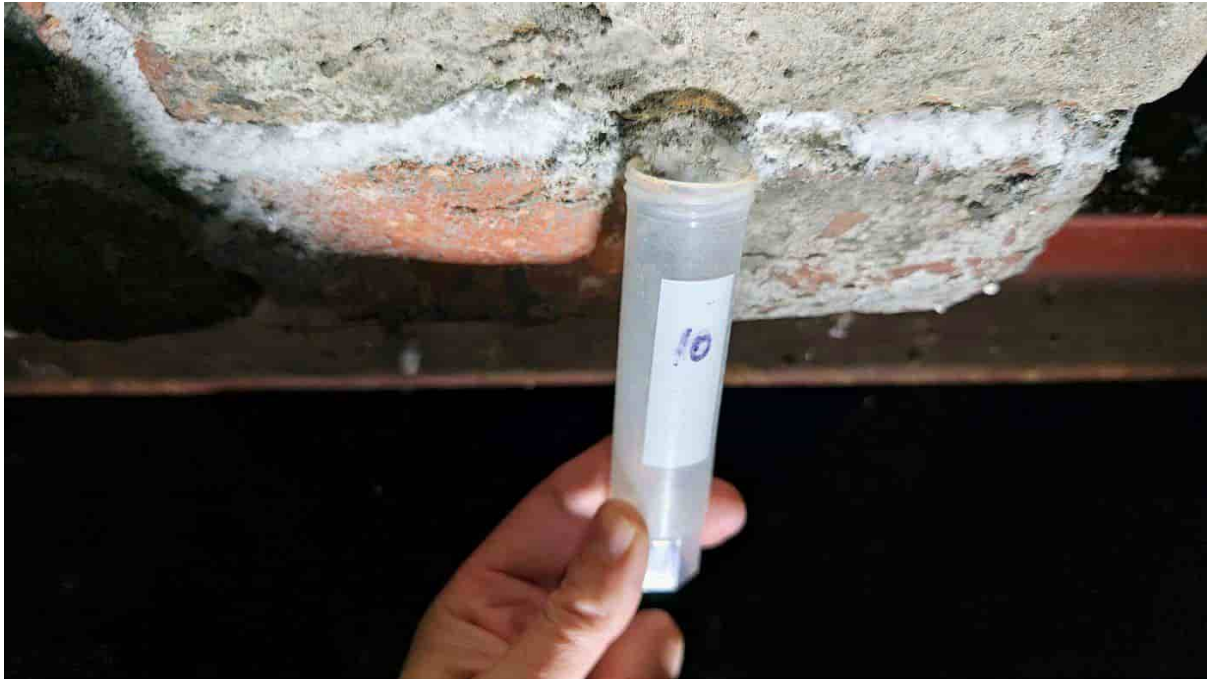
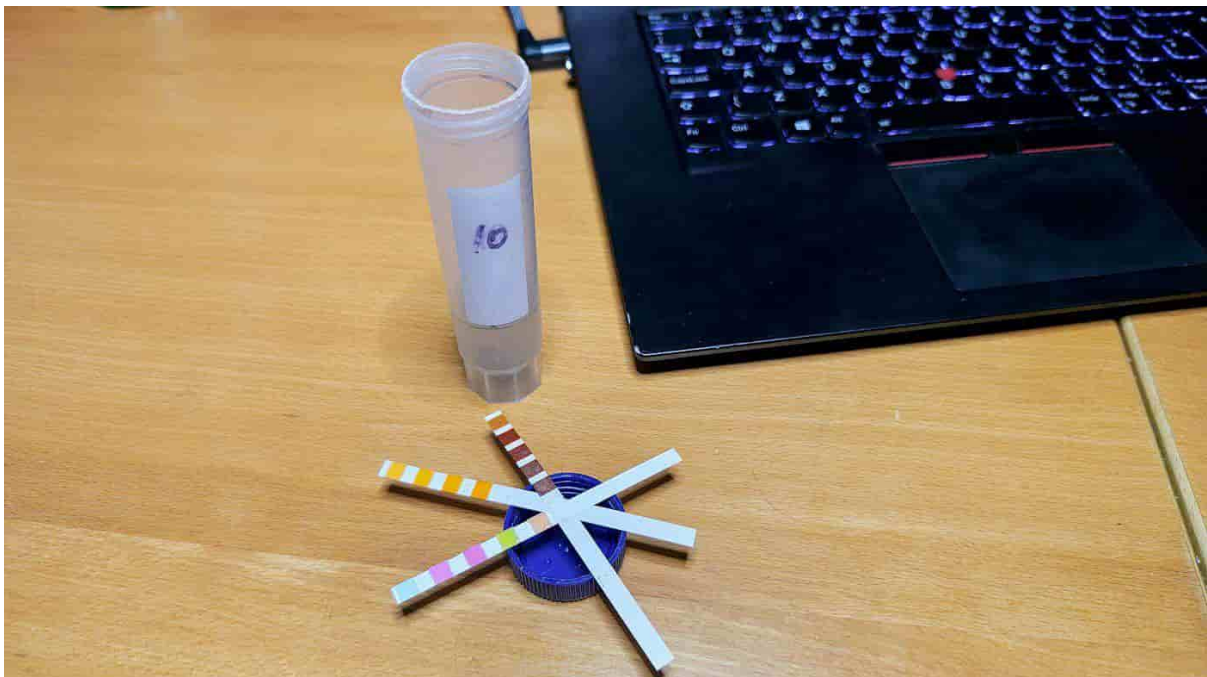
- **Sulphates** (pink to orange): **very high concentration**, originating from the cement, where gypsum powder (calcium-sulphate) is added to slow down the setting of cement.
- **Nitrates** (white to purple): **medium concentration**, most likely from washed down bird guano.
- **Chlorides** (brown to white): none.
