Dampness Report

Old Pub Building

3 March 2025

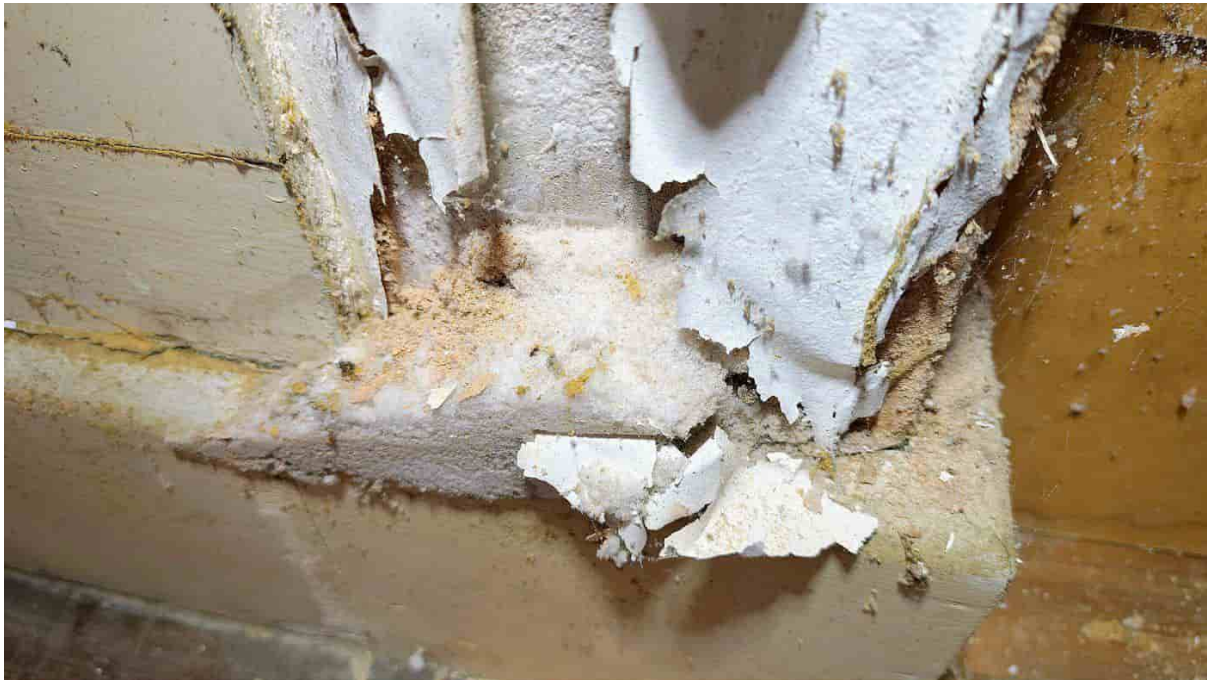
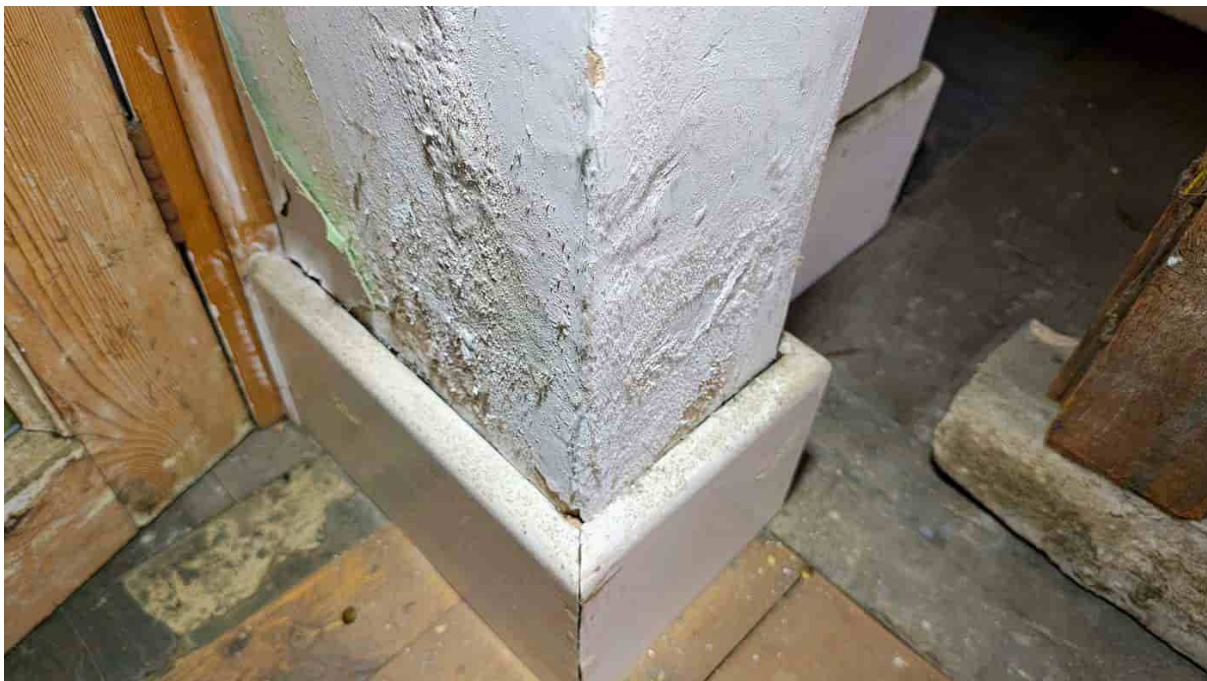
Due to the building's age, the ground floor of the building is affected by rising damp.

The water evaporates through the plaster and when the growing salt crystals expand in volume (up to 10X), they break down the building fabric, resulting in potential crumbling, peeling and/or damp patches.

There is heavy salt crystallization on some ground floor wall sections.

- The general removal of the old modern plaster is recommended, followed by a sympathetic holistic restoration concept using lime-based plasters and breathable materials.

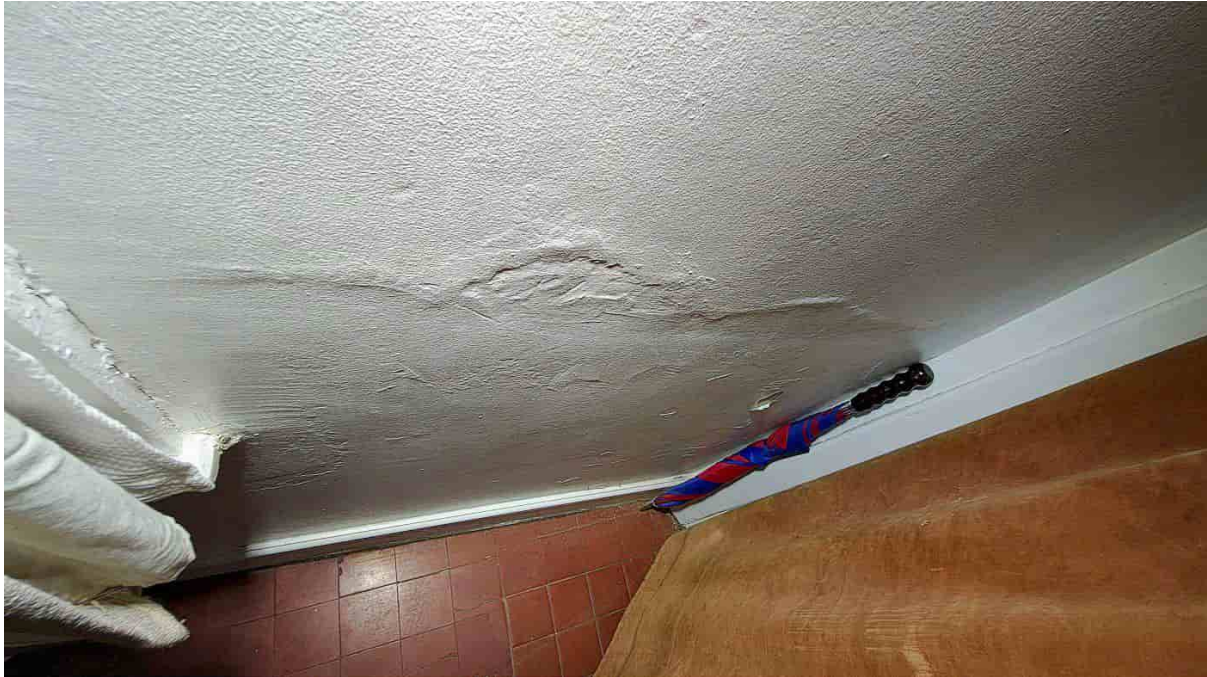
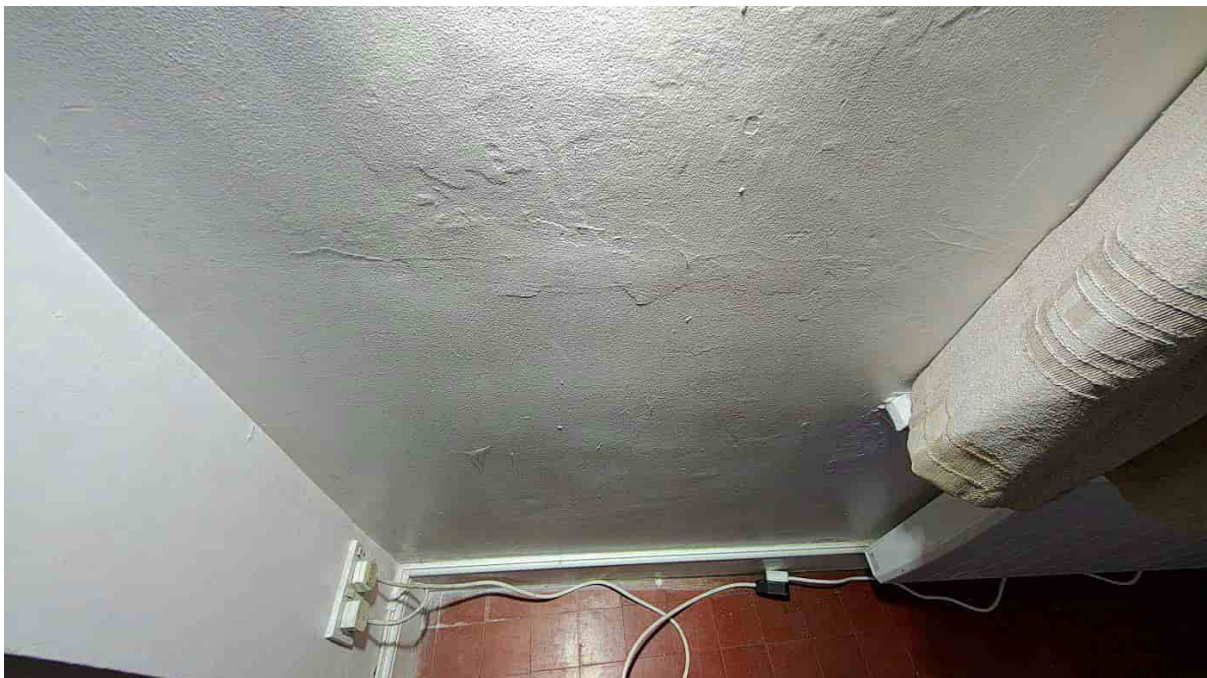
Rising damp is not a new problem but a rather old one. Some replastering on the lower side of the walls indicates that rising damp has been attempted to be sorted before – however the problem still persists.

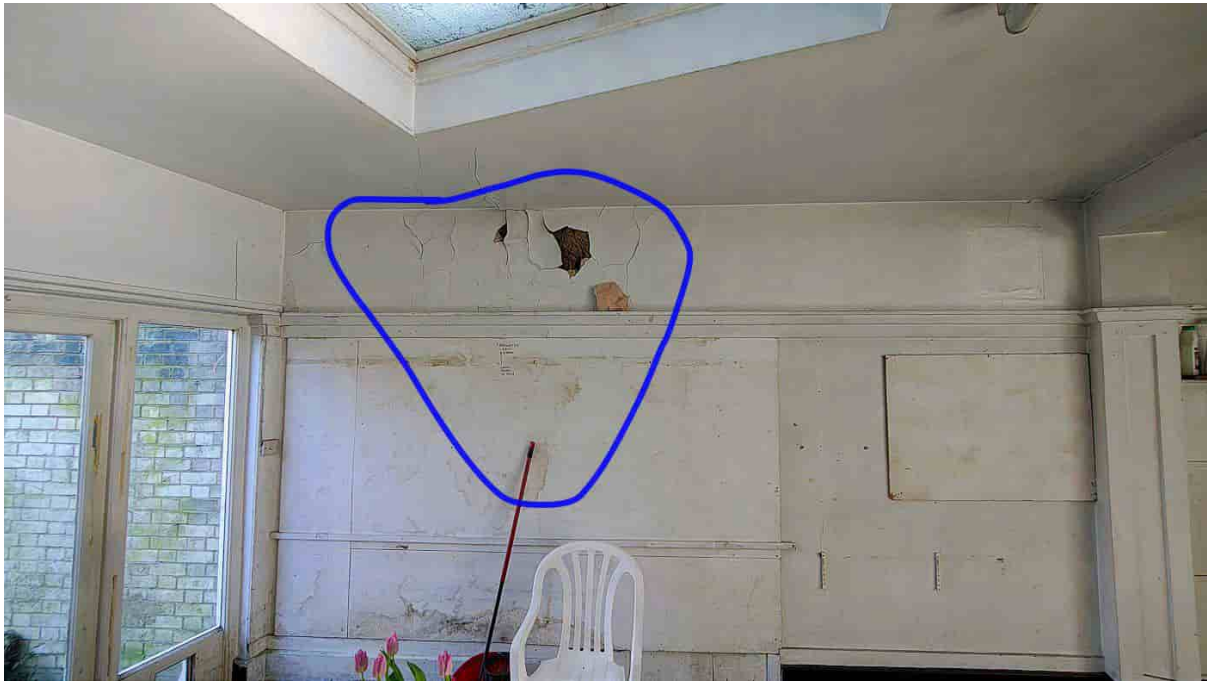
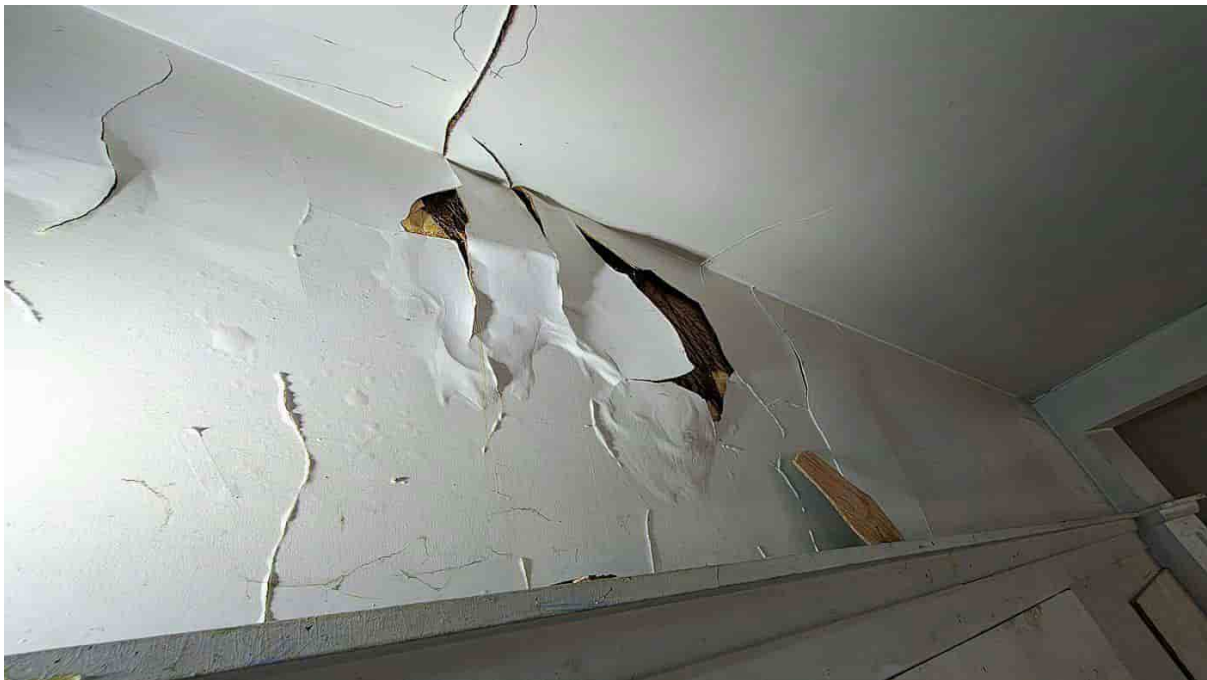
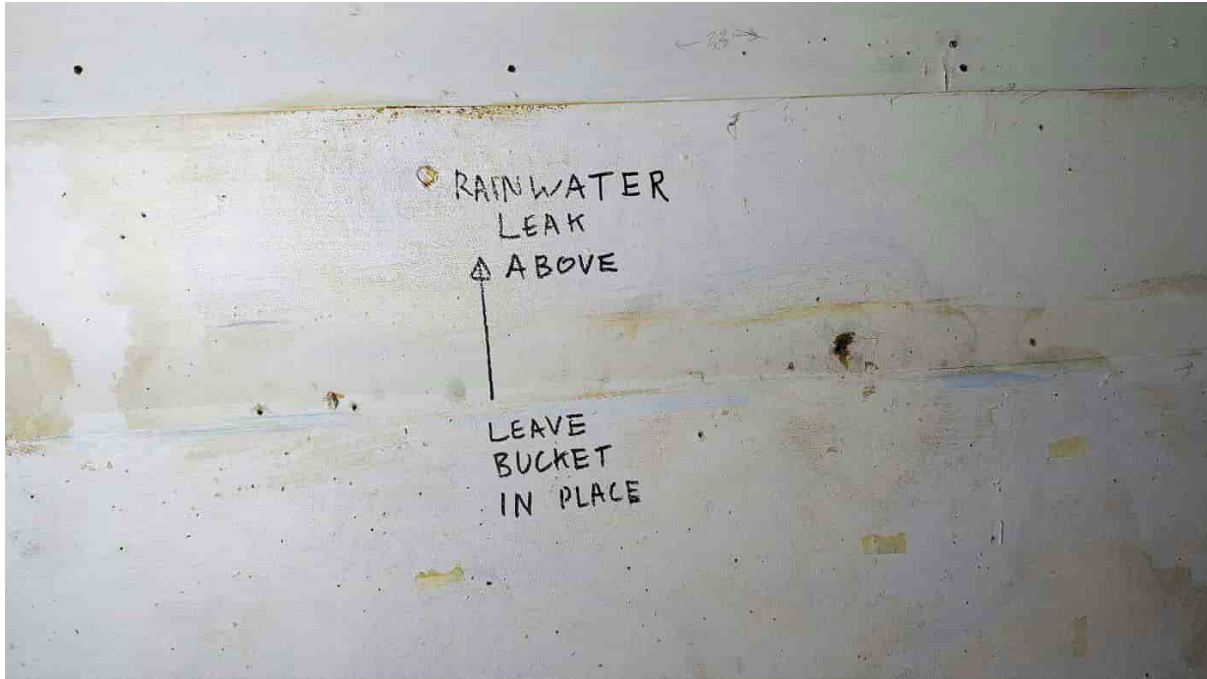
This external wall has been affected by a severe water leak, still ongoing today.

These leaks need to be investigated and if still present, remedied.

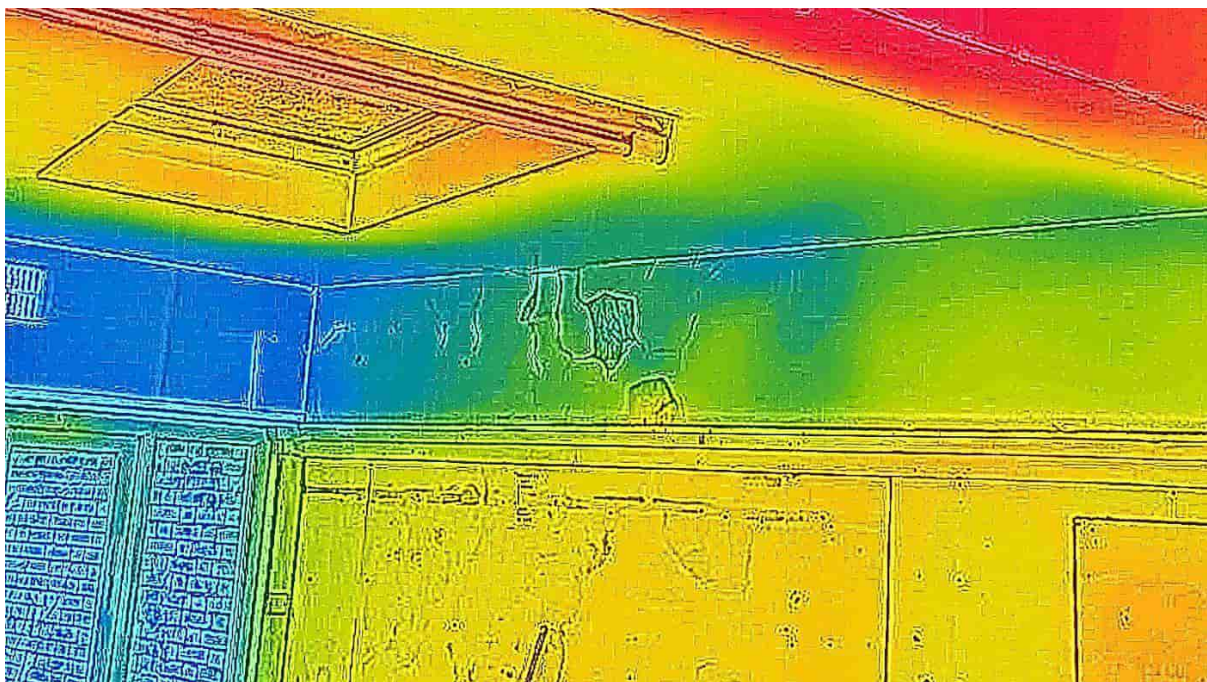
The damp area of the walls is colder, as highlighted by the blue/green colour of the infrared camera.

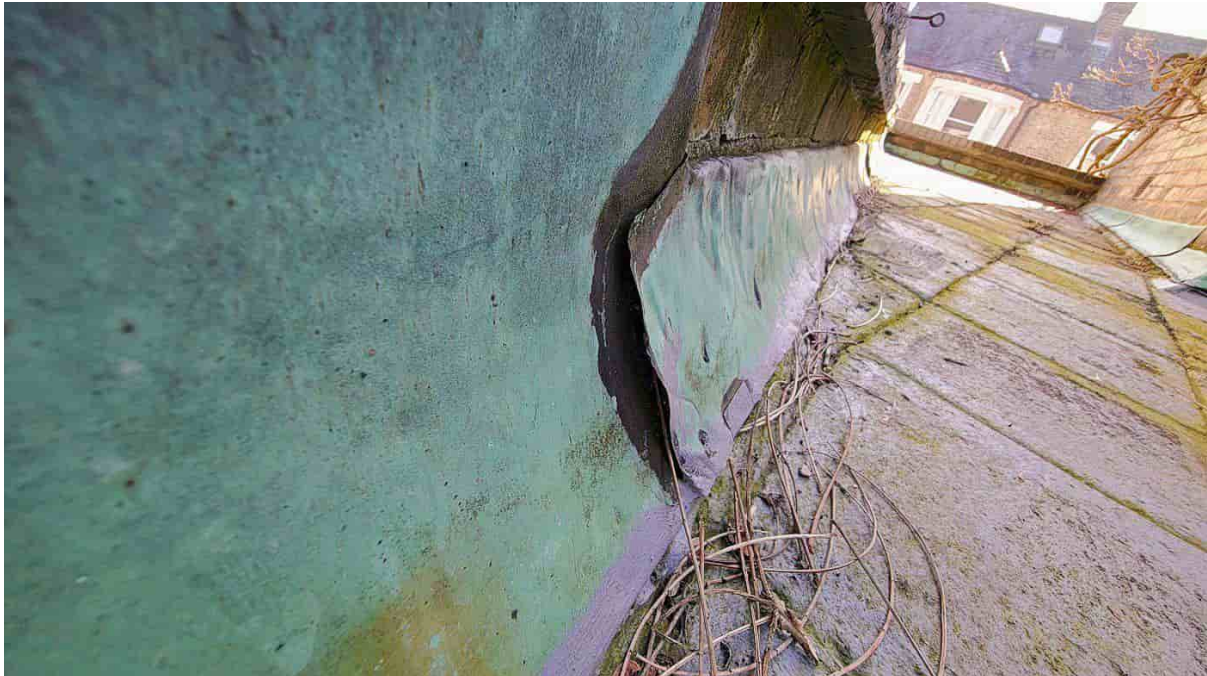
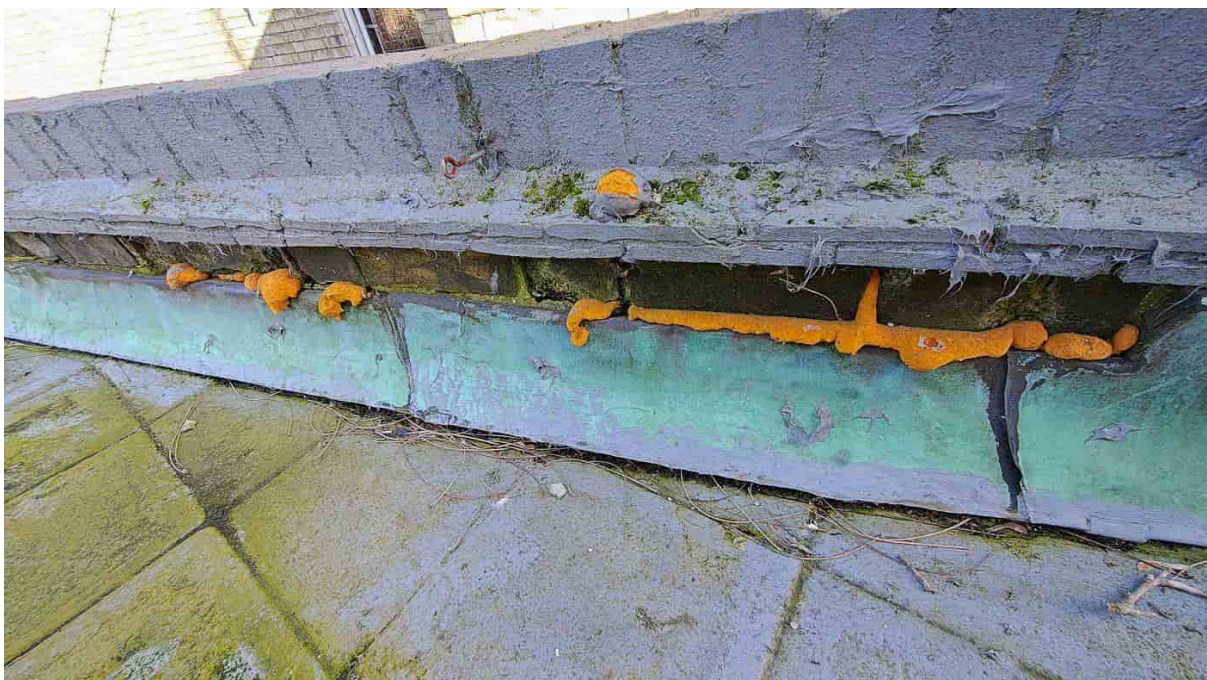
This leak is most likely originating from the flat roof above. The flashing in some areas came off which has been attempted to be patched up with foam insulation.

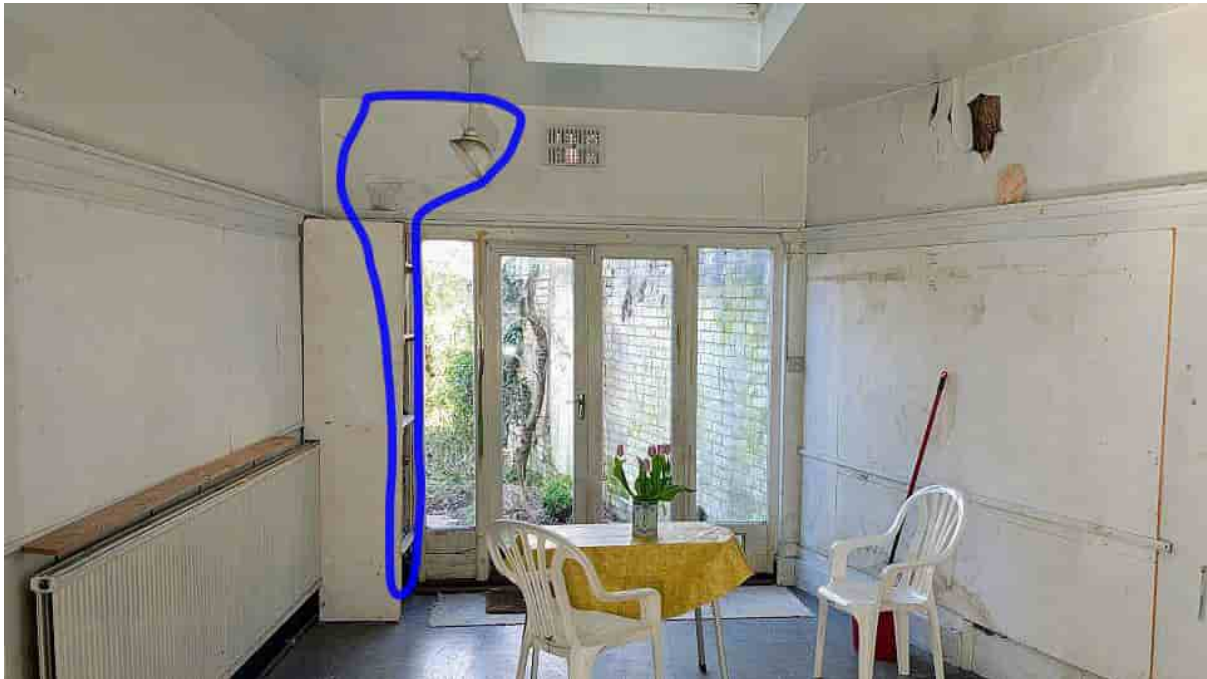
There is another leak on the left side of the rear garden door.

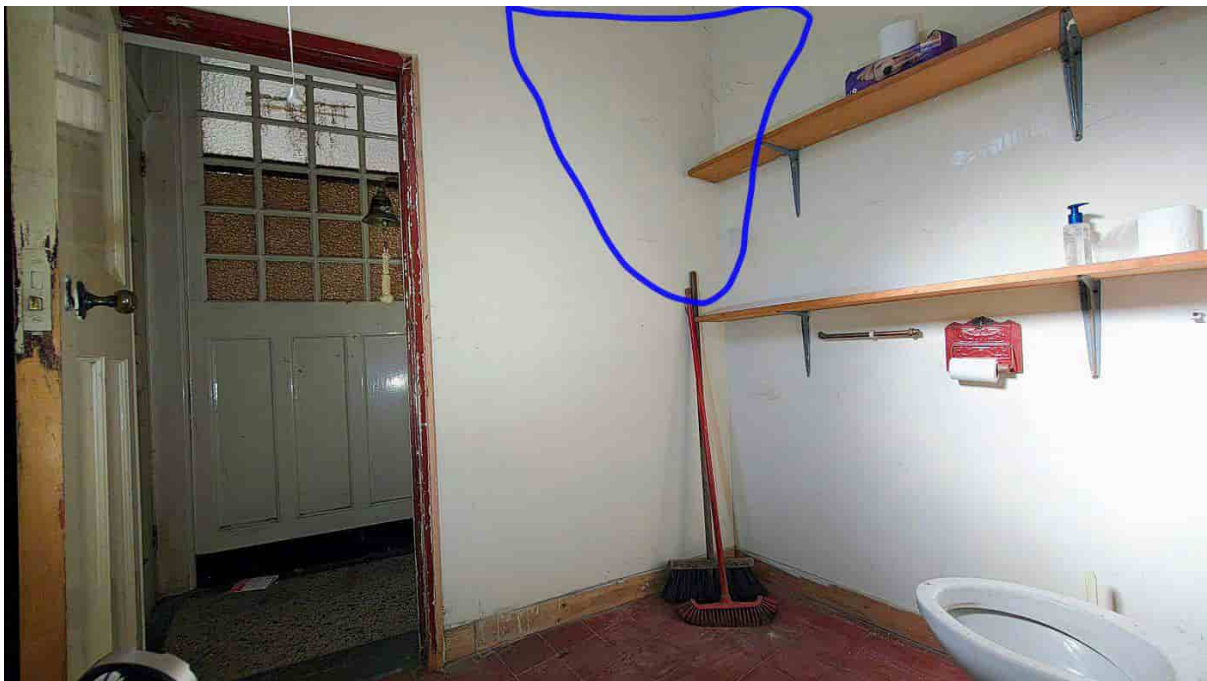
Then another leak from the ceiling of ground floor bathroom.

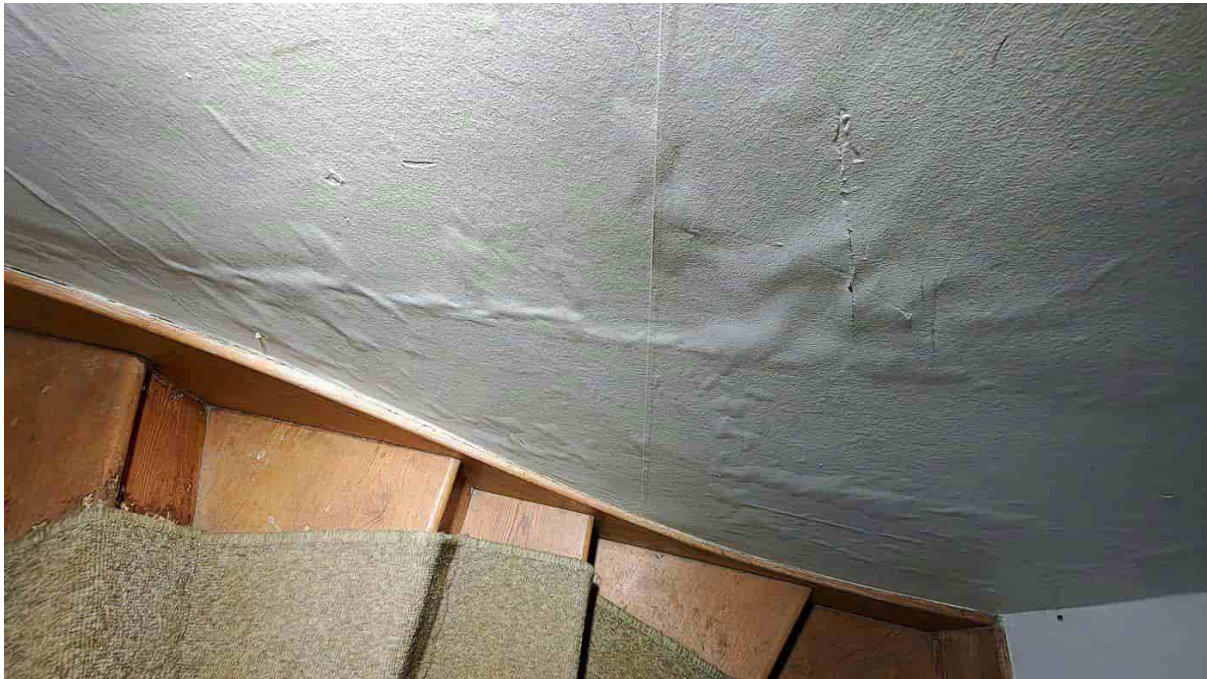
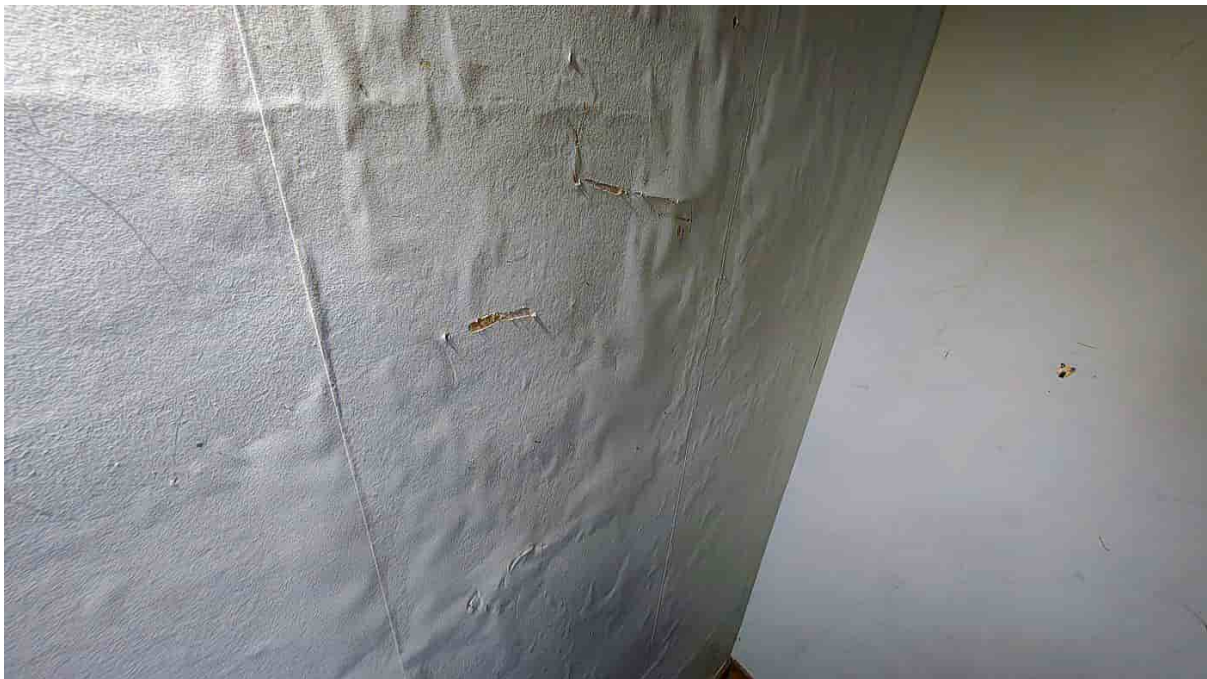
The staircase wall looks affected by a water leak, however this is a historic issue, not a problem in present time.

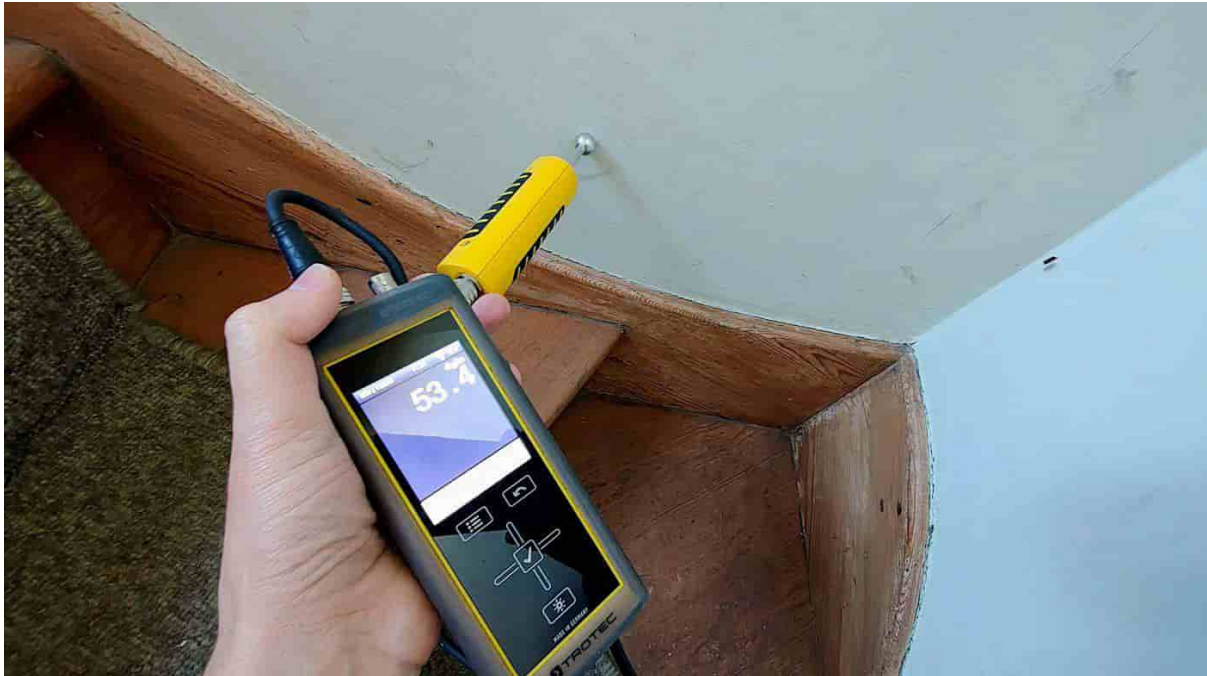
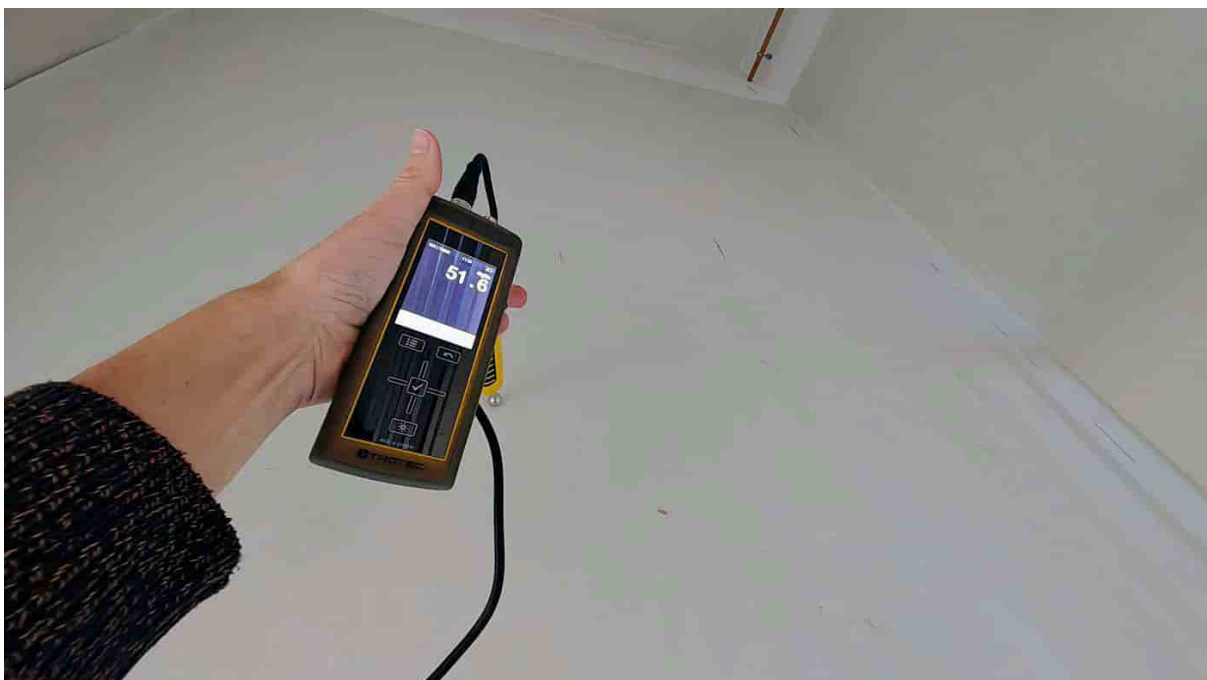
The staircase wall is not damp, as indicated by the deep penetrating dampness meter. The readings are all under 70, thus in the normal range.

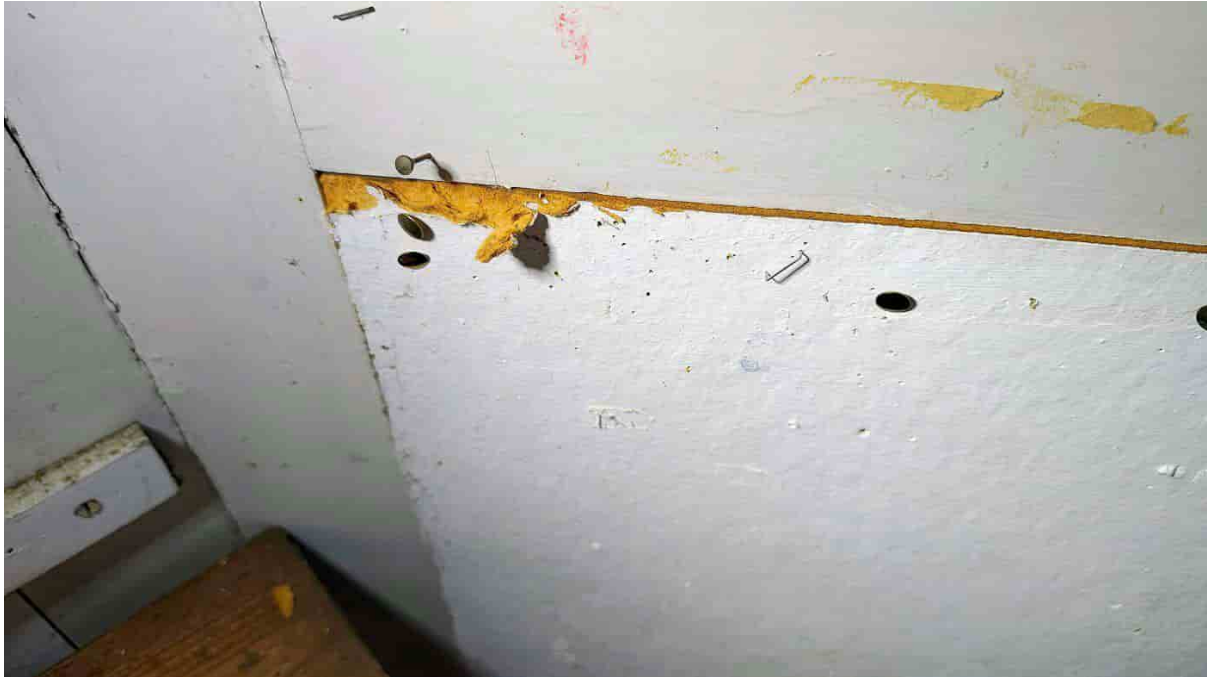
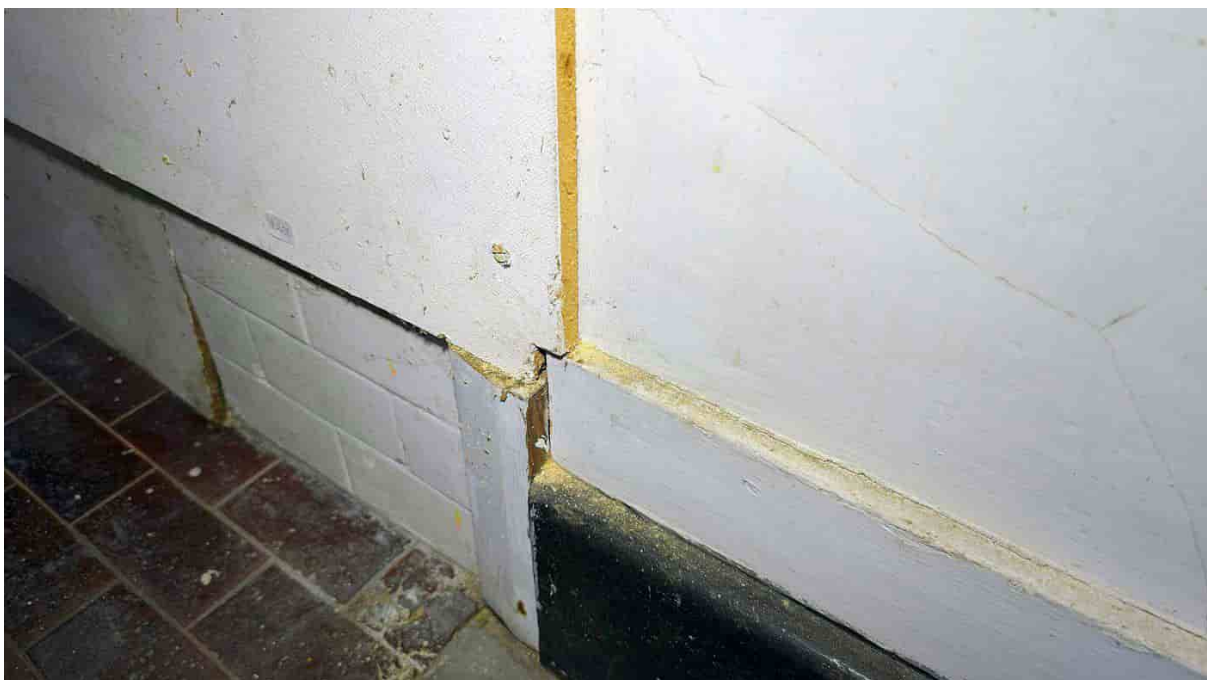
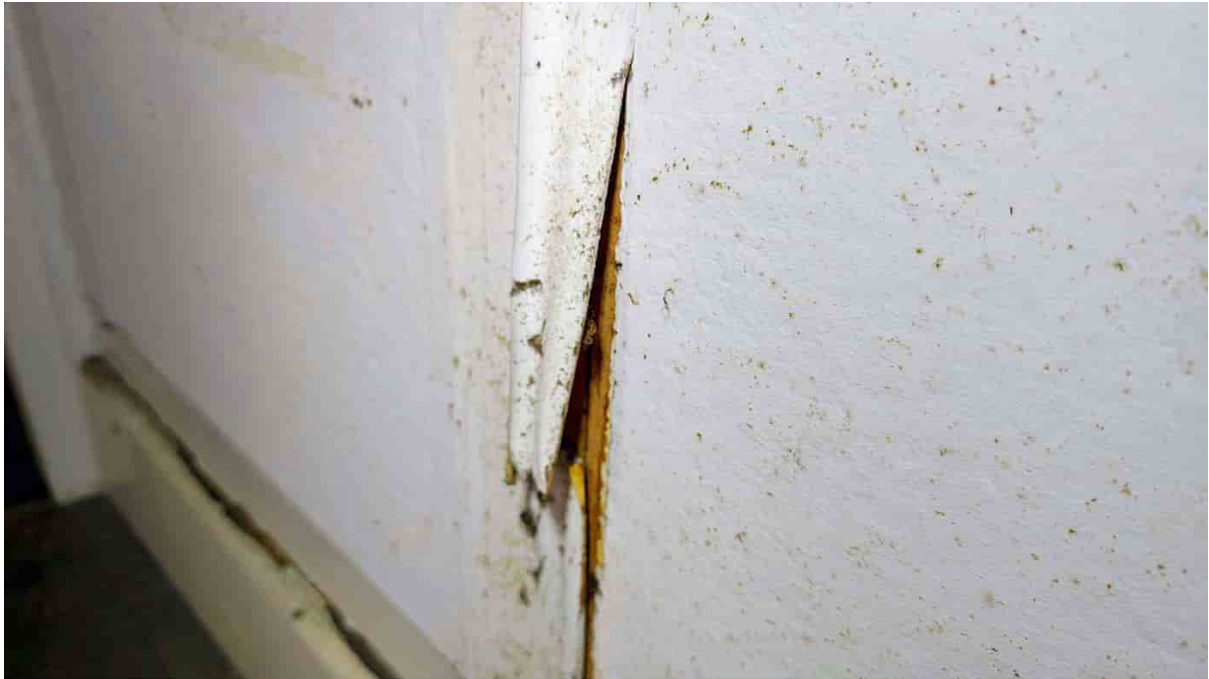
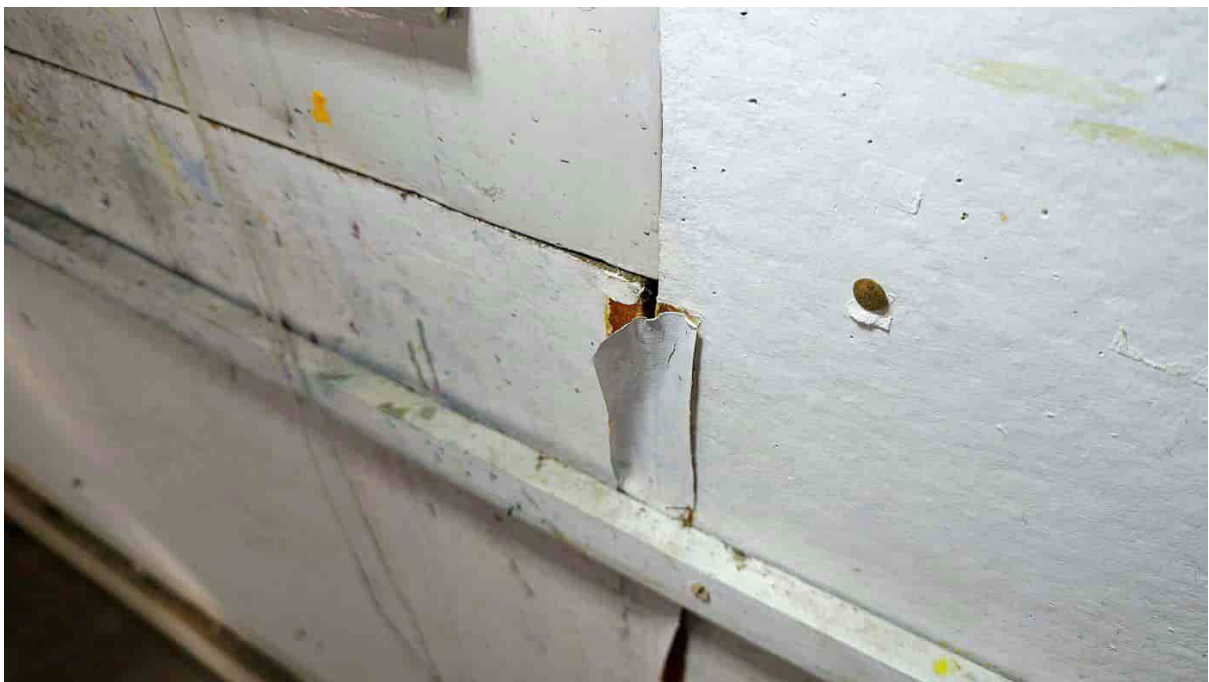
Many wall sections on the ground floor are covered up by boards or pieces of cardboard. This boarding most likely has been installed with protective purposes, to protect the walls from chairs and general wear-and-tear while the building was still a pub. However, these boards can easily hide various dampness related problems.

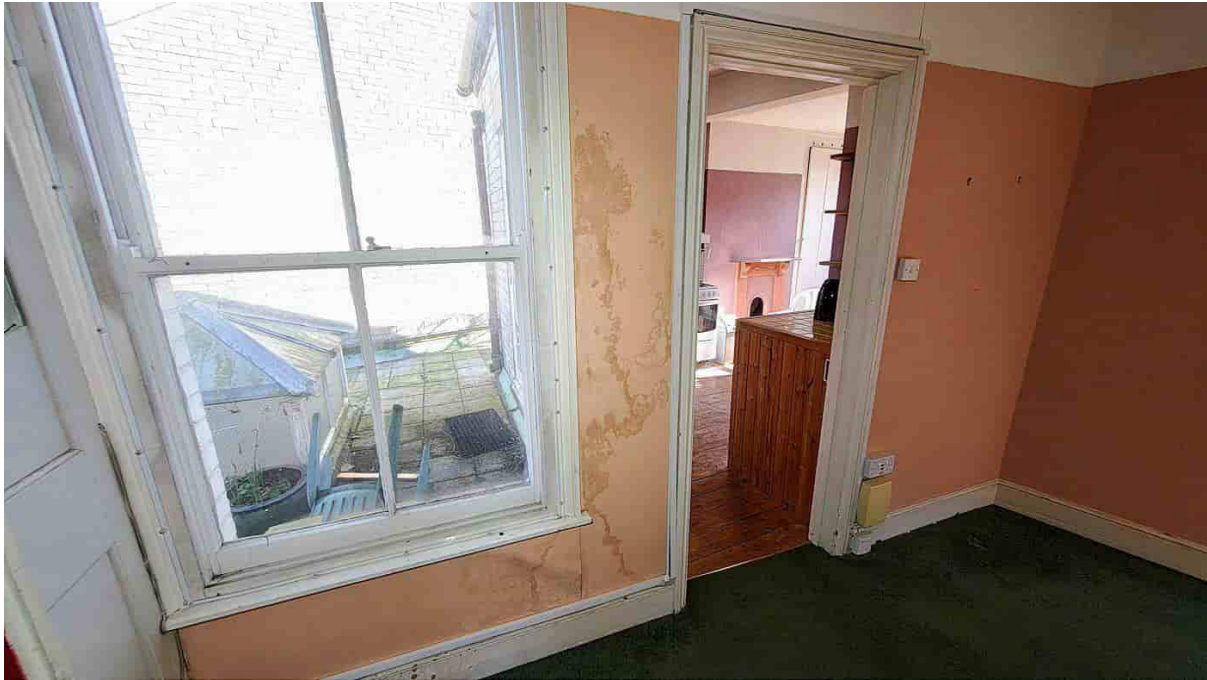
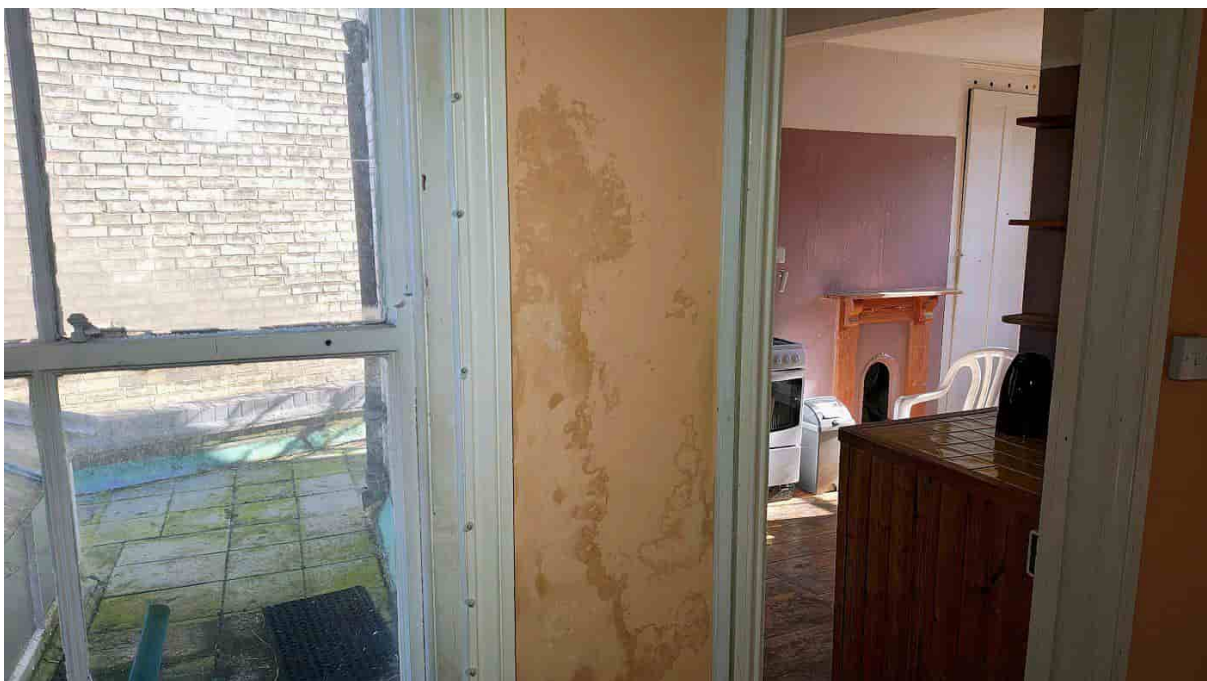
There are some water leaks signs around the hallway window.

Measuring the moisture content of the wall, the problem seems historical, the wall presently being dry. The wallpaper has not been changed, indicating a poor maintenance history of the property.

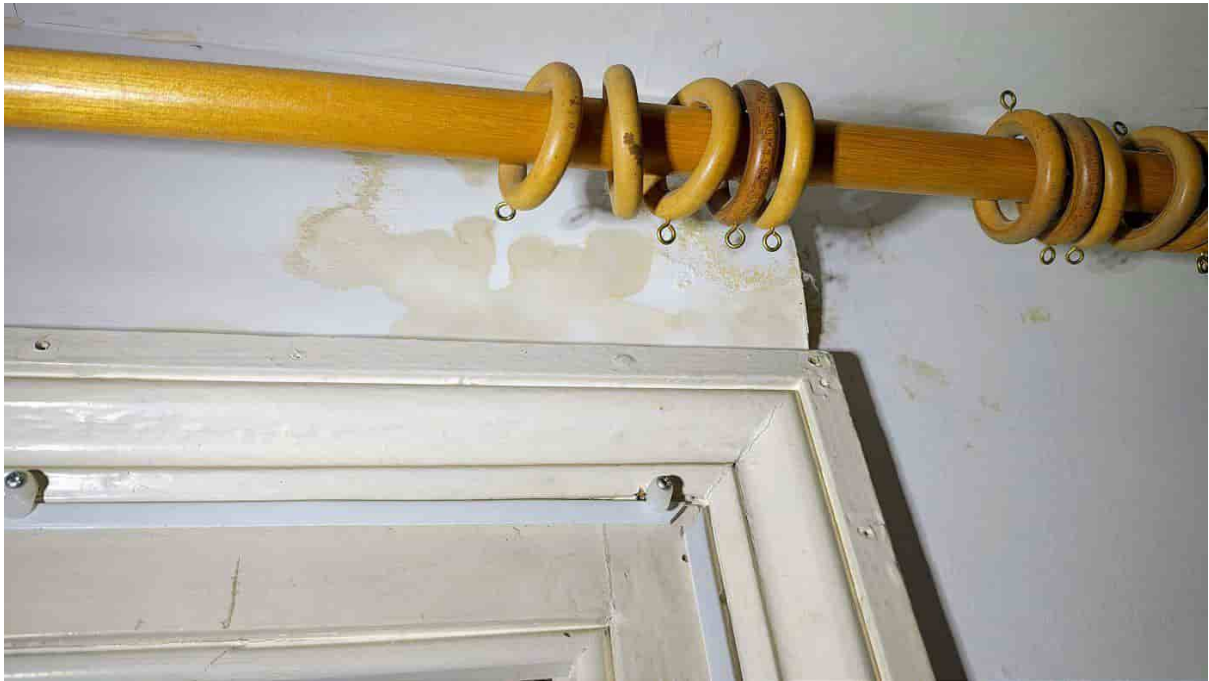
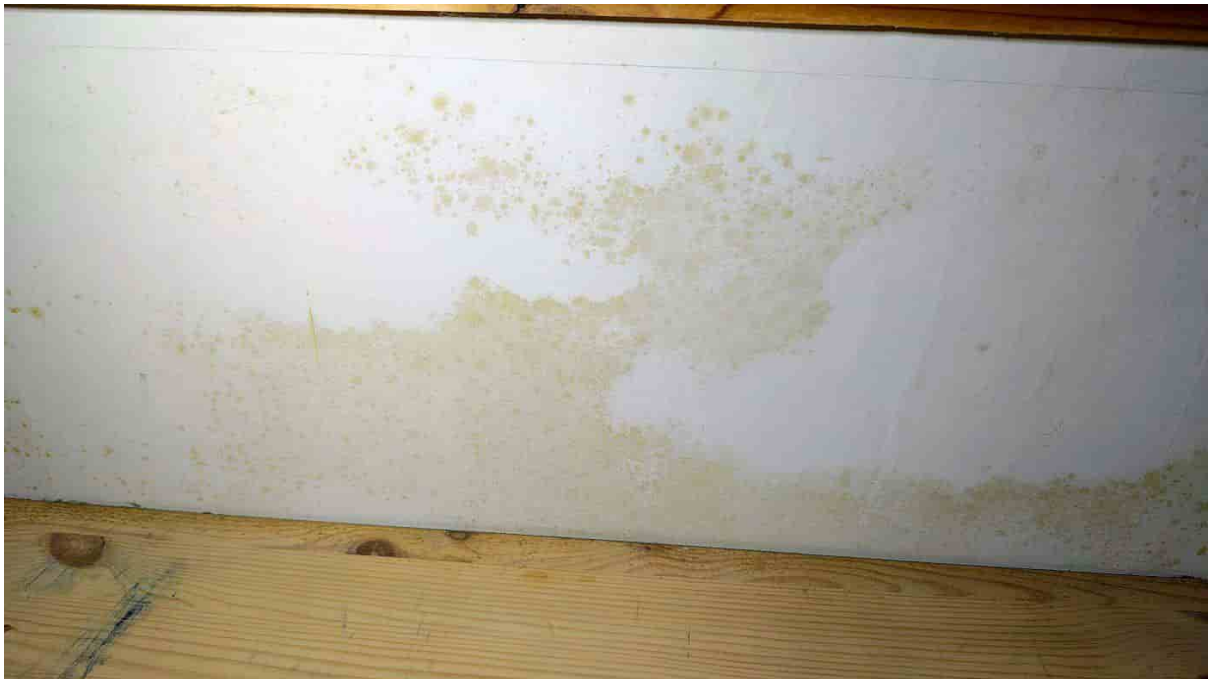
The front room wall is mouldy and stained, possibly from some past water leaks. The wallpaper also looks very old and worn.

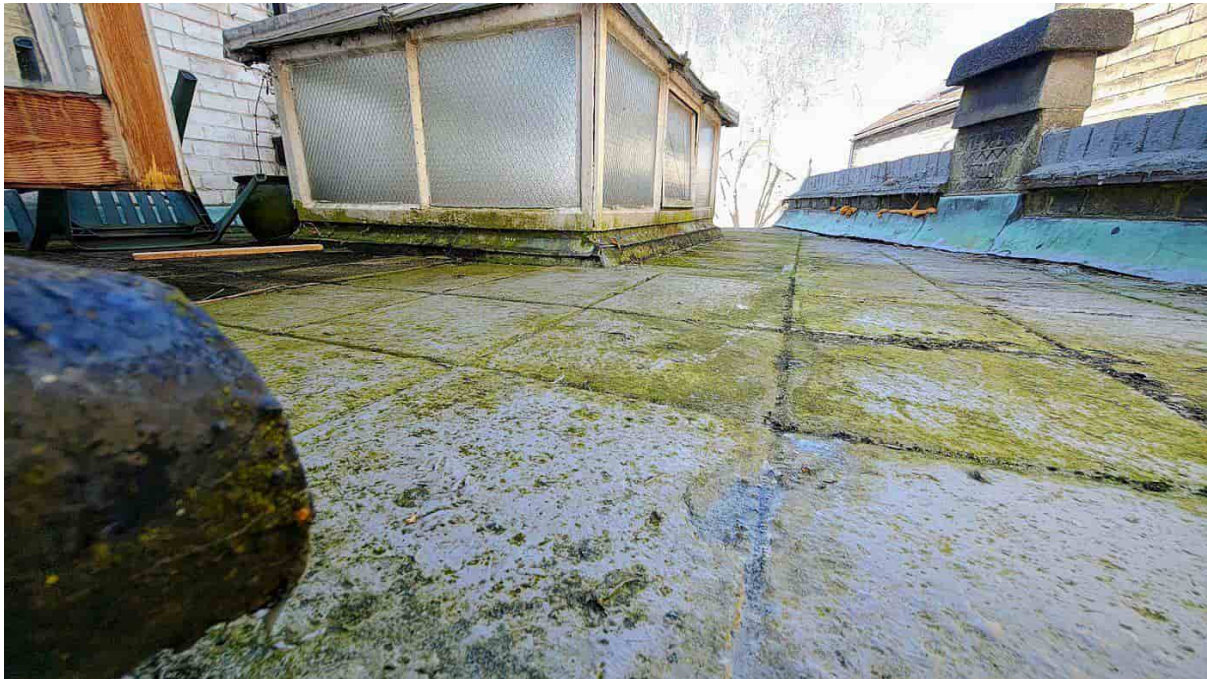
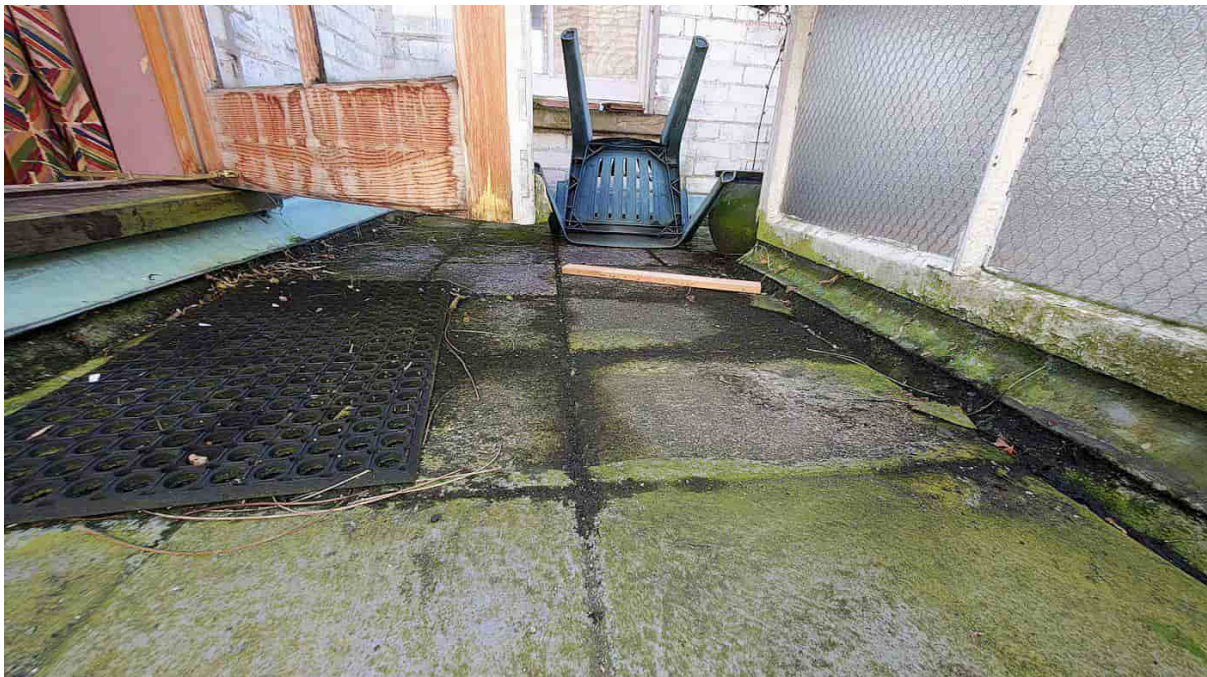
The building has a fairly large flat roof. The roof is largely covered in moss indicating consistent water flow. The water seems to have flown on the roof in every direction, resulting in moss deposits, which grow in very wet areas.
