Dampness Report

Old Pub Building

3 March 2025

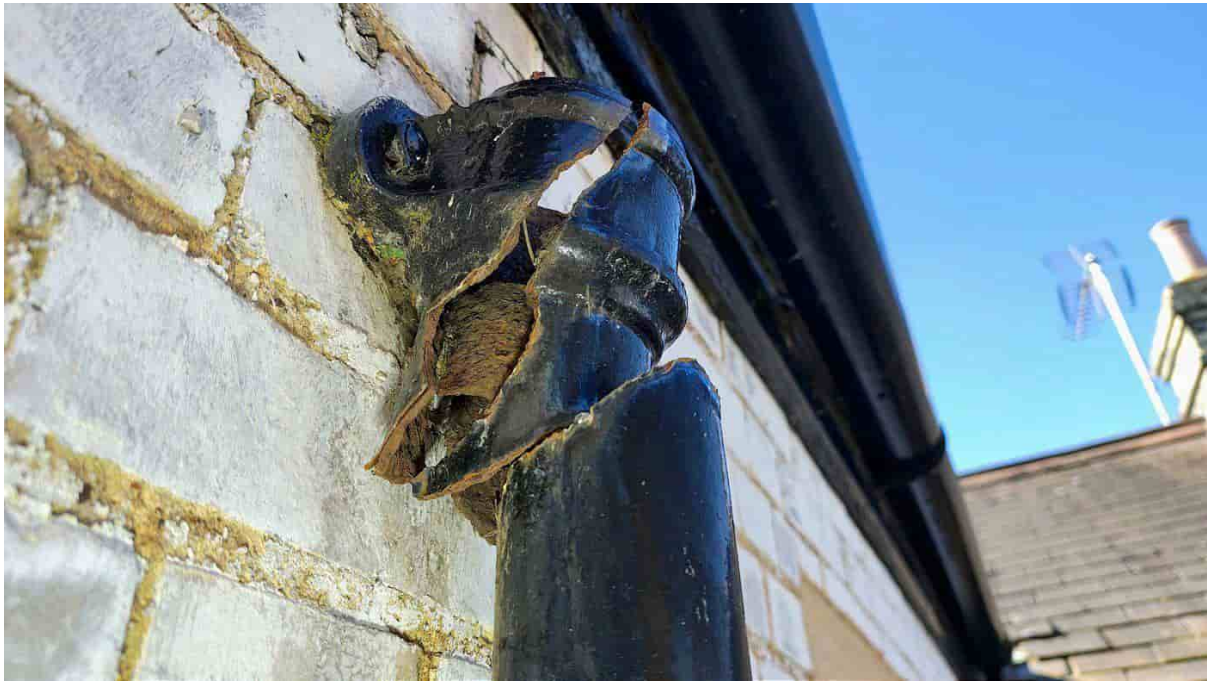
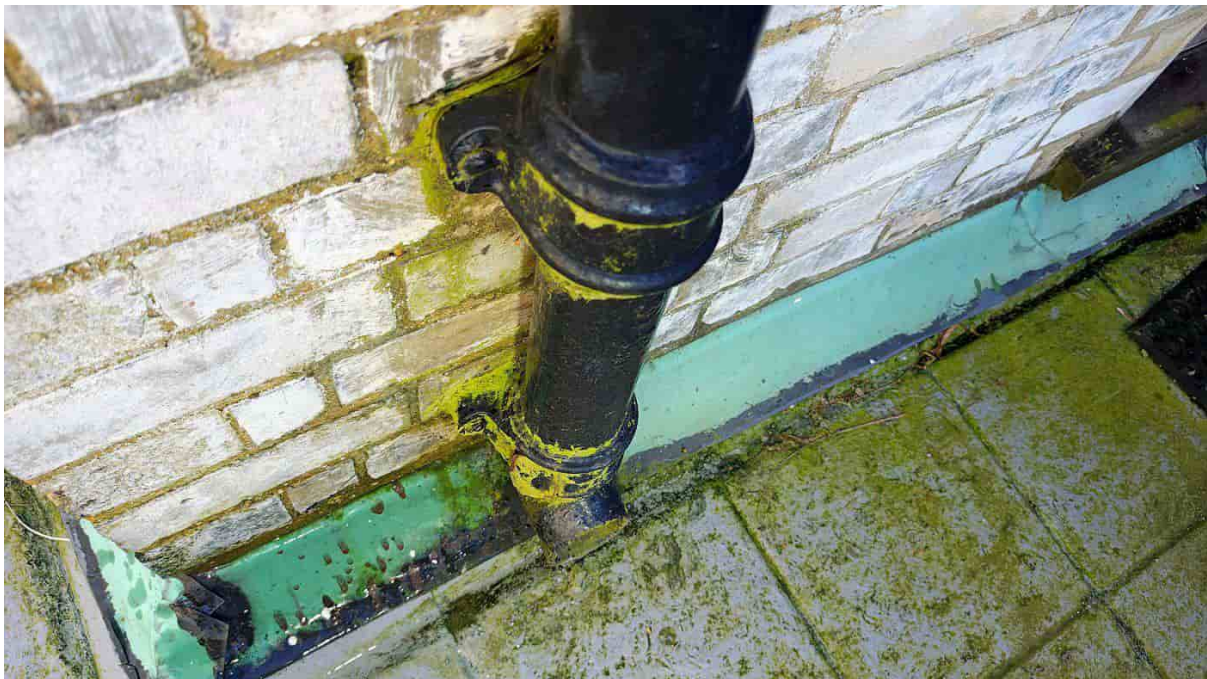
The unchanneled water flow partially can be attributed to a cracked drainpipe making water run down the wall and go everywhere on the flat roof.

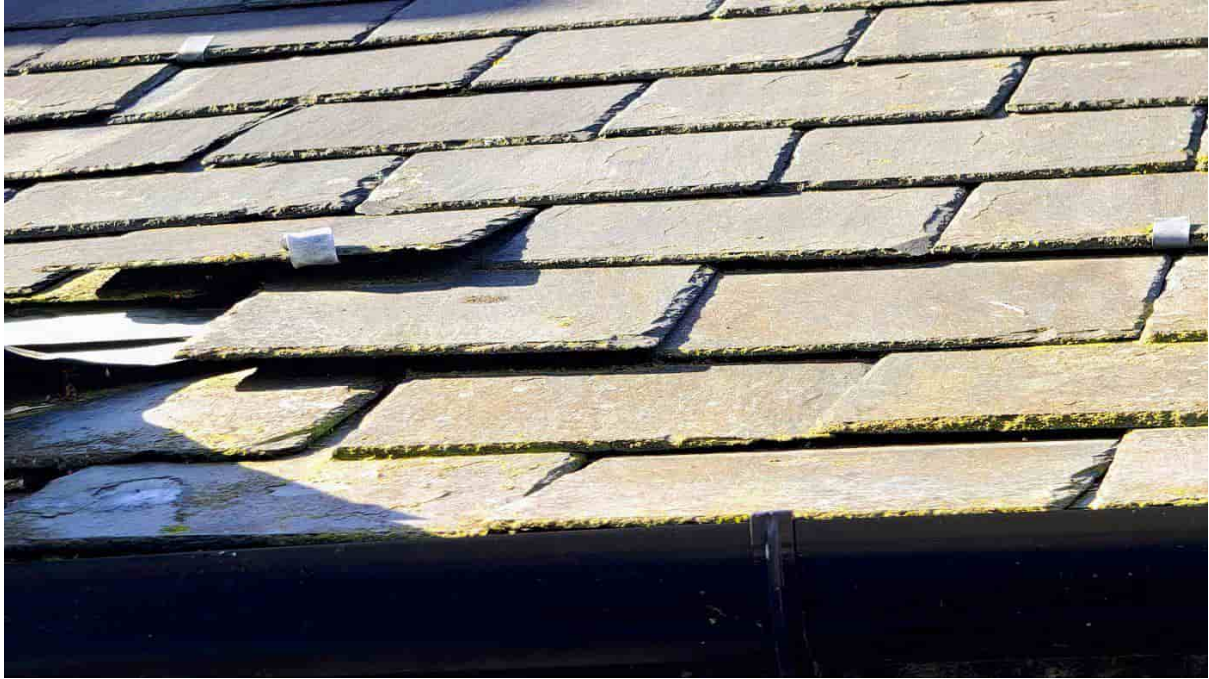
A visual inspection of the roof area and chimneys revealed some dislocated roof tiles.

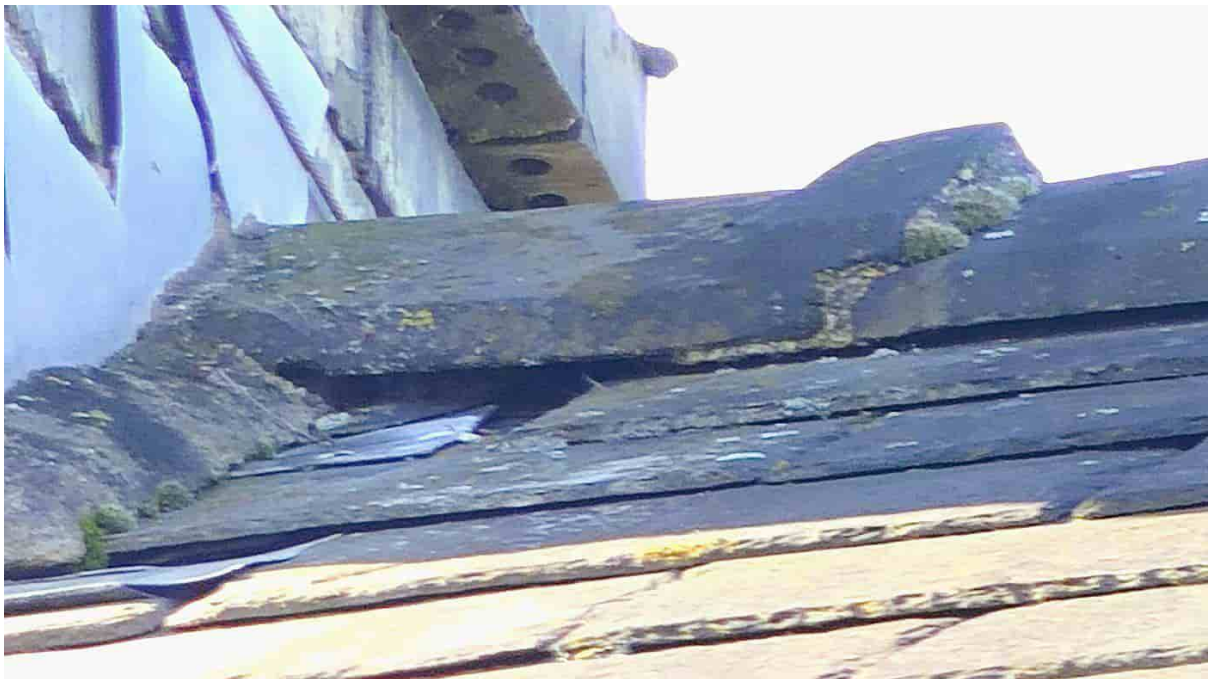
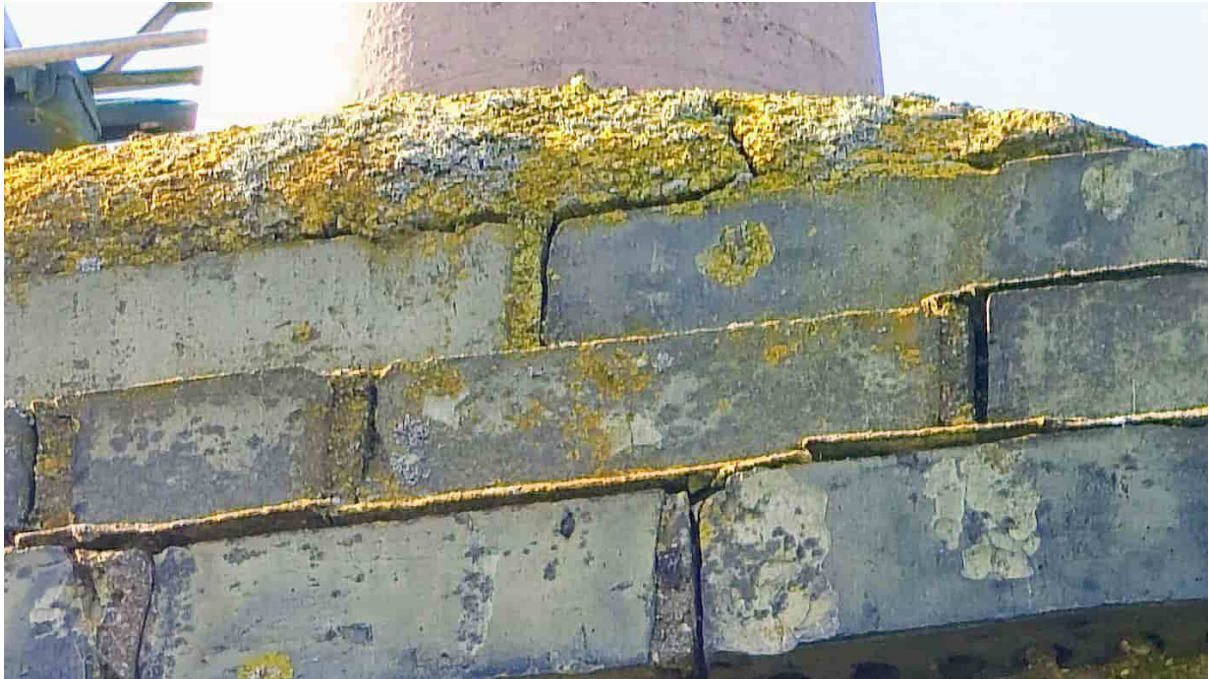
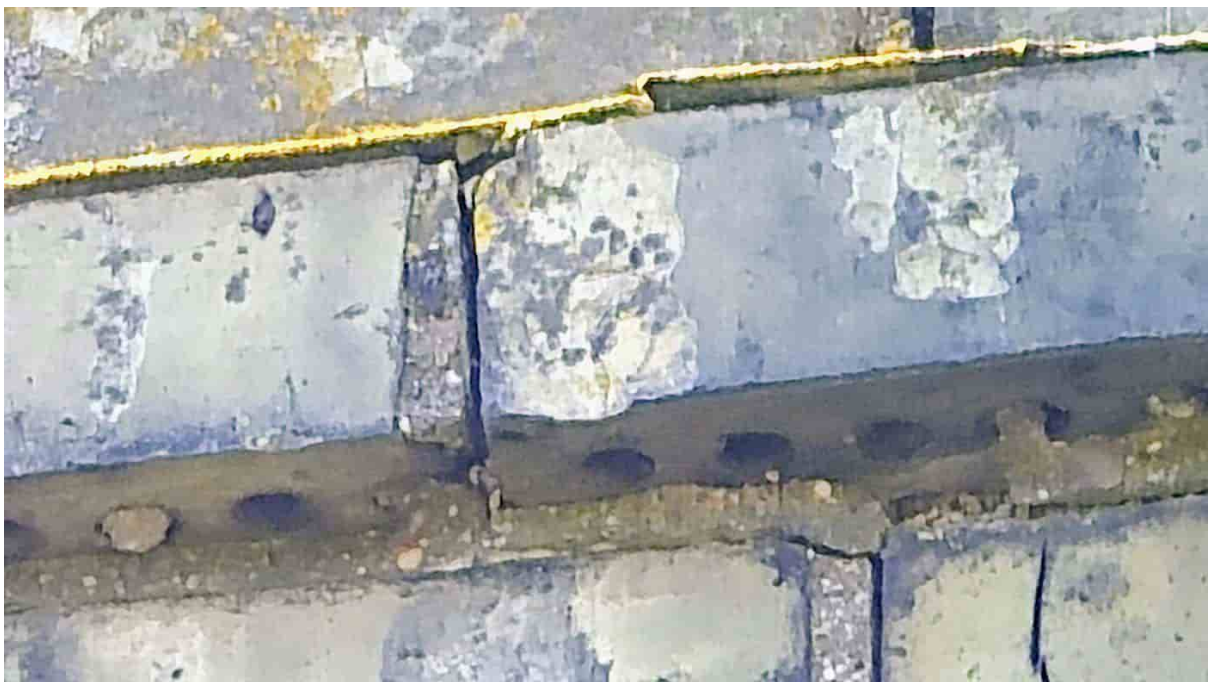
The chimneys in the past have been pointed with cement. The pointing has many cracks which can cause water leaks inside or around the chimneys.

The cracks along the flashings of the chimneys must be rectified and redone with lime.

The chimneys **should be inspected for leaks** to ensure that there is no ongoing water ingress. Any pointing of flashing deficiencies found should be remedied, making the chimneys watertight.

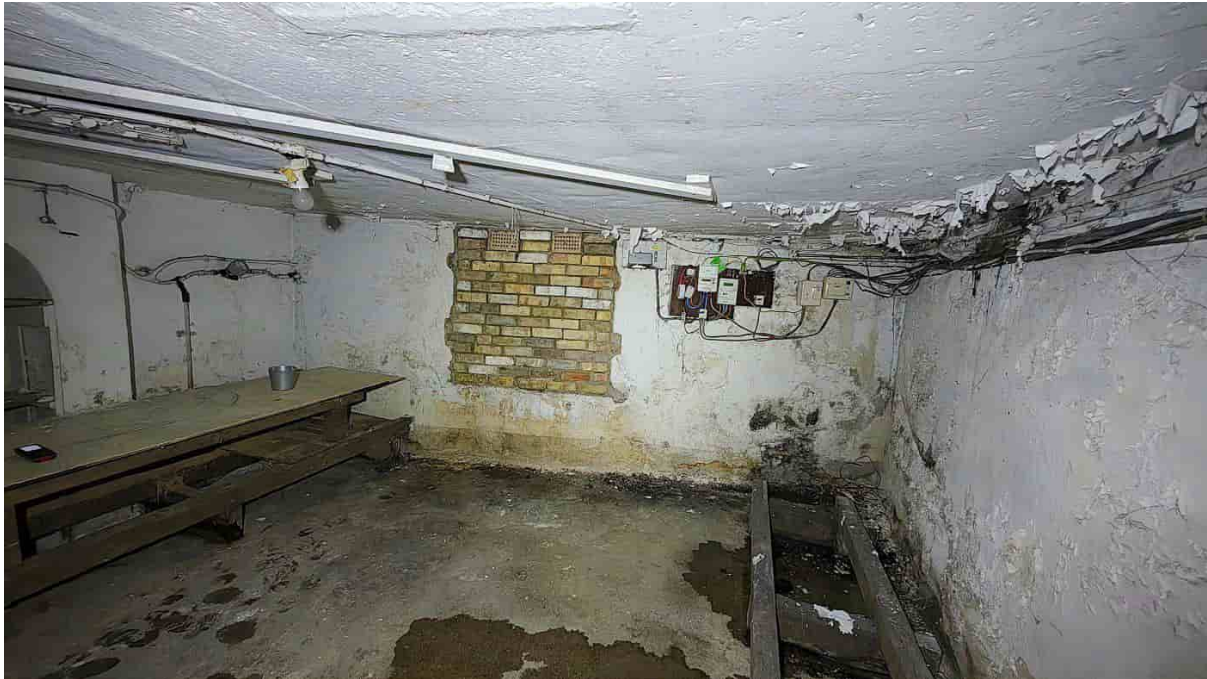
Being a pub, the cellar in the past has been used mainly for storage. To keep the cellar waterproof, it has been tanked with a modern cement plaster then painted with some modern paint. Both the paint and plaster are decaying badly.

The cellar can be made waterproof with the Rinzafo MGN Roman waterproofing mortar by applying 2 x 10 mm coats onto the walls and the floor.

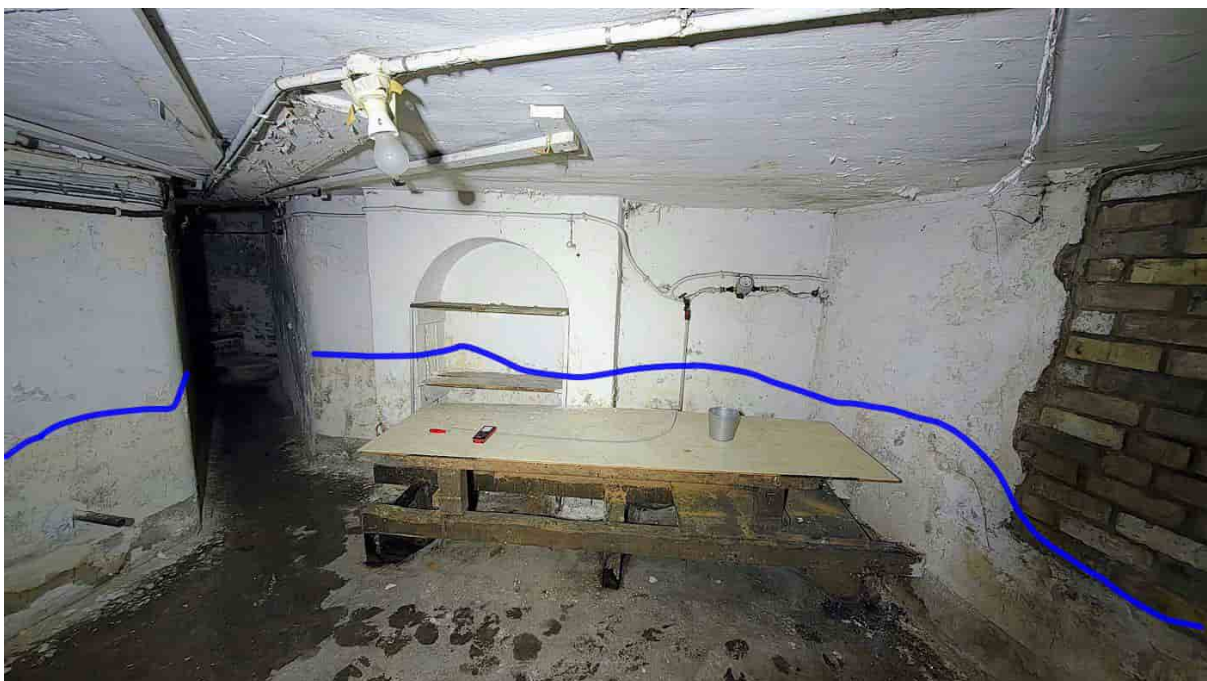
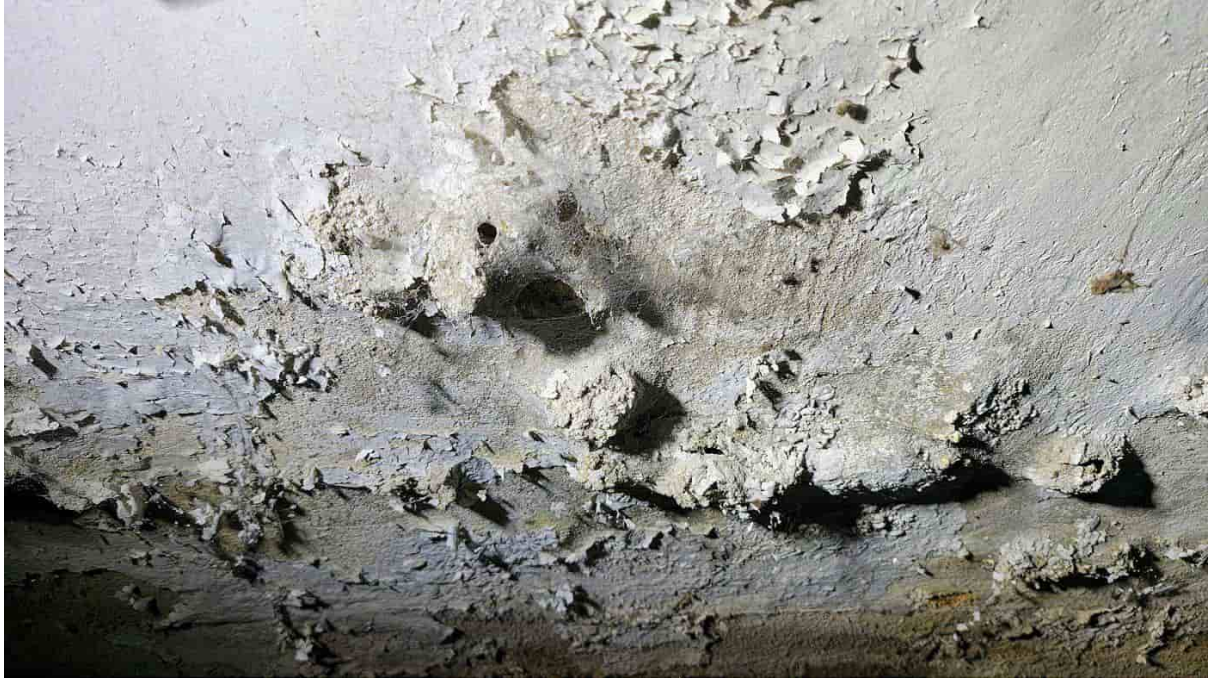
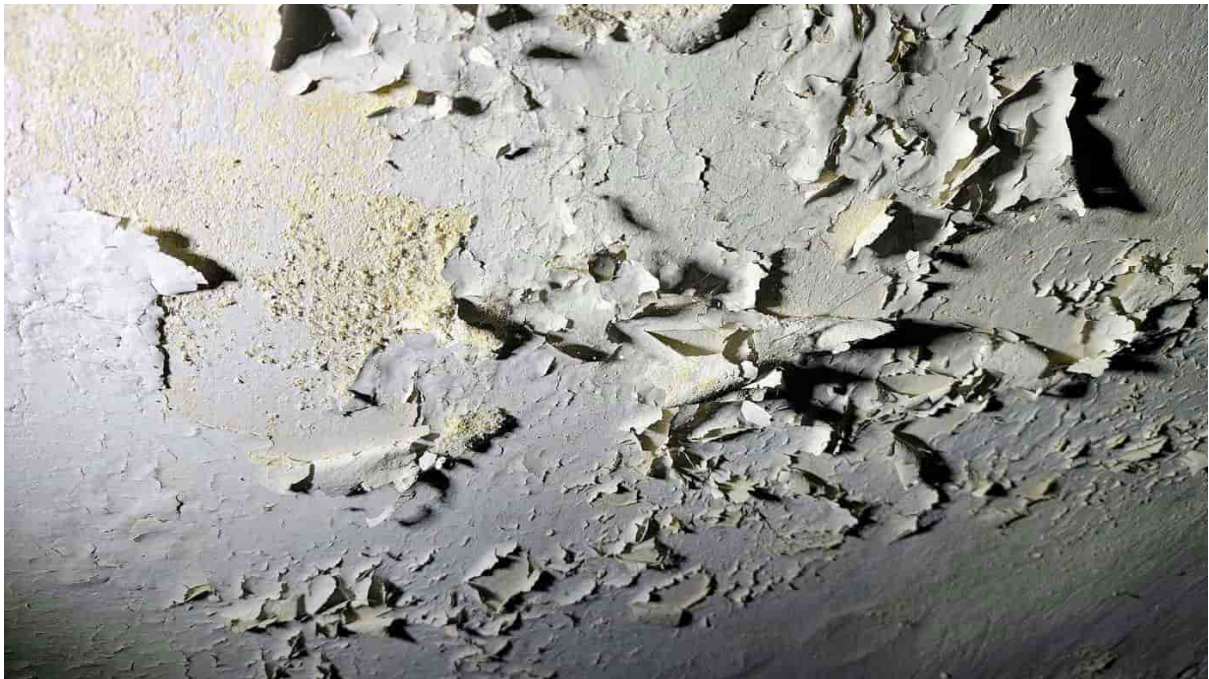
The lower part of the walls is most affected by plaster decay.

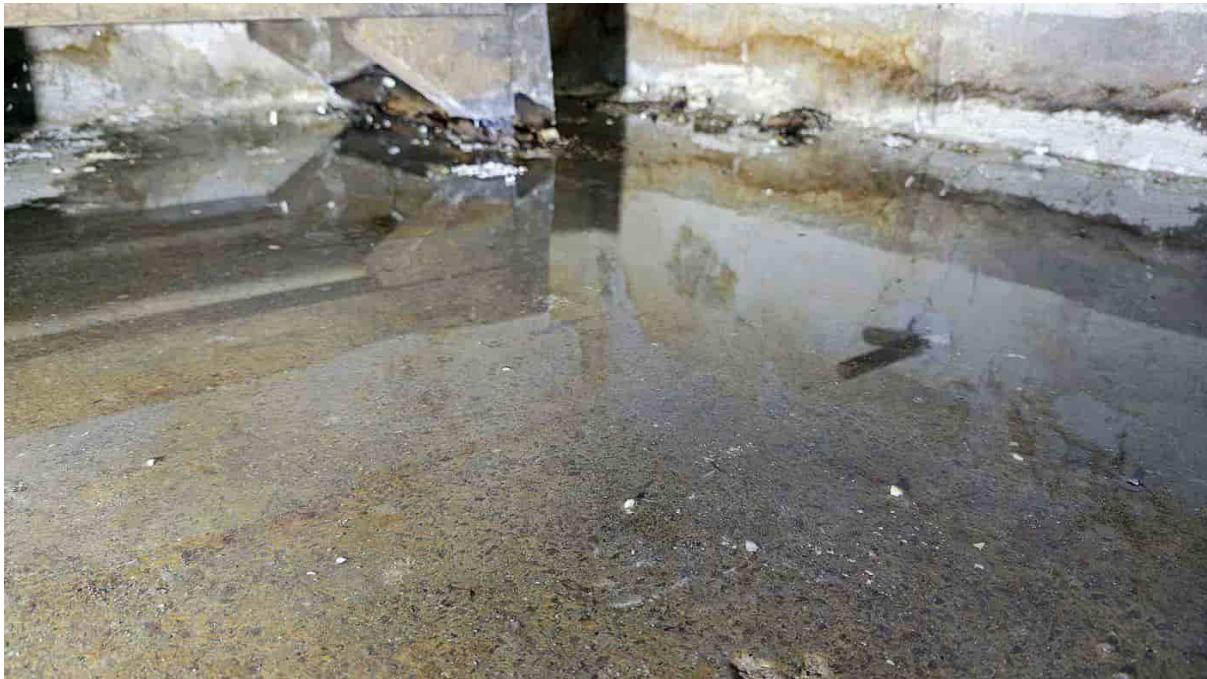
At the time of inspection there was liquid water on the floor, most likely from the rising water table, water seeping through the wall / floor cracks.

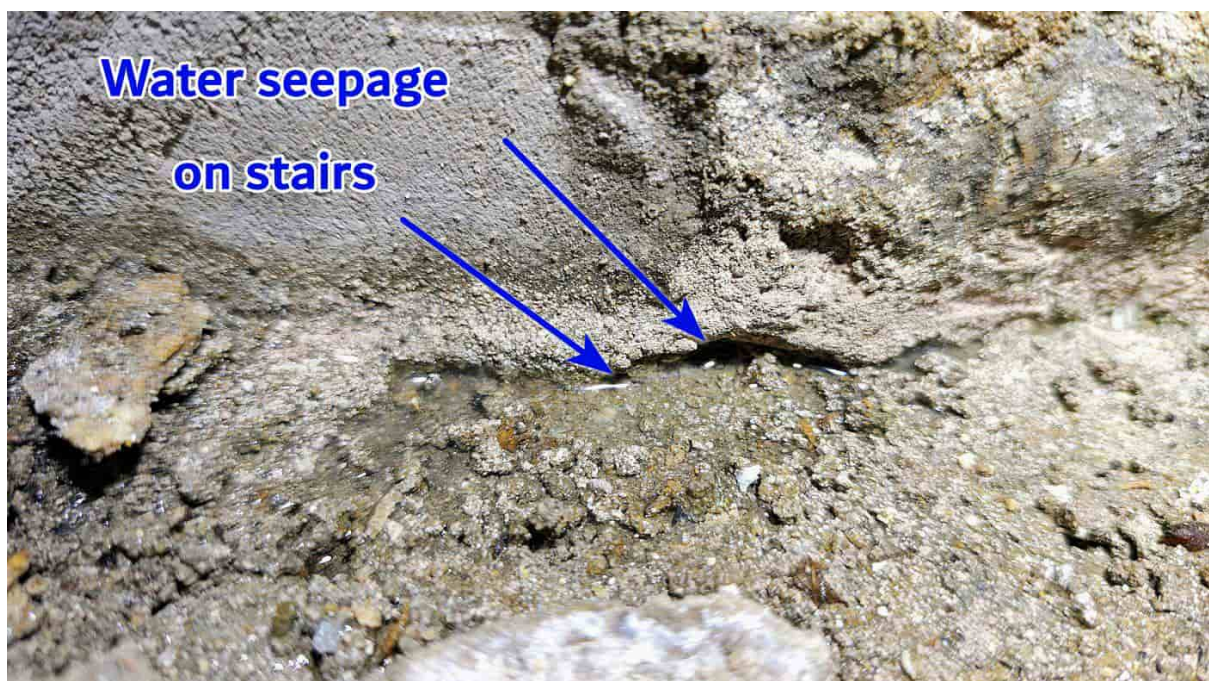
Ongoing water seepage was visible from the bottom stairs.

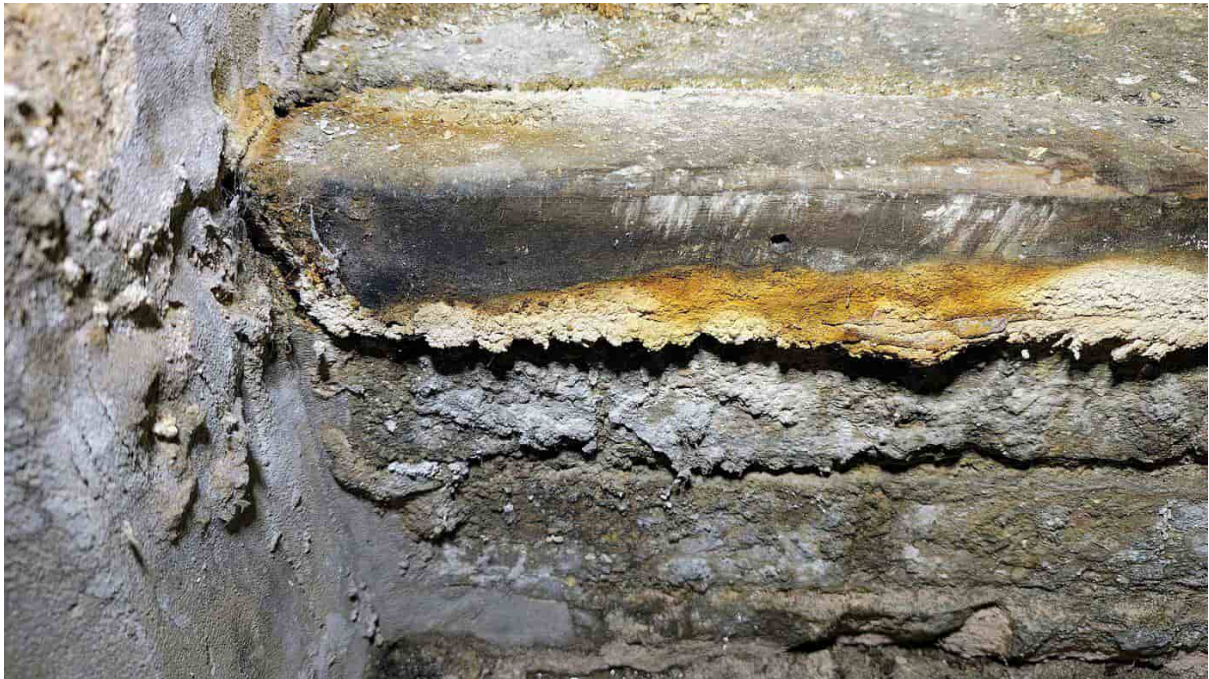
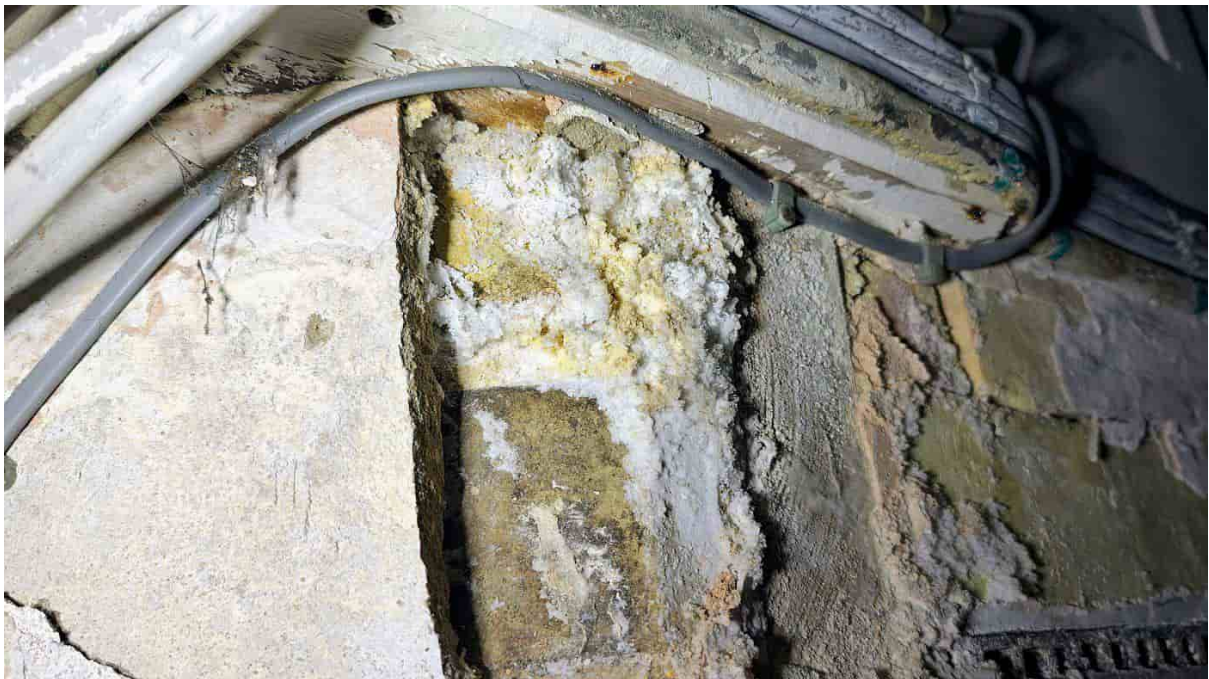
Heavy salt crystallization is present along the steps and the bottom of most walls.

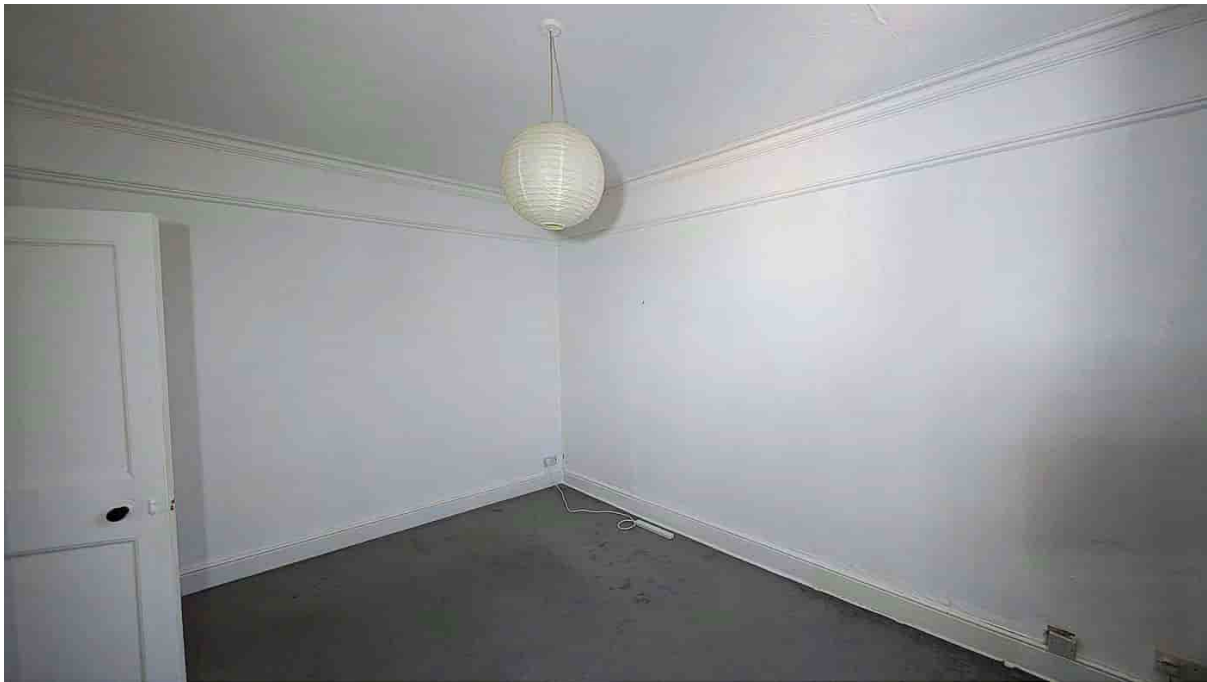
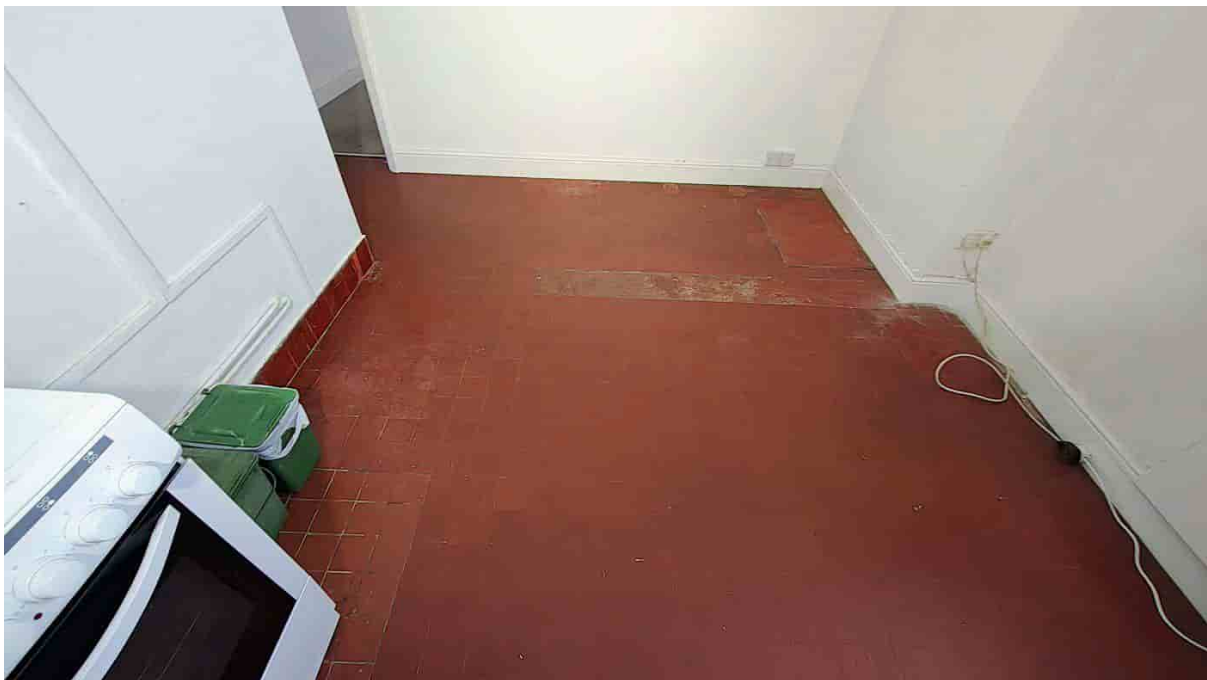
There is a standalone flat behind the building. The one-bedroom flat is largely suffering from the same problems than the rest of the building. There is rising damp near the base of the walls, and modern materials cause moisture accumulation inside the walls.

a full stripping and replastering will be needed both in the main building and rear flat. All works should be completed with building-friendly lime-based or other breathable materials and renovation procedures.

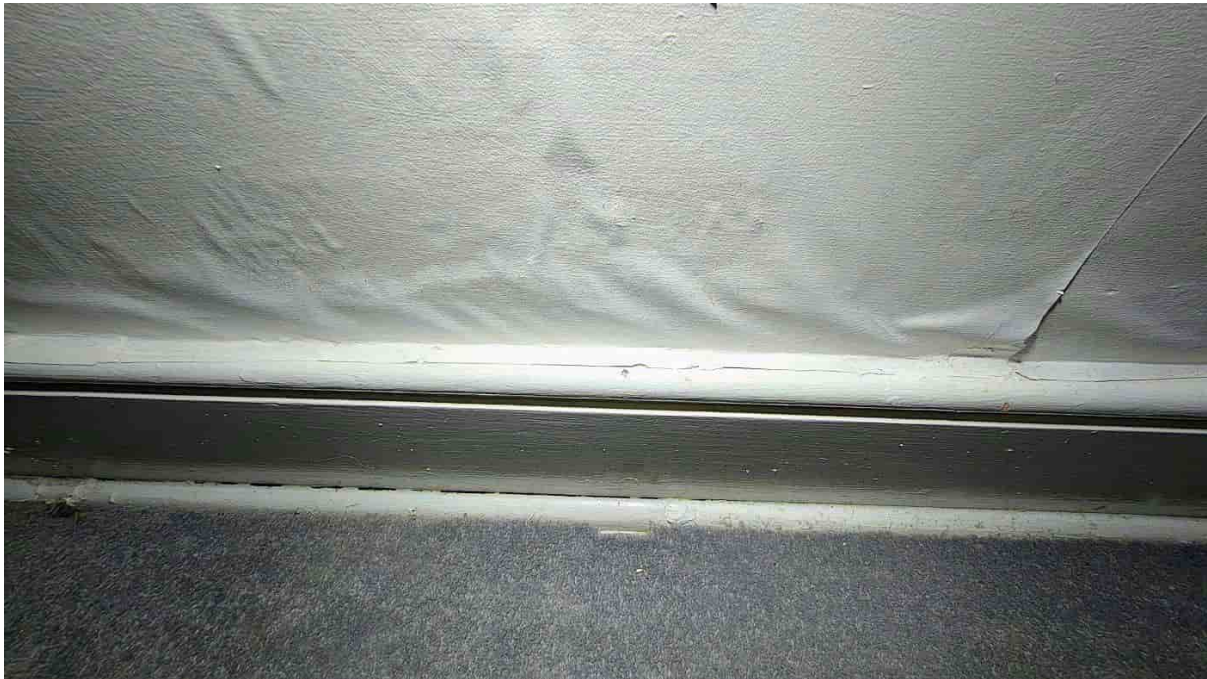
The wallpaper is damp and raised near the base of the wall.

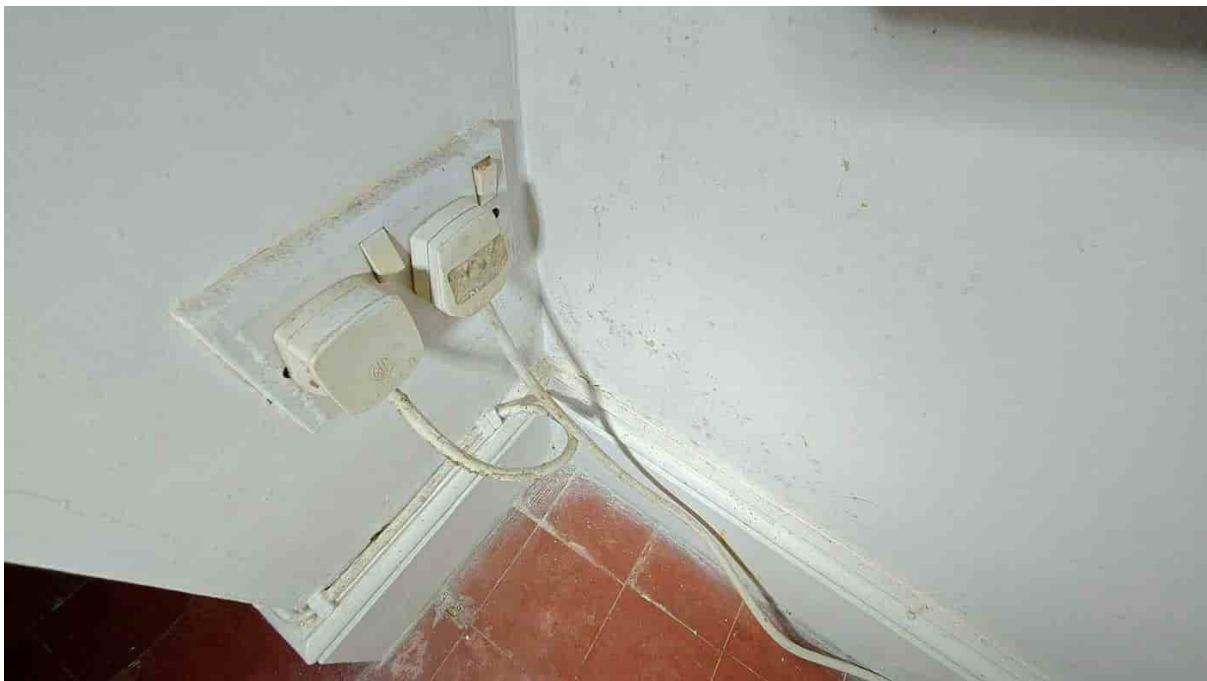
There is also some condensation in the corner of some external walls.

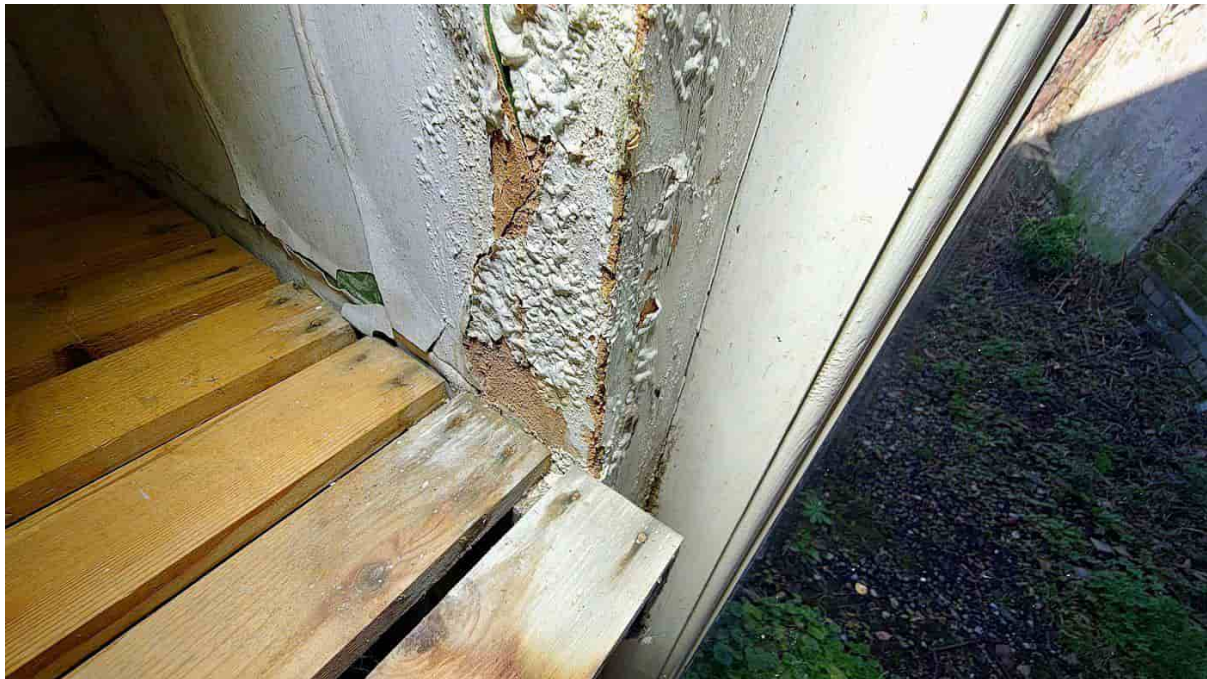
The internal plastering is modern cement and gypsum, which are not breathable. Modern plasters also contain salts, which are one of the most significant causes behind the decay of old masonries. Salts, through expansion, cause crumbling, leading to the gradual destruction of the historic wall fabric.

A non-breathable plaster is **not the cause of dampness problems**, however by blocking the evaporation of existing humidity, it can significantly accelerate the long-term accumulation of moisture in the wall fabric.

Future renovation works are recommended to be done with breathable lime plasters. Modern cement plasters should be entirely avoided.

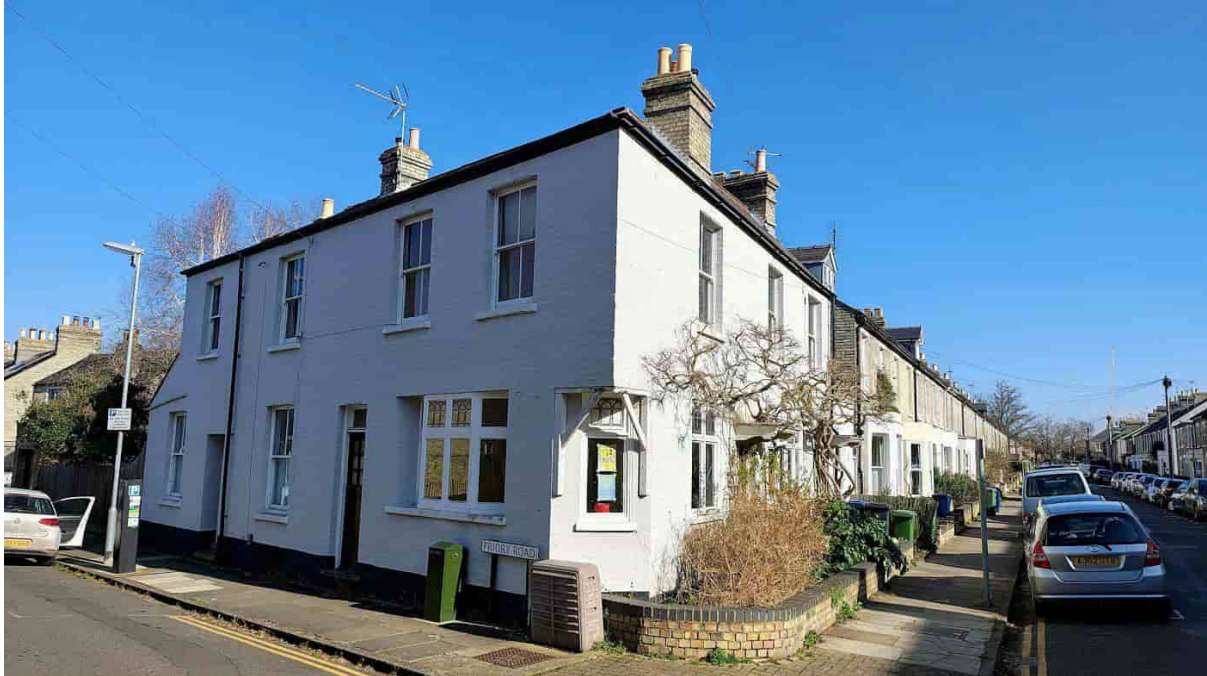
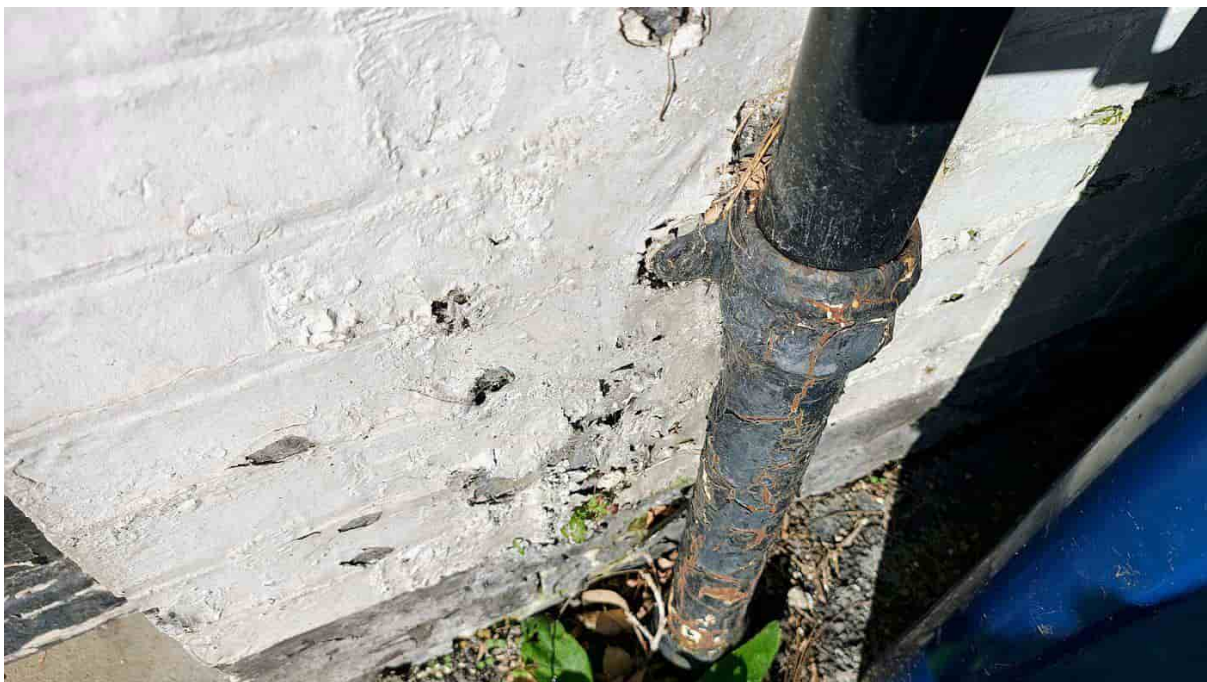
The building is painted outside with modern, non-breathable masonry paint. Such paints retain moisture, contributing to accumulation of moisture inside the wall fabric.

The use of breathable paints and finishes is recommended for the future.

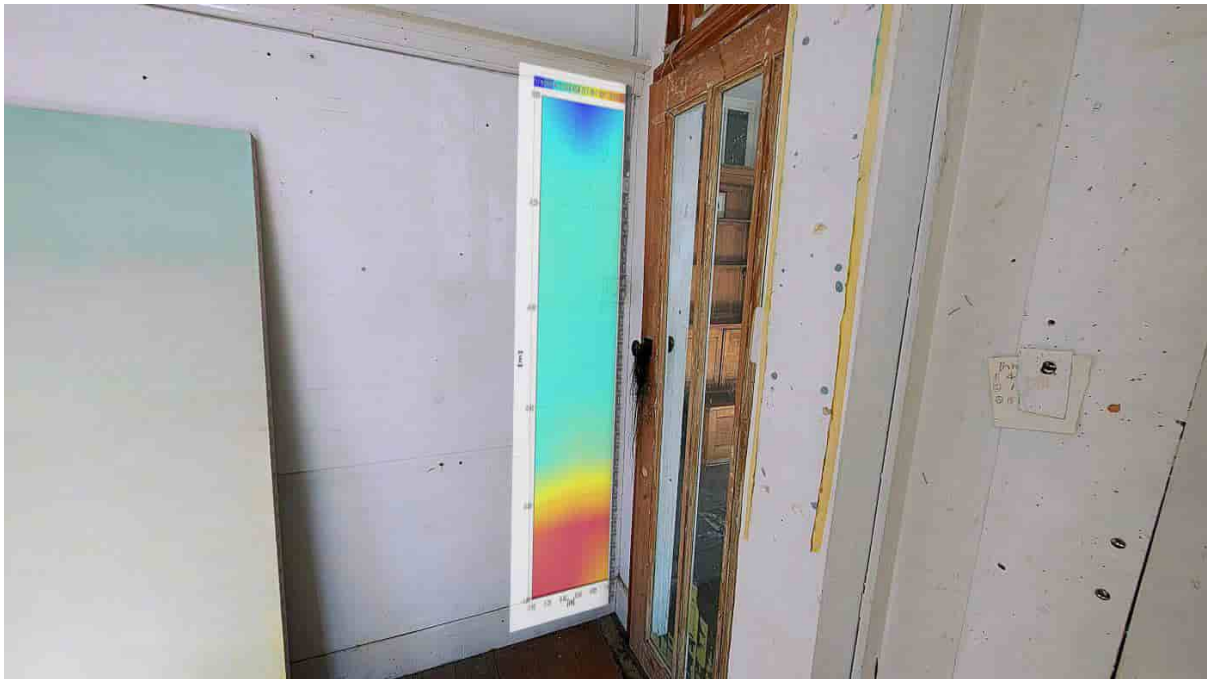
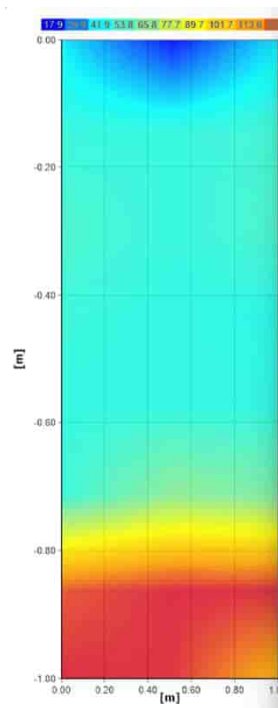
Wall 1 – Pub Internal Wall

Red / orange / yellow areas are very damp, light blue moderately damp which need attention, while dark blue areas are normal. Rising damp near the base of the wall shows up as a distinct red area.

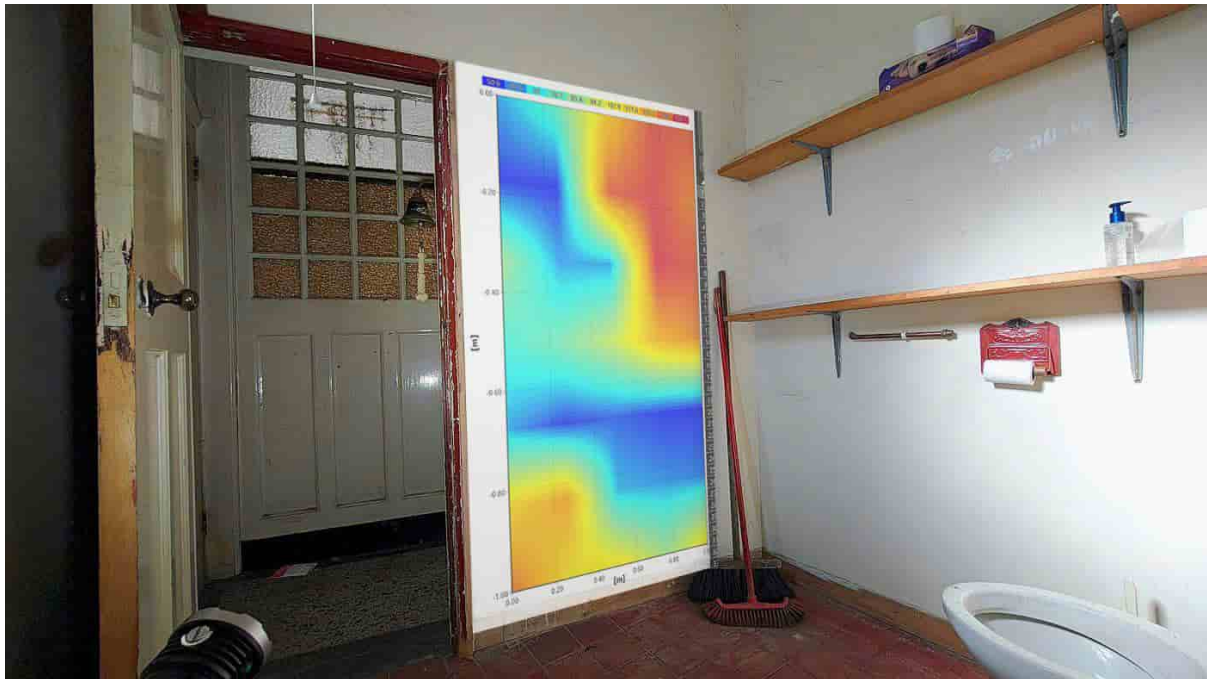
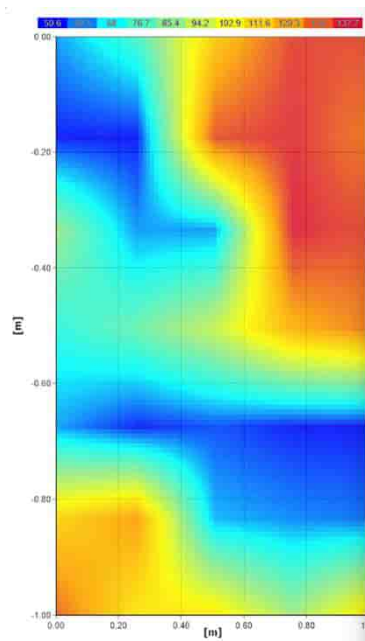
Wall 2 – Bathroom Wall

Red / orange / yellow areas are very damp, light blue moderately damp which need attention, while dark blue areas are normal. Rising damp at the bottom, water leaks from the top. We can see rising damp at the bottom and some water leaks on the top right corner.

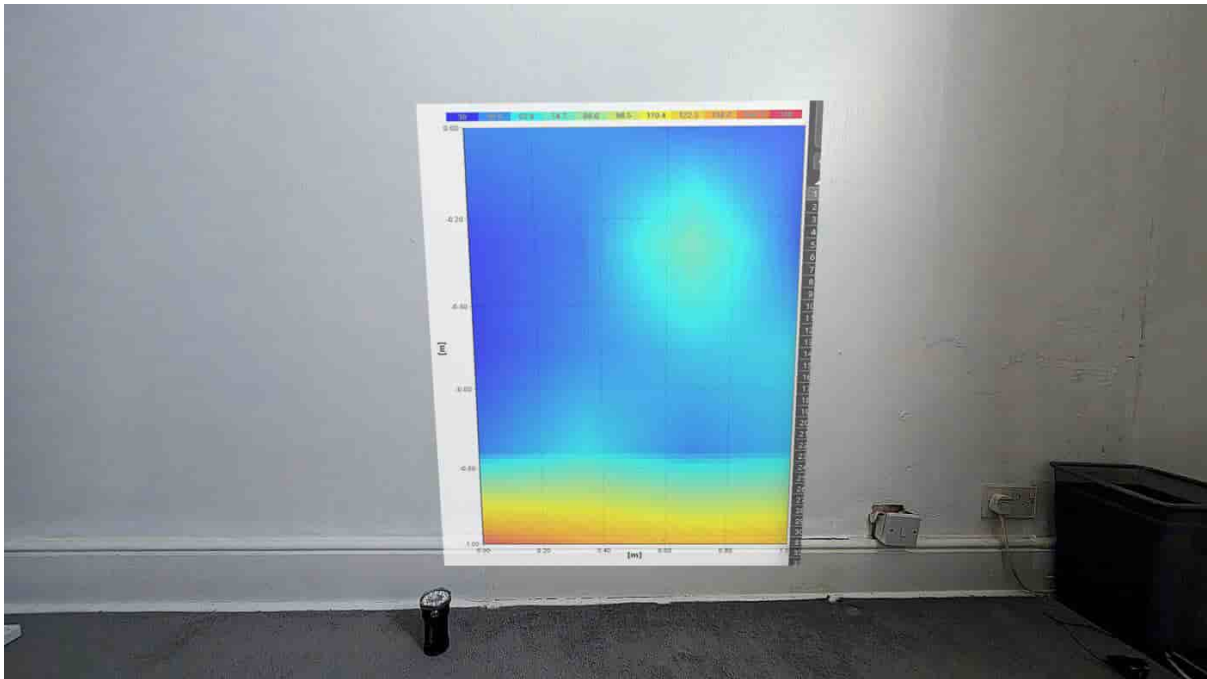
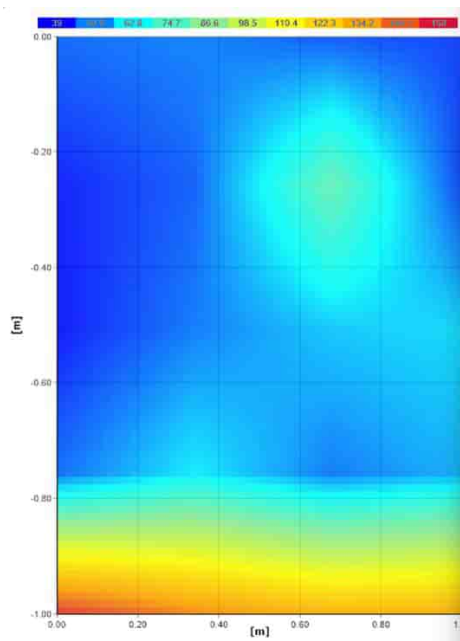
Wall 3 – Flat Bedroom Wall

Red / orange / yellow areas are very damp, light blue moderately damp which need attention, while dark blue areas are normal. Some rising damp is visible where the wallpaper is damp and raised.

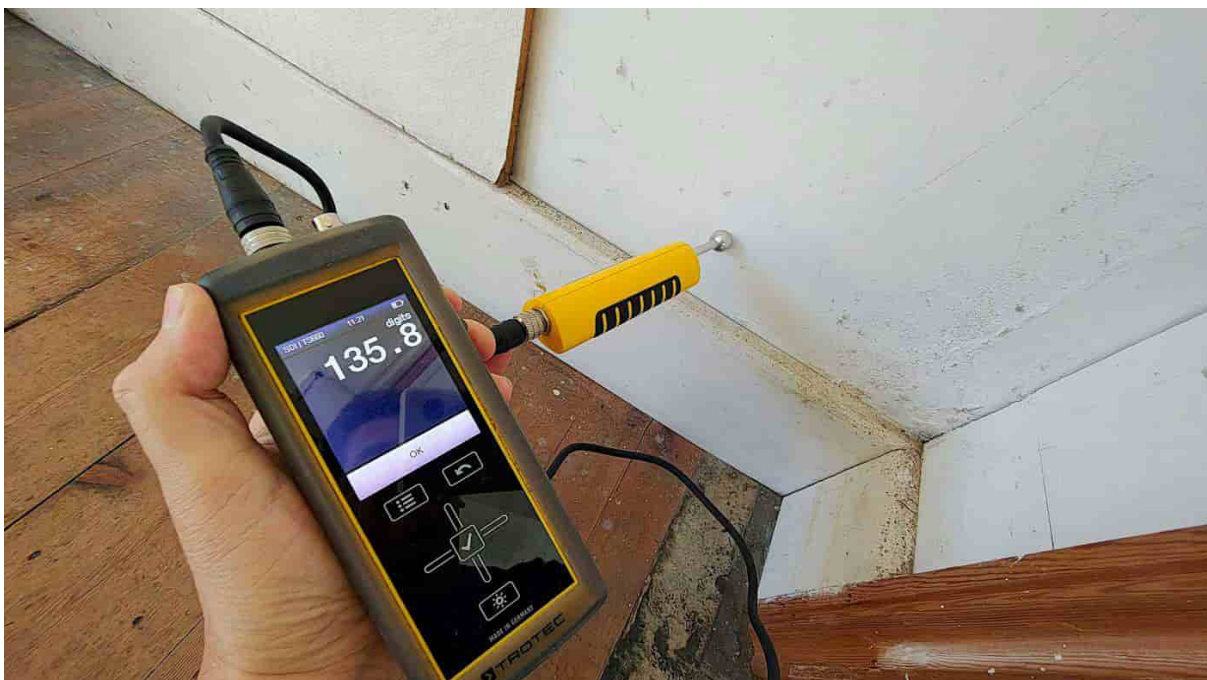
Dampness meter readings confirm this. **Readings over 70 are higher than normal.** There is a significant difference between the upper and lower parts of the walls.

Damp values at the bottom: 135

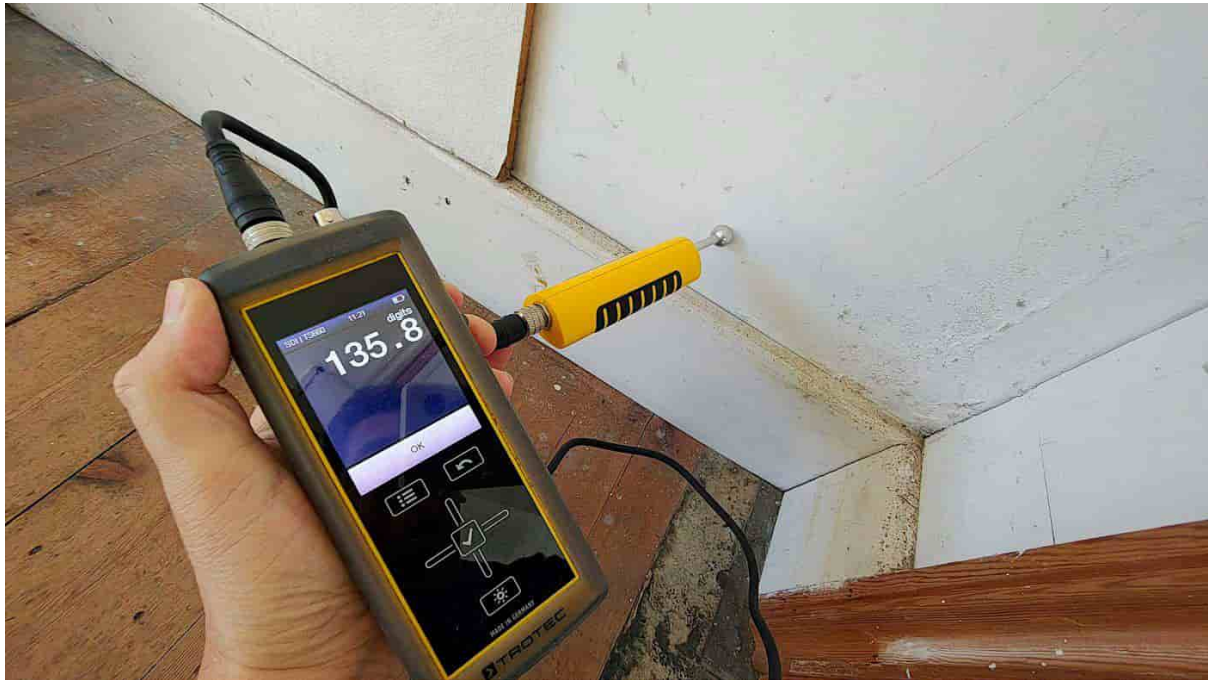
On top: 59

Other areas show similar values.
