Dampness Report

Old Pub Building

3 March 2025

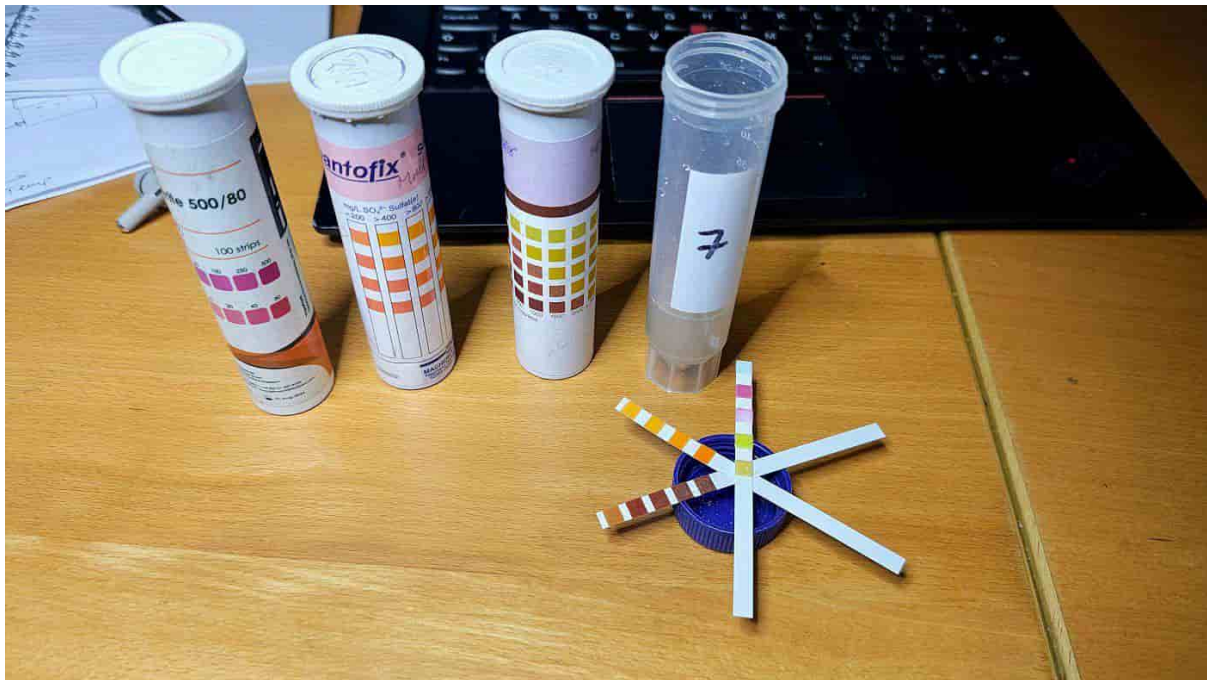
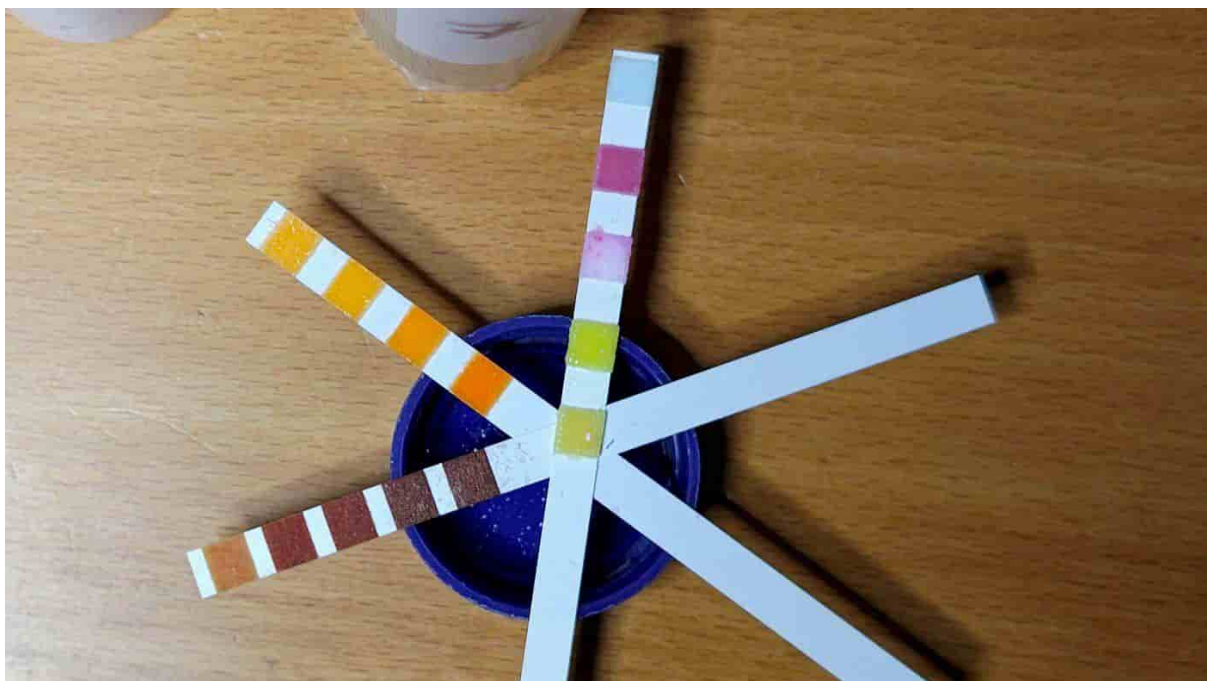
- **Nitrates** (white to purple): very high concentration, from the ground, as a result of rising damp.
- **Sulphates** (pink to orange): high concentration, can originate from several sources, including the ground or the decaying gypsum plasterboard.
- **Chlorides** (brown to white): none.
