# Dampness Report

Lower Ground Flat, London

27 November 2024

We have been asked to investigate the dampness problem in this **Grade 2 listed** lower-ground residential flat due to previous damp proofing works and recent cracking of the decorative finish.

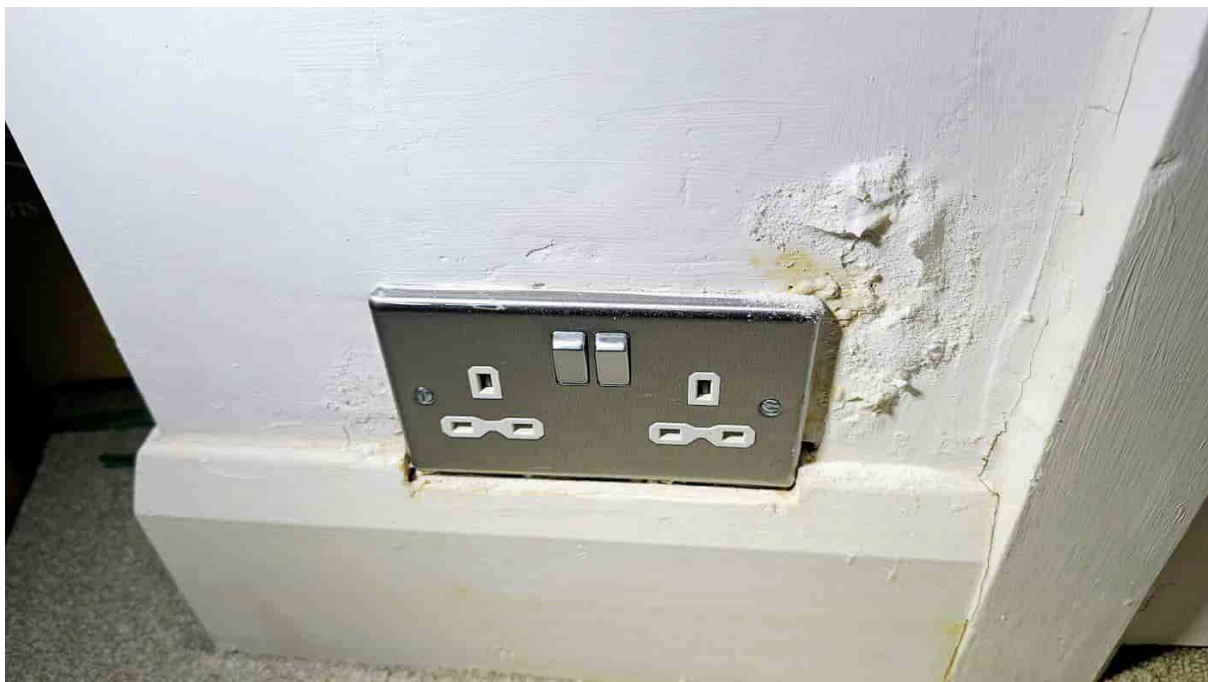
The main reason behind the crumbling and degradation of plastering in the building is **rising damp**.

The water is rising from the ground carrying into the wall fabric various minerals known as **salts**. The water evaporates through the plaster and when the growing salt crystals expand in volume (up to 10X), they break down the building fabric, resulting in potential crumbling, peeling and/or damp patches.

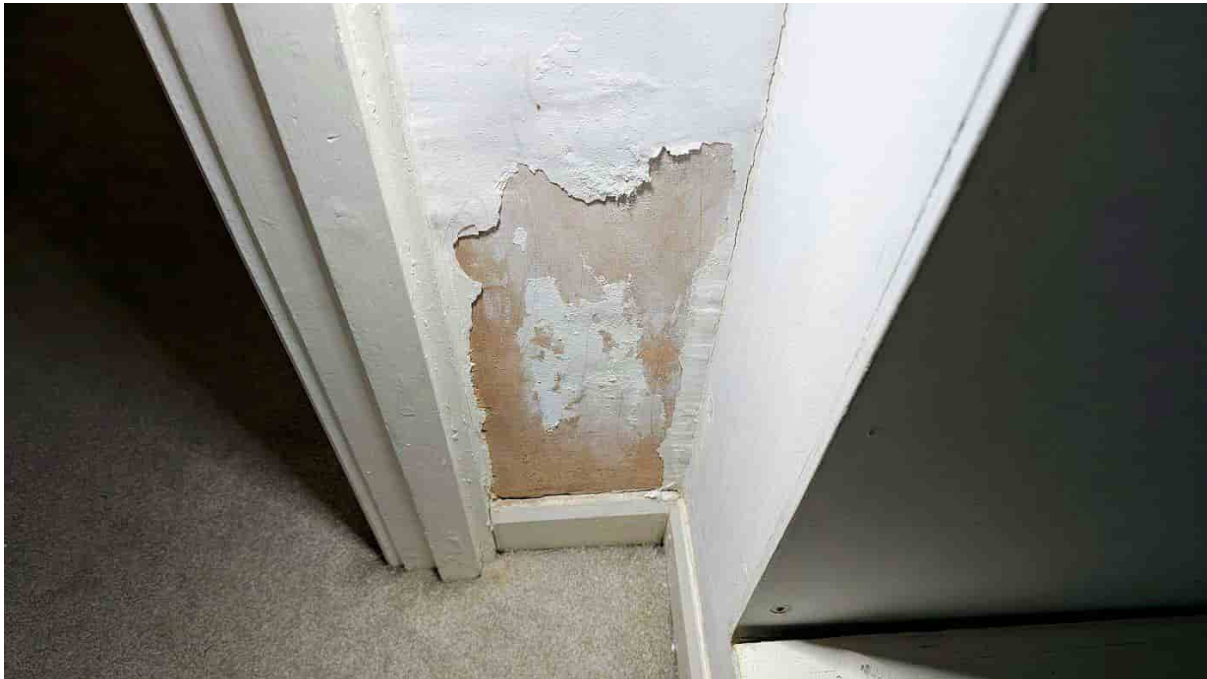
As a result of evaporation and salt crystallization, first the paint starts peeling then the plaster crumbles, eventually leading to damages of the mortar and brickwork.

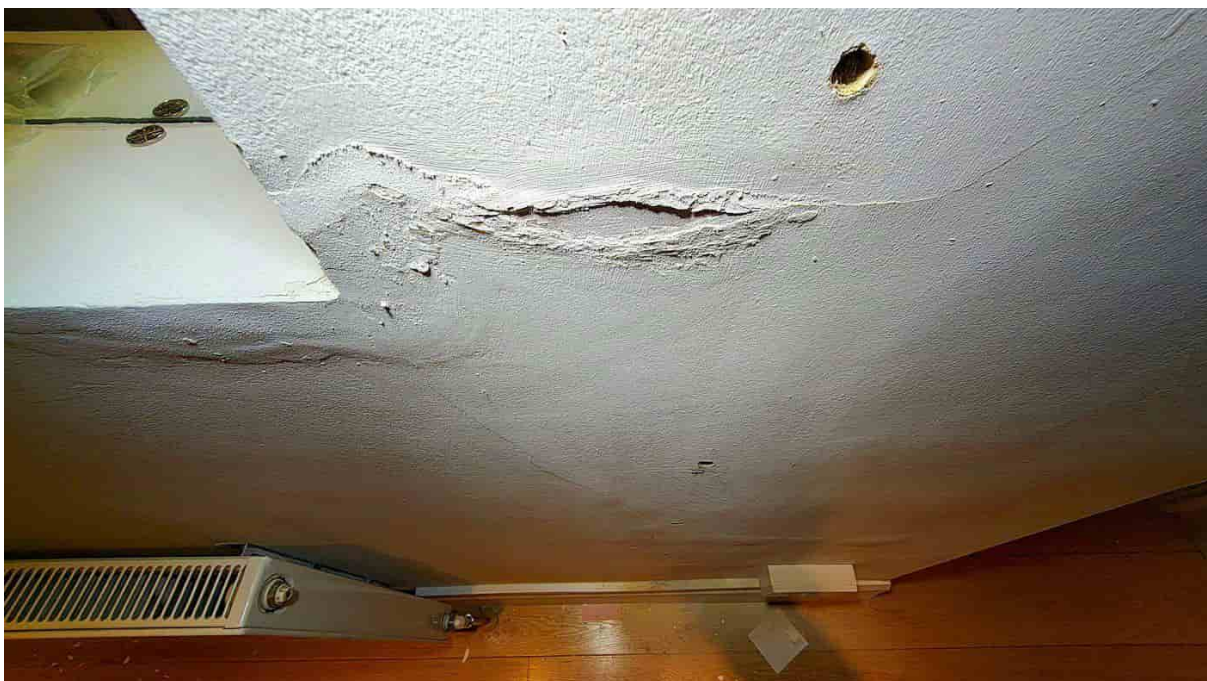
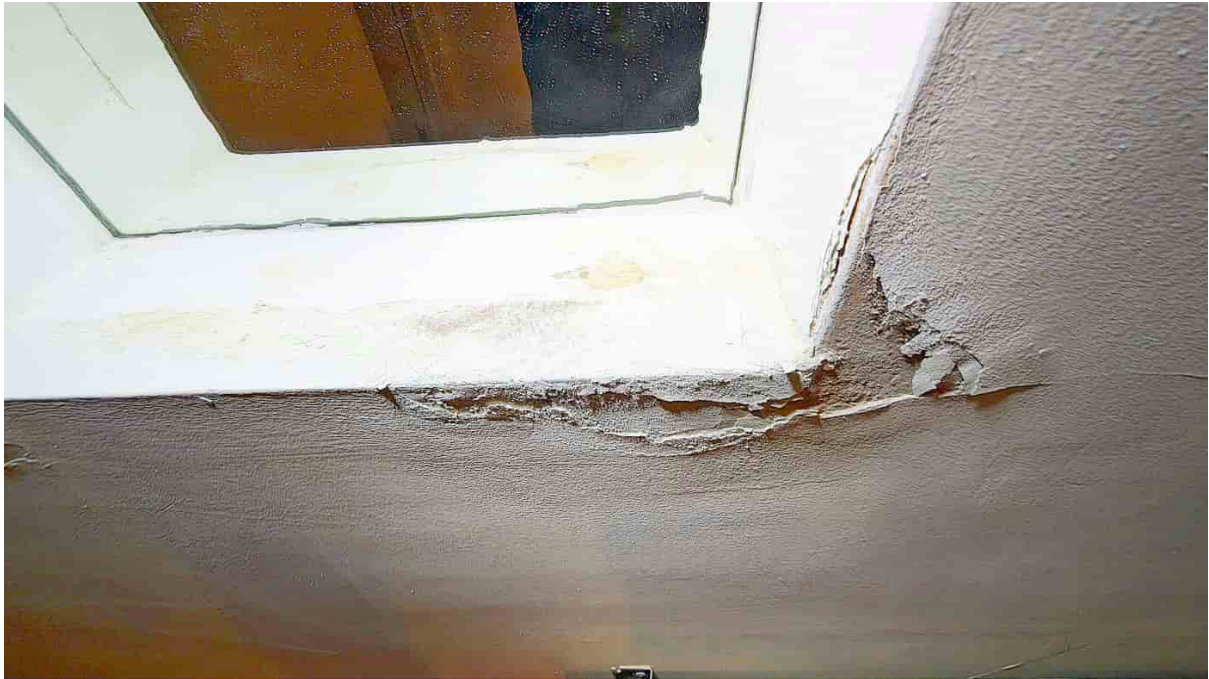
Modern cement plasters and renders just shift the dampness problem, making it rise higher or push it sideways. If the evaporation of moisture is hindered by modern non-breathable materials, moisture can rise over the proverbial 1 metre height.

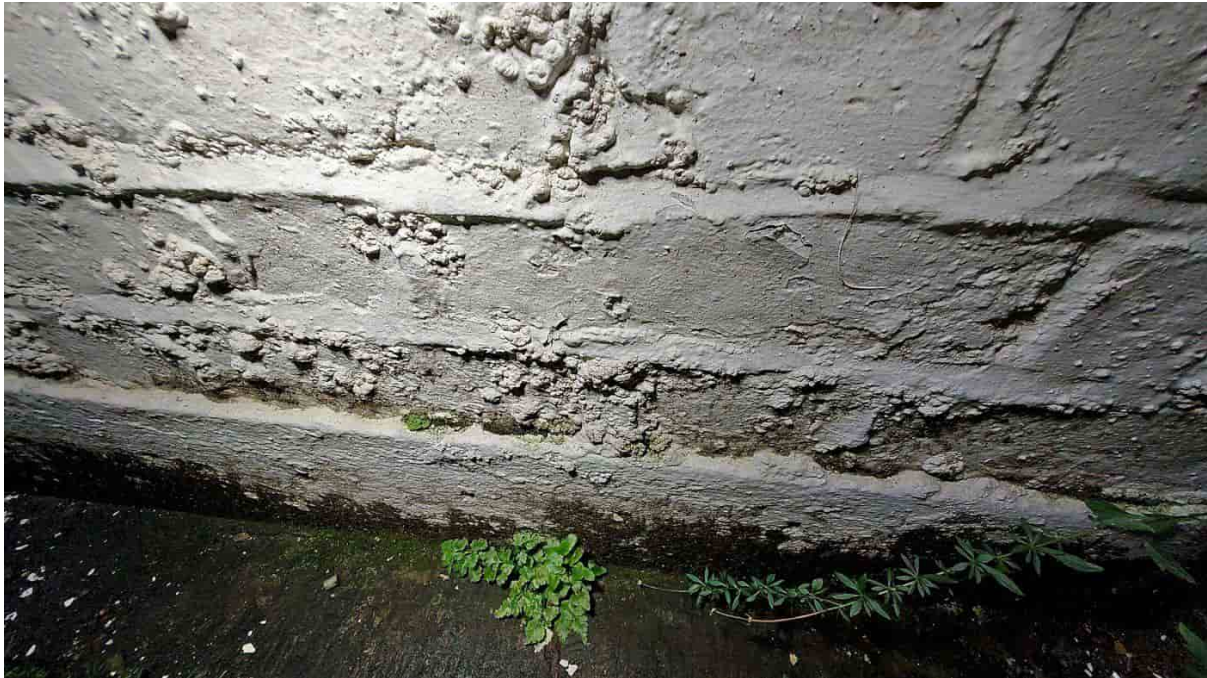
Salt crystallization is also visible outside in form of salt “blisters” along the mortar bed.

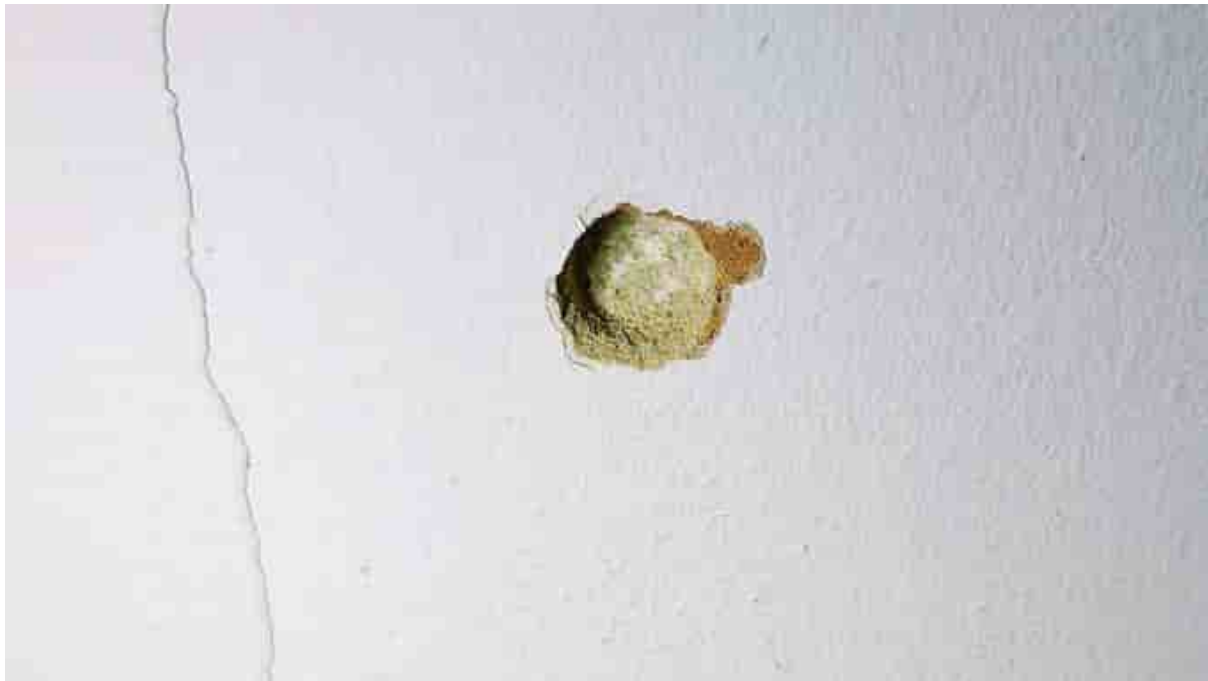
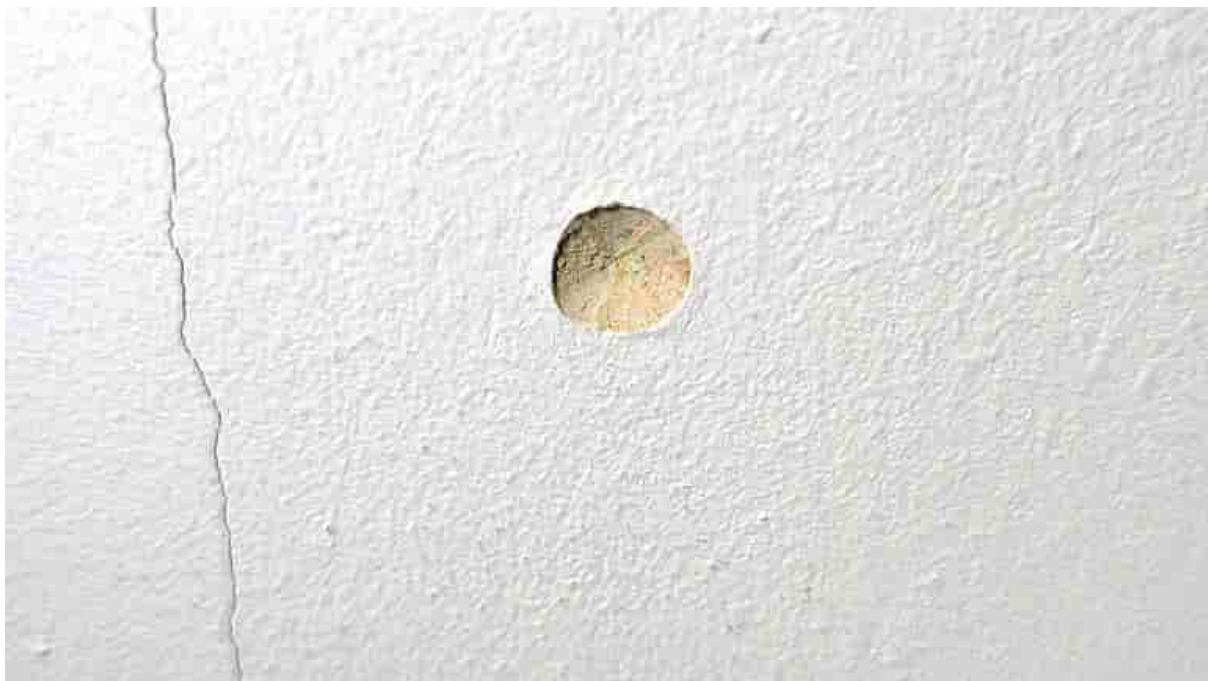
Taking plaster samples indeed confirms the presence of cement plaster and gypsum finish, as shown below:

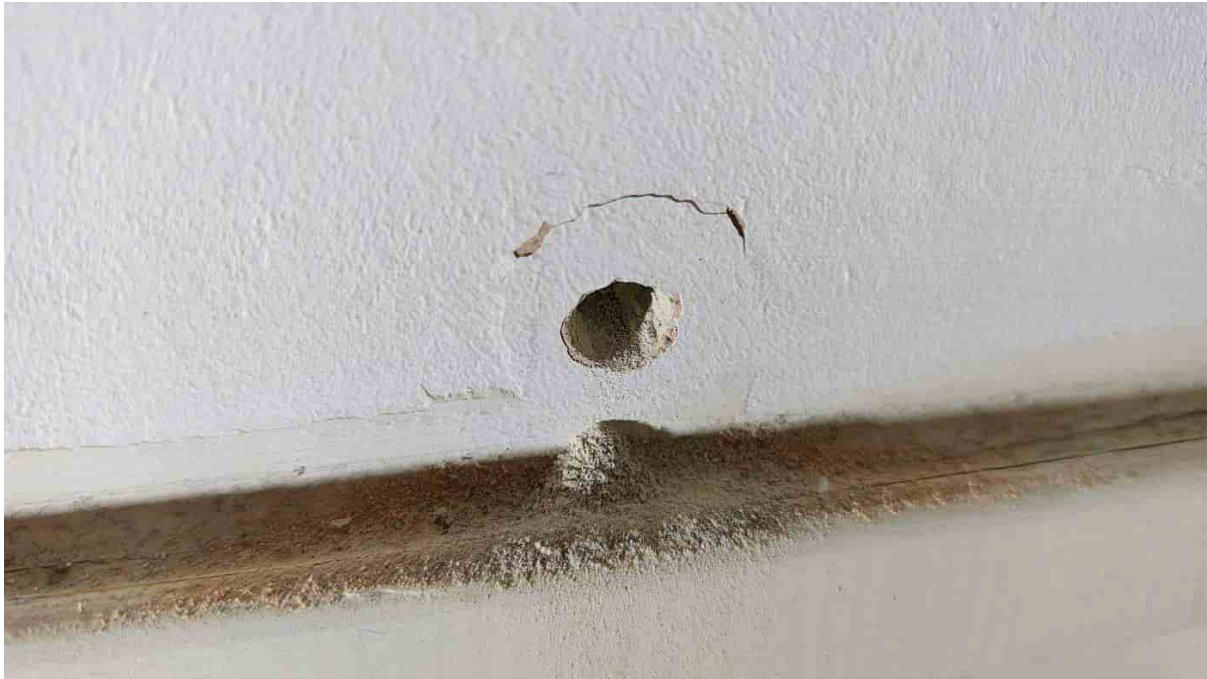
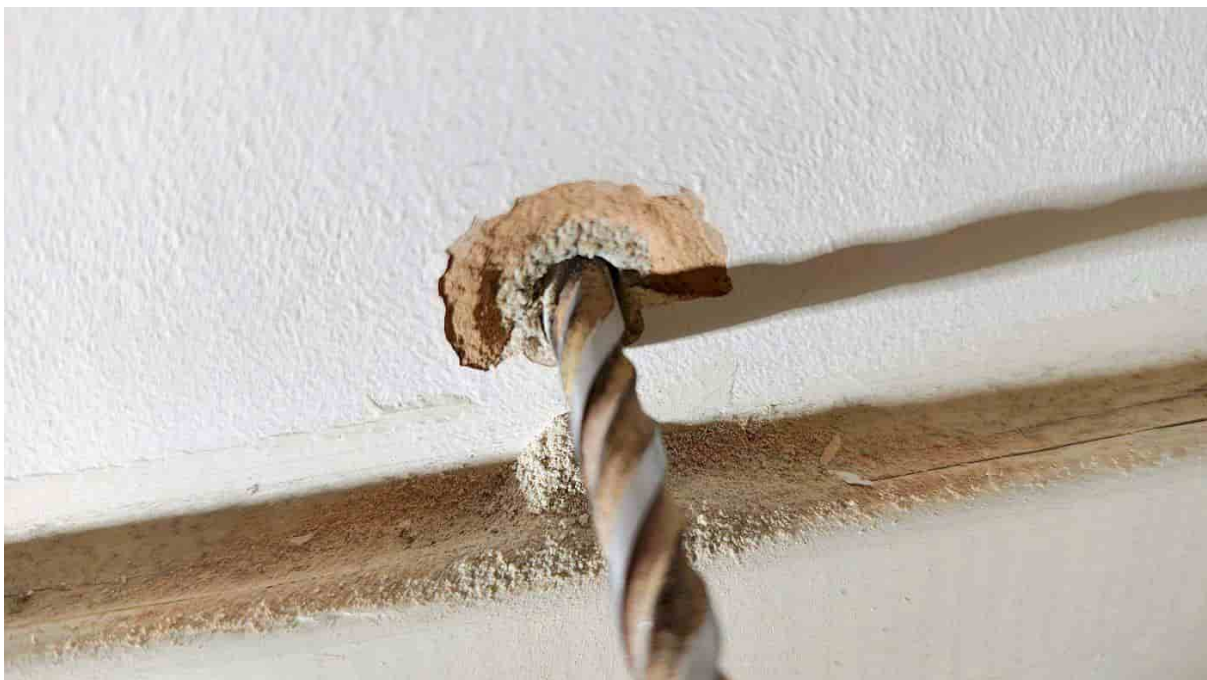
The internal **gypsum finish is badly cracked** throughout, spoiling the decoration. This is the result of the plaster mix and/or poor plastering work, resulting in an extremely brittle and fragile finishing.

During core sampling (detailed later) the vibration of the drill caused cracking then the complete delamination of the finishing.

Due to the presence of modern cement plaster and the poorly applied gypsum finish we have discussed the complete replastering of the internal building with **lime materials only**.

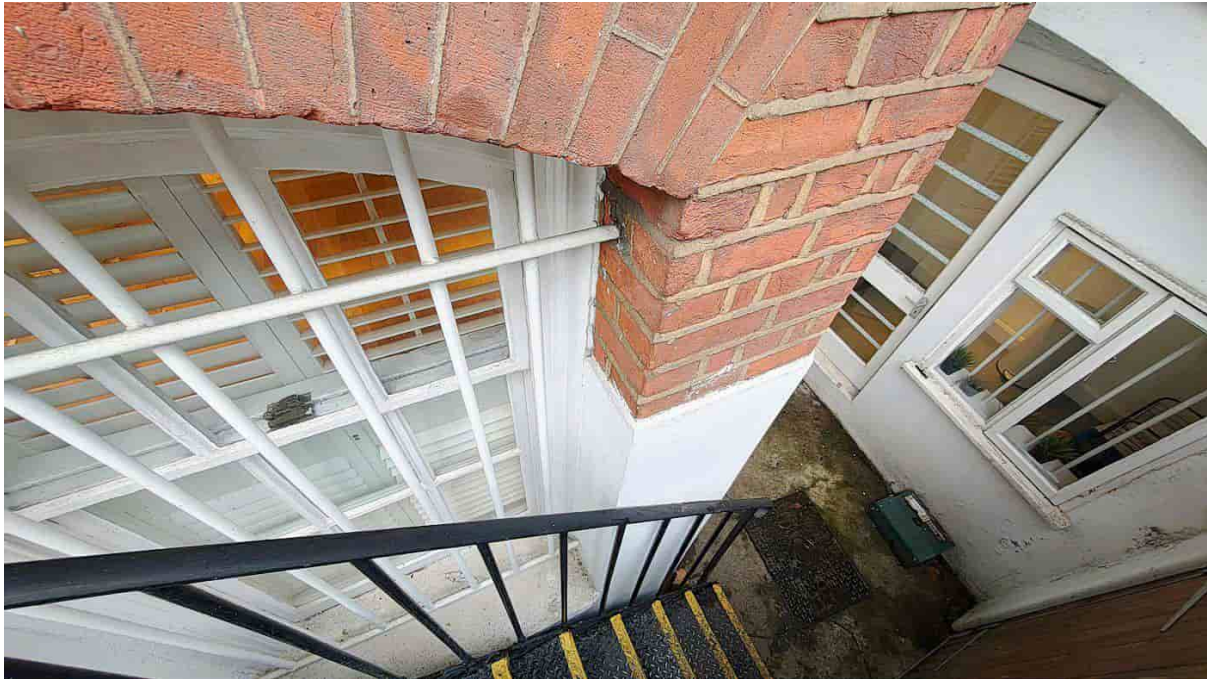
The front part of the building has been rendered up to about 2 metres height with a modern cement render, most likely to protect the fabric from rain. Modern cement renders are also often also part of the overall dampness problem, for the following reasons:

- **Non-breathable:** a cement render prevents the evaporation of water that finds its way under it, locking the moisture into the building fabric
- **Hard & brittle:** it cracks as the building moves, letting rainwater into the building fabric, resulting building fabric decay and dampness problems
- **Dense and poor thermal insulator:** contributes to potential condensation and mould problems, especially on external wall inner surfaces.

**No immediate action is required.** The existing render seems to be intact, performing its intended function, protecting the front of the building from rain. However, non-breathable renders contribute to accumulation of moisture inside the wall fabric.

During future renovations a **breathable lime render** should be considered, these being compatible with the old building fabric. More information here: [Re-rendering old buildings with lime – Technical guide](#)

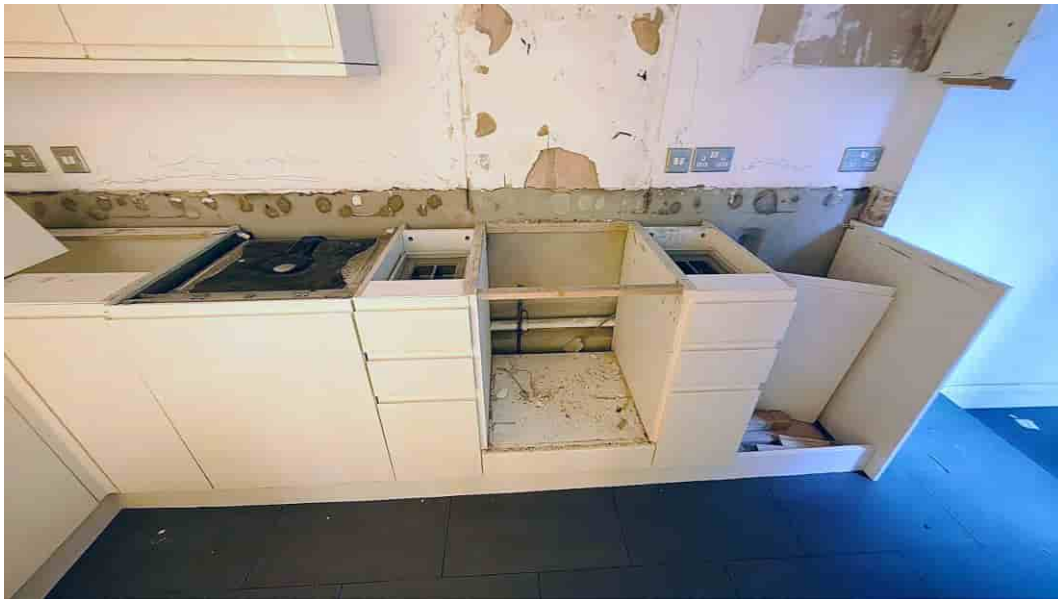
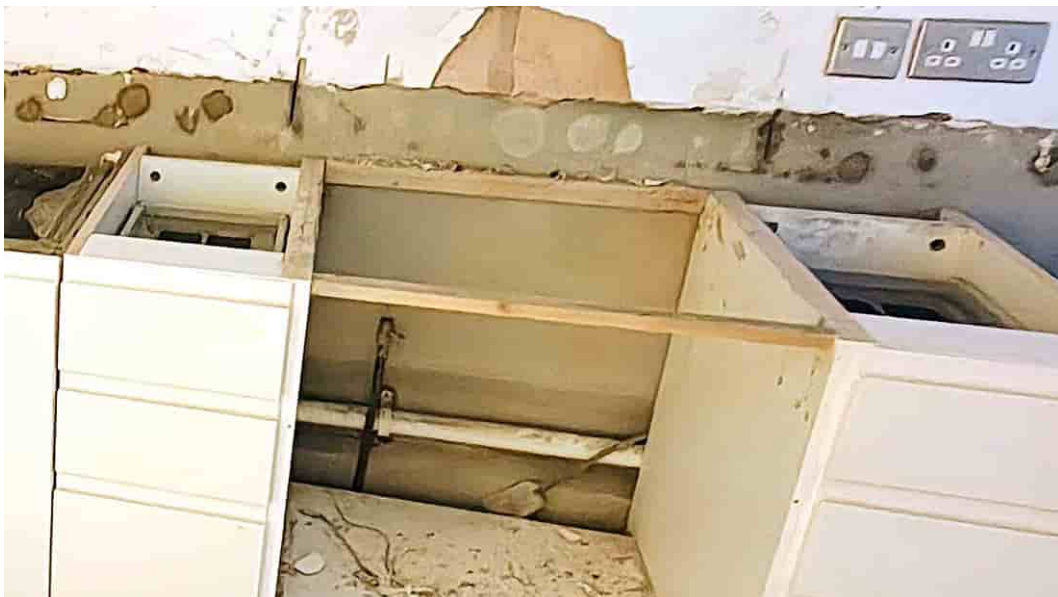
The internal plastering is a modern cement plaster which is not breathable.

A non-breathable plaster is **not the cause of dampness problems**, however because it blocks the evaporation of moisture from the fabric, it can significantly accelerate the long-term accumulation of moisture in the wall.

All future renovation and plastering works are recommended to be done with **breathable lime plasters**. Modern cement plasters should be entirely avoided.

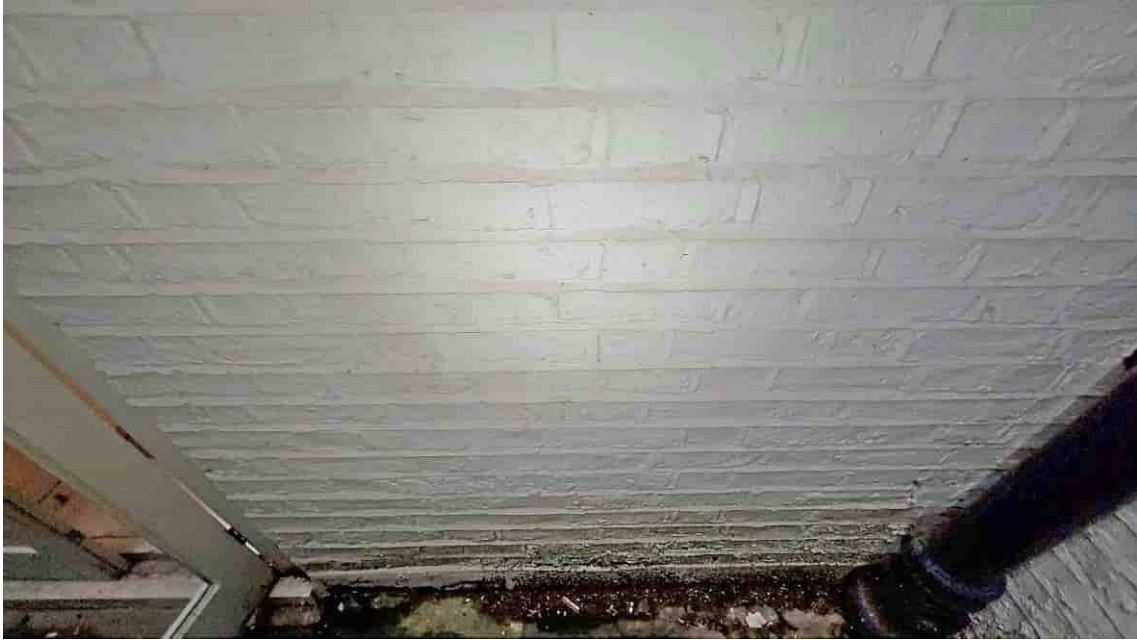
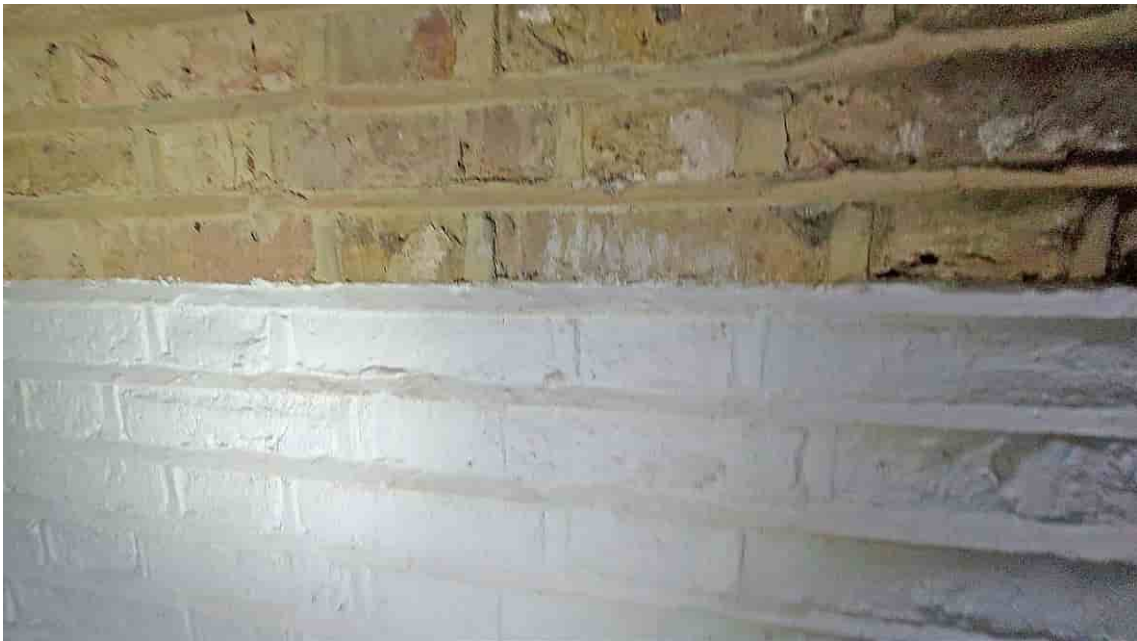
Originally, the building has been built with lime mortar. However, at some point during the recent decades the building has been repointed with cement mortar.

Any future pointing is recommended to be done with a **traditional lime mortar** instead of modern sand & cement mortars.

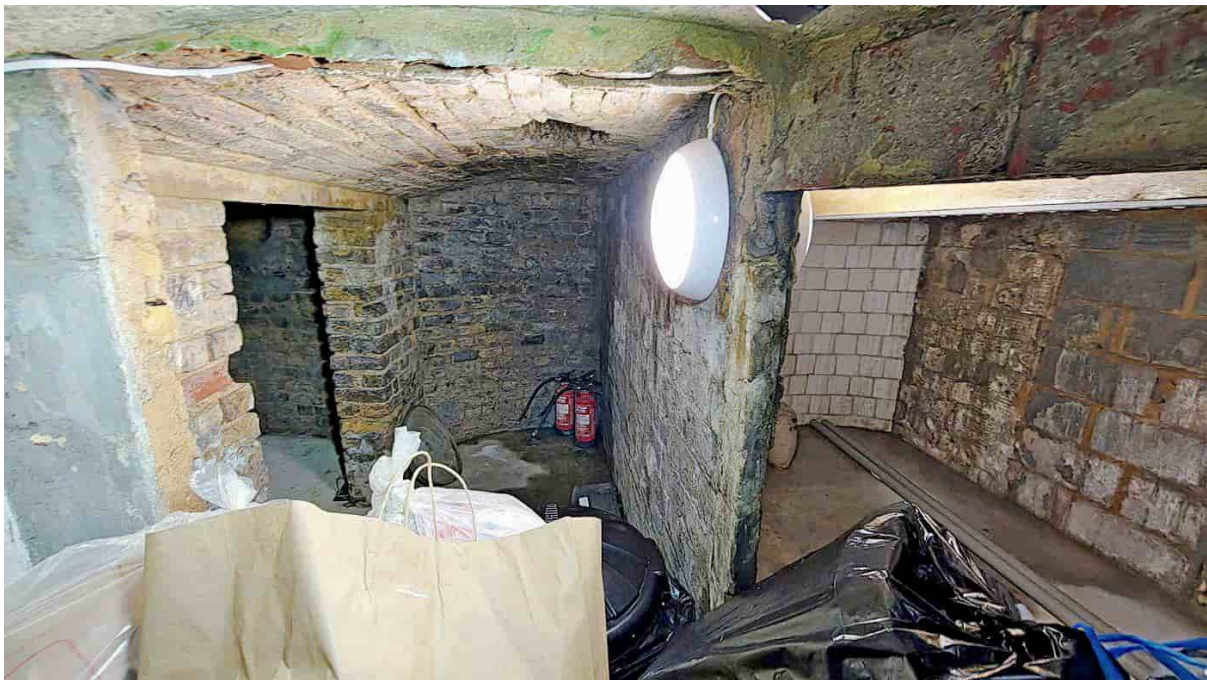
There are 3 vaults under the external pavement. These vaults, during the pre-war period, have been used **for the storage of coal**.

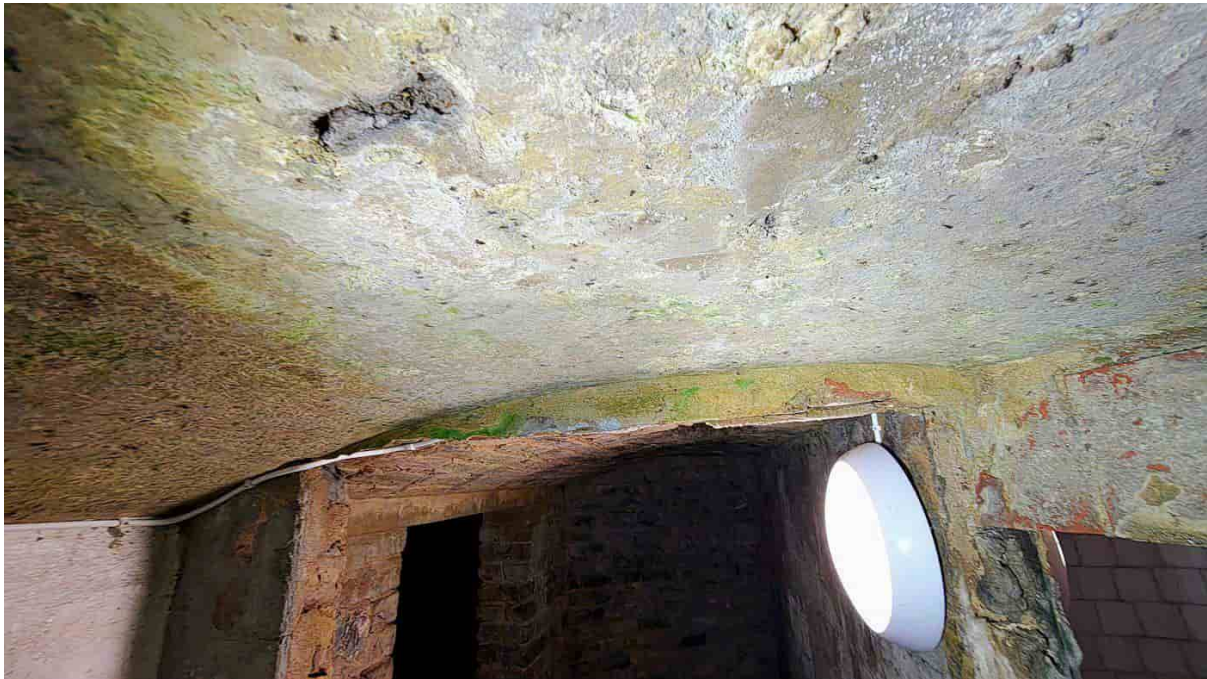
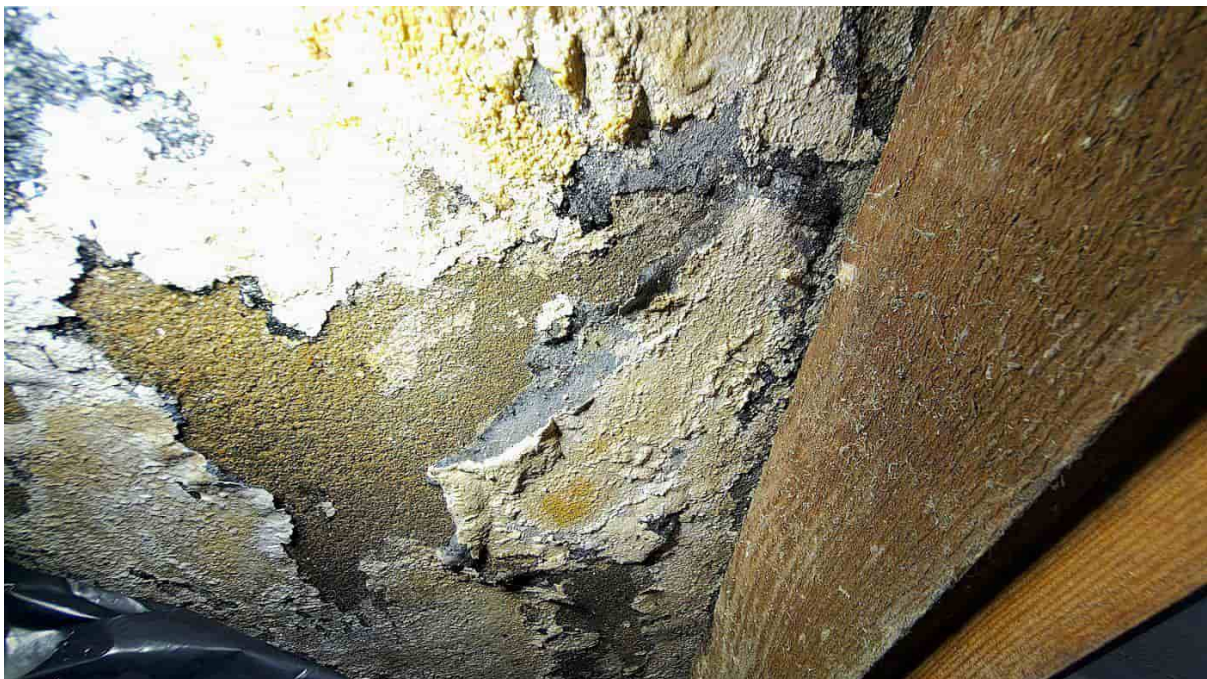
The storage areas in the past **have been partially tanked with a modern tanking slurry.**

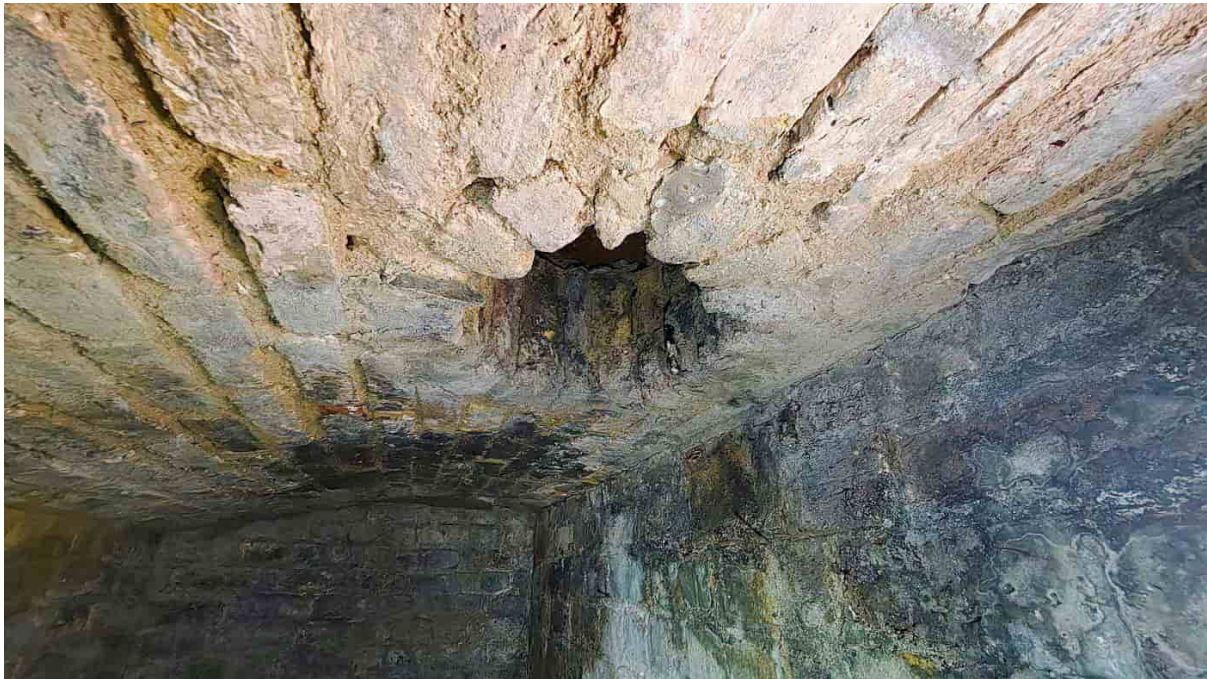
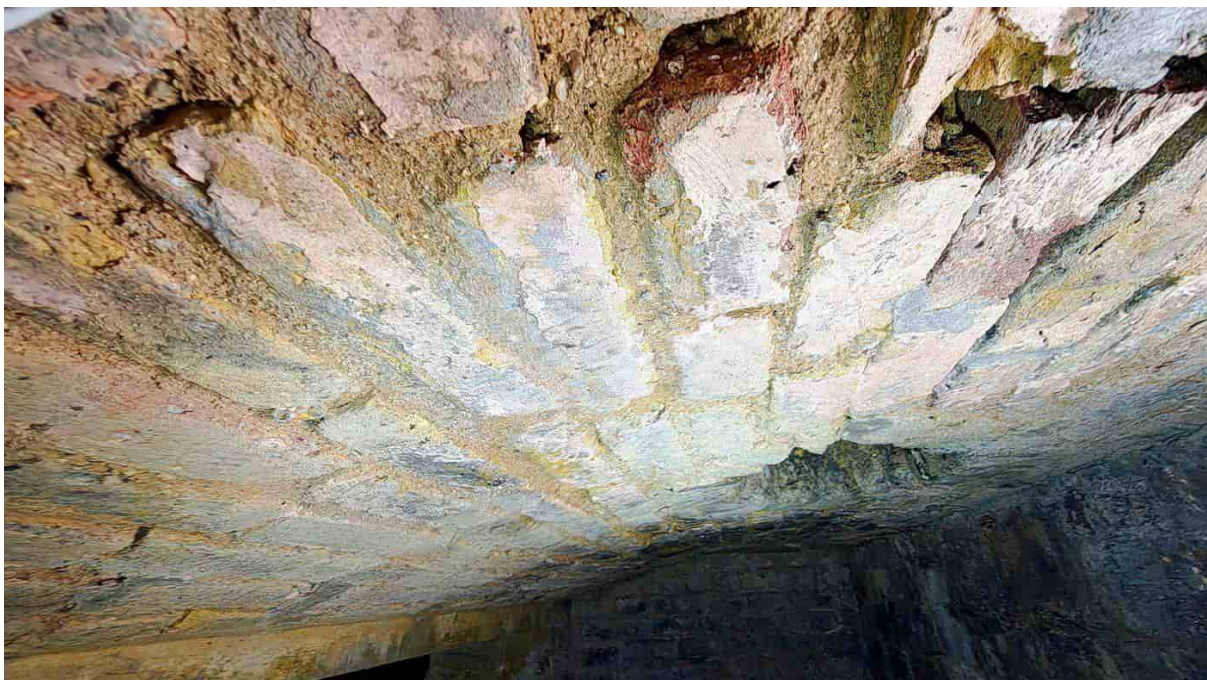
Other areas, however, areas are still intact. In these places the original lime mortar is still visible on some of the vault ceilings.

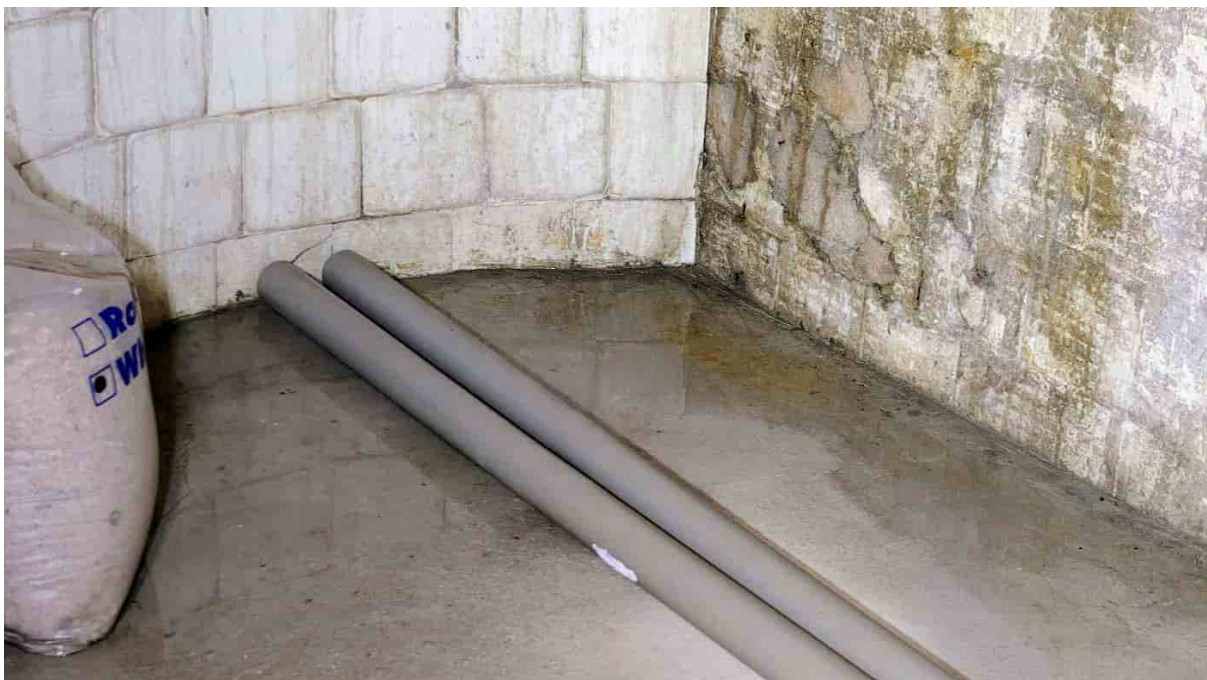
There is also water ingress from above, and in one of the vaults there is liquid water pooling on the concrete floor.

Basements and cellars can be made waterproof with the Rinzafo MGN Roman waterproofing mortar by applying 2 x 10 mm coats onto the ceiling, walls and floor.

The ventilation in the cellar also needs to be improved to reduce the high internal humidity levels.

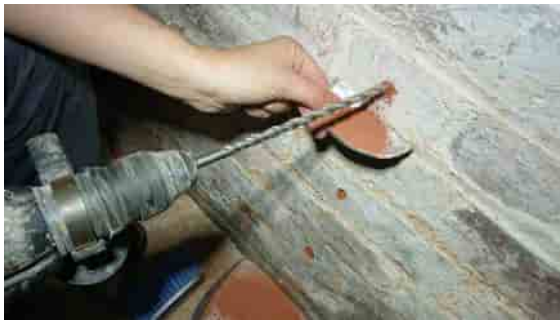
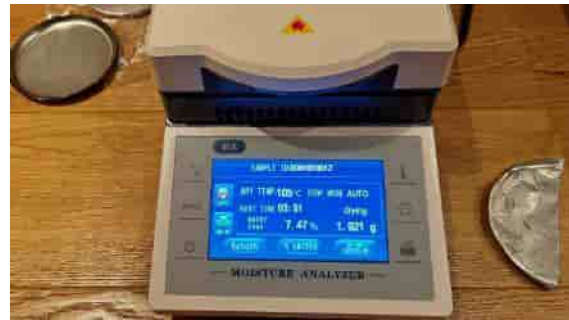
Wall core moisture measurements

The moisture content of the walls has been determined using industry-standard **gravimetric analysis**. The true moisture content of the masonry is determined **from drilled core samples** taken from the core of the wall, at different heights, using a precision scale and a drying oven.

Each wall sample is first weighted (wet weight), dried in the oven, then weighted again (dry weight). The moisture content is calculated from the difference between the wet and the dry weights.

The results of the moisture measurements are displayed instantly on the digital display.

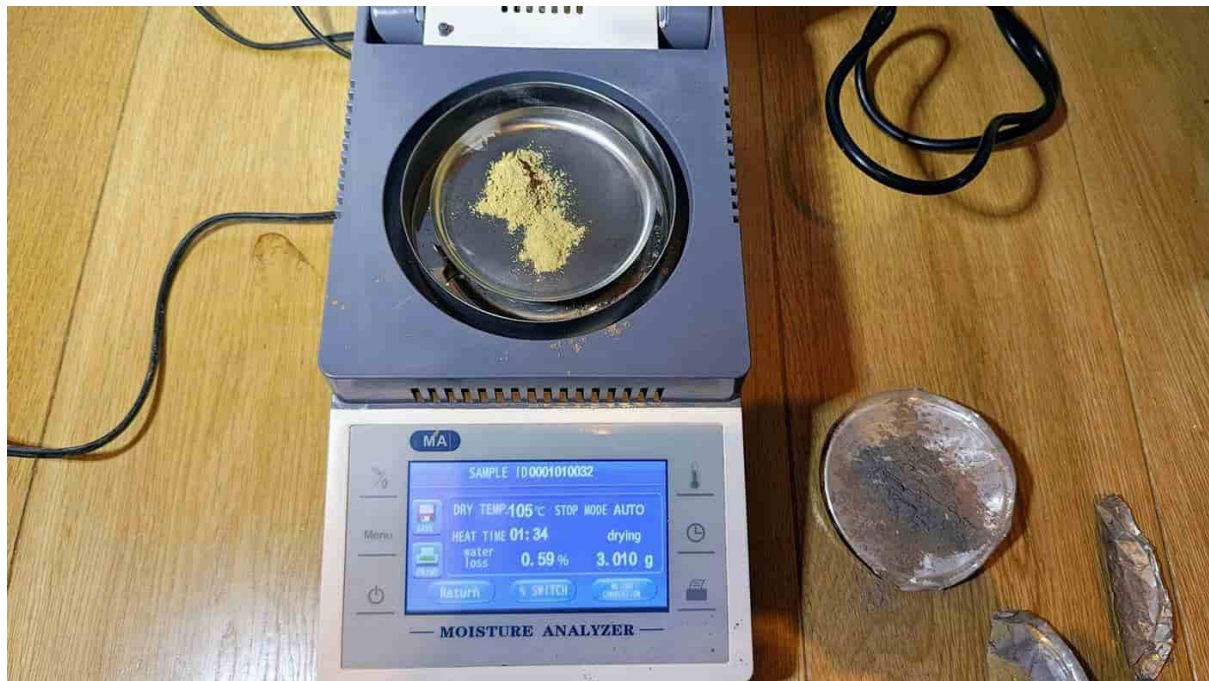
Here are some of the dry masonry values – here 0.59 % moisture content by weight.

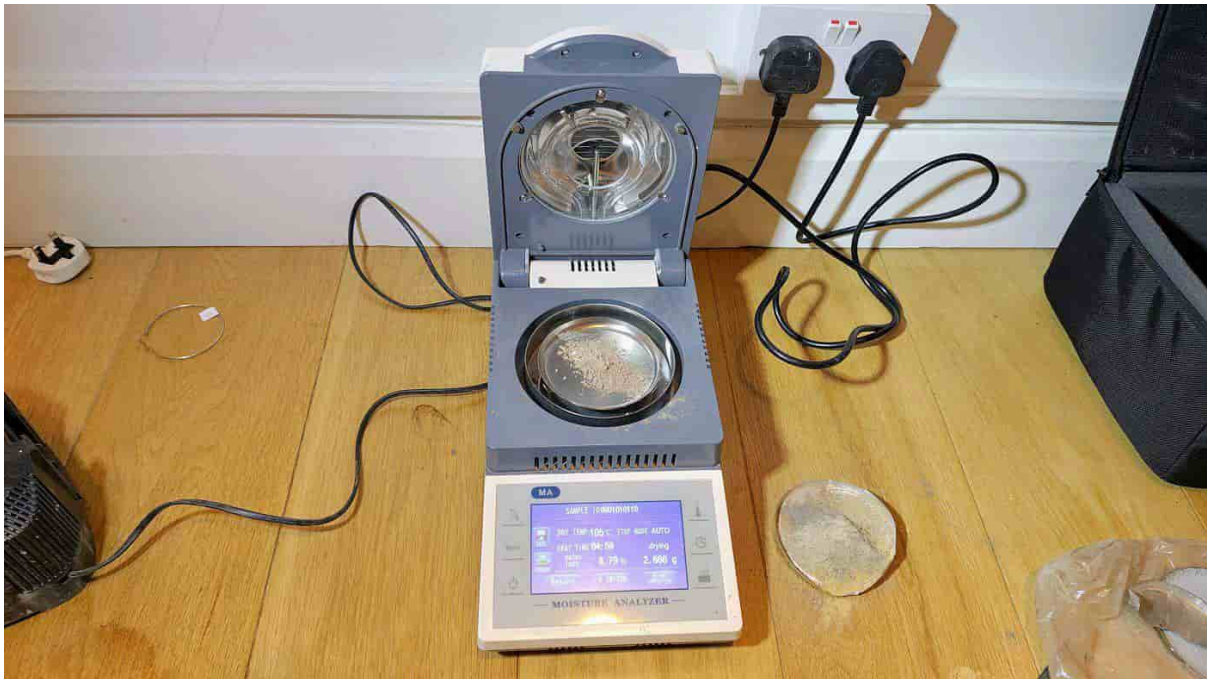
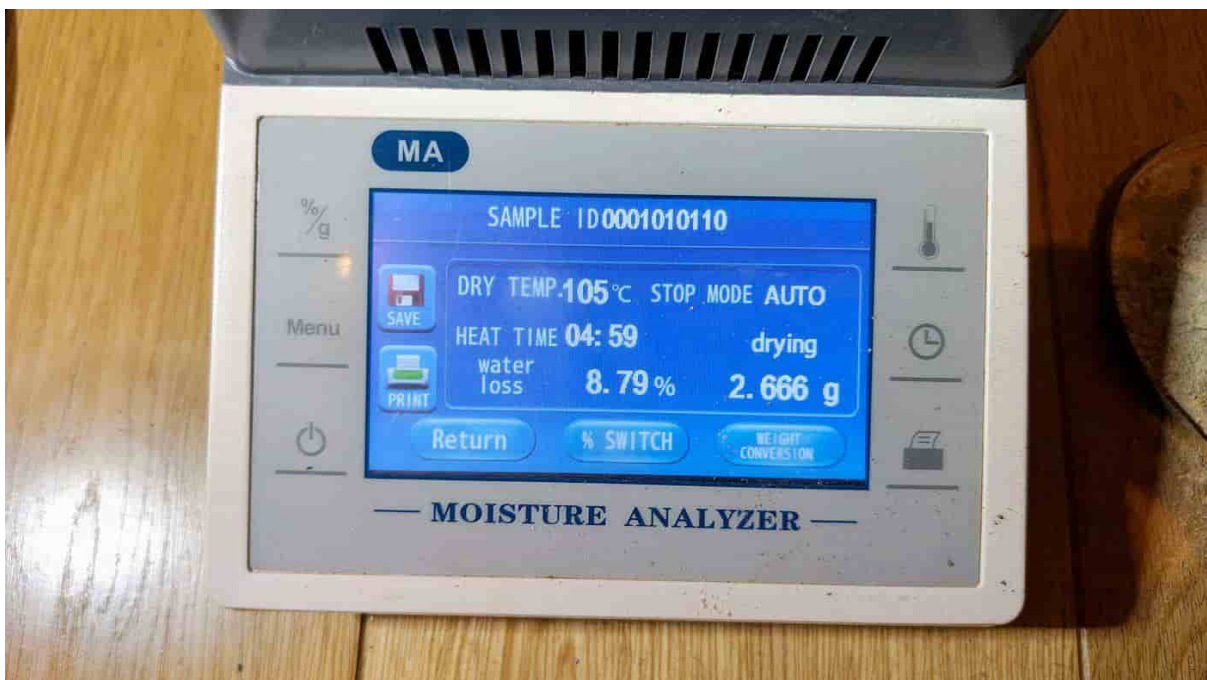
**Dampness values** over 3.0 % need attention. In the flat we have **over 8.7 %** moisture content, these walls being significantly damp.

Here are some of the damp masonry values – here 8.79 % moisture content by weight.

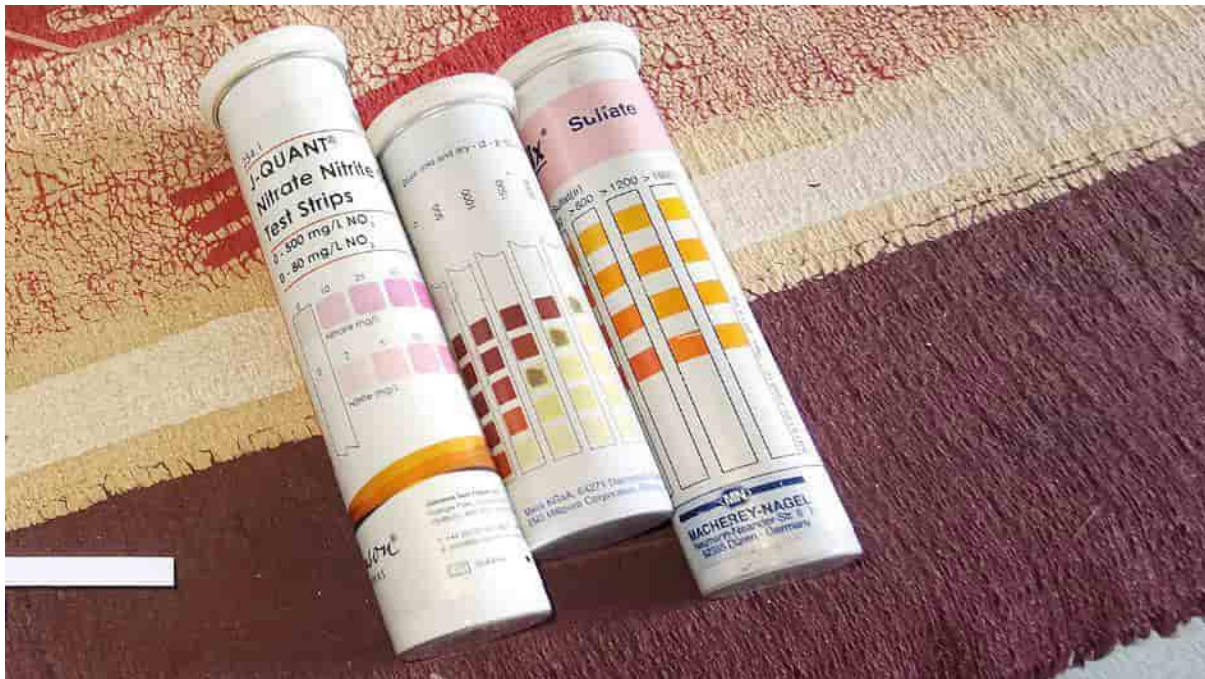
A professional salt analysis has also been performed, and the concentration of **chlorides, nitrates and sulphates** – the most common salt types known to damage the masonry – has been determined using lab grade chemical strips.

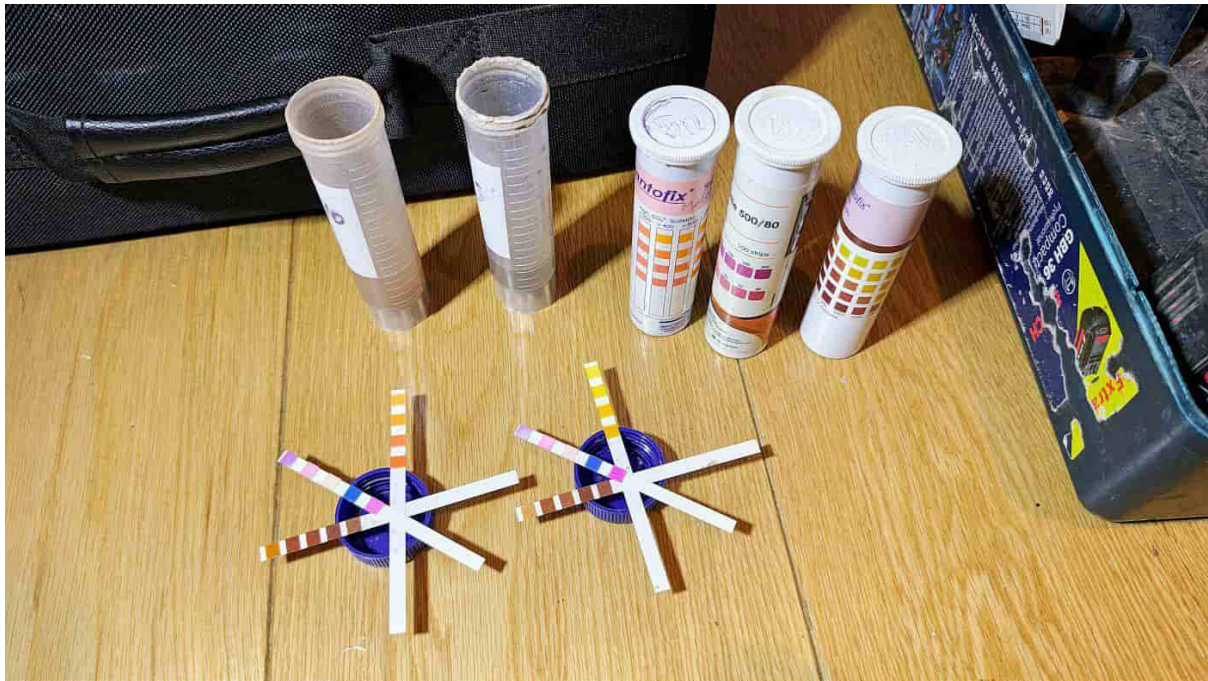
The following salts have been found in your walls:

- **Sulphates** (pink to orange): medium to high concentration, can originate from several sources, including the ground.
- **Nitrates** (white to purple): medium concentration, from the ground, as a result of rising damp.
- **Chlorides** (brown to white): none found.

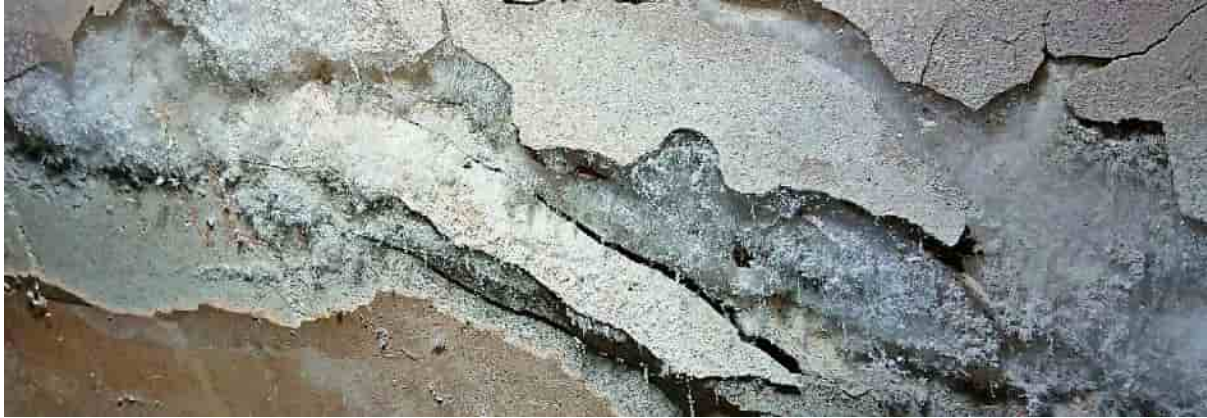
A significant majority of plaster damages (flaking, crumbling, peeling etc.) are **not the result of humidity, but salts**. These most often originate from the ground from rising or penetrating damp, but salts can also originate from the air (sea spray, air pollution etc.). Due to the ongoing evaporation, most salts are drawn to the outer 10-15 mm area of the wall where they **crystallize**, increasing in volume by 500% – 1,000%. The crystallization pressure can exceed 800 atmospheres which breaks down the plaster, the wall fabric, even concrete – the strongest concrete rarely can withstand 550 atmospheres.

Additionally, salts **can chemically bond humidity from the air** (hygroscopy). Crystallizing salts near the surface can make the plastering look damp even when the wall fabric in depth is much drier.

Crystallizing salts breaking down the plaster

To prevent the crumbling of the plastering a **salt-resistant protective lime base coat must be used under the main lime coat**. This protects the plastering by preventing the migration of salts into the fresh plaster, making it last much-much longer, typically decades even in high dampness conditions.
