# Dampness Report

Lower Ground Flat, London

27 November 2024

We have been asked to investigate the dampness problem in this **Grade 2 listed** lower-ground residential flat due to previous damp proofing works and recent cracking of the decorative finish.

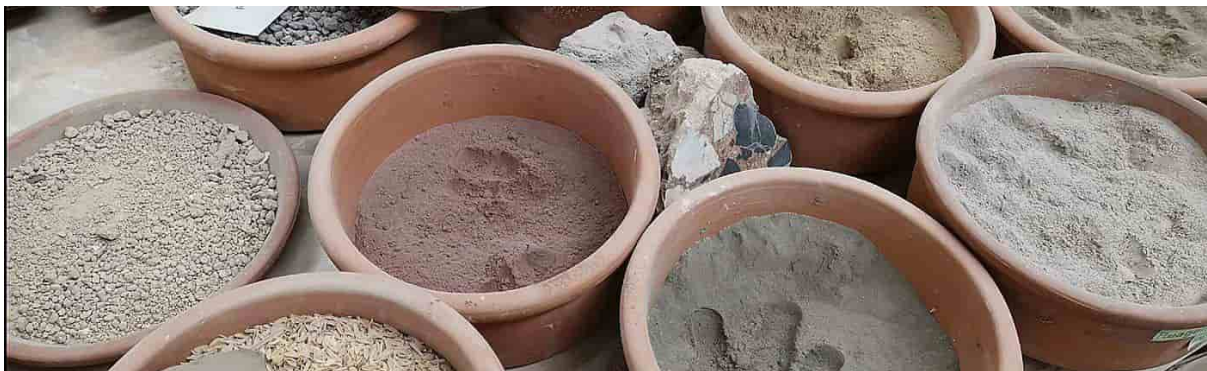
Such breathable and salt-resistant materials exist. These plasters have been “invented” by the Romans, who discovered that mixing lime with carefully selected **volcanic ashes and sands**, in the right proportions, results in special lime plasters that are salt-resistant. Moreover, they are also waterproof that can stop liquid water while letting water vapours through.

A selection of volcanic sands and ashes

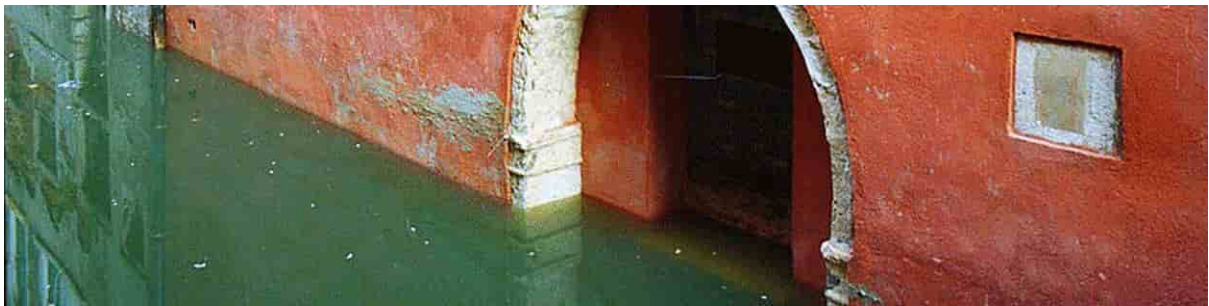
Applying one coat of Rinzafo MGN Roman waterproofing mortar – described next – onto the walls can make them waterproof and salt-resistant while preserving the wall fabric's breathability.

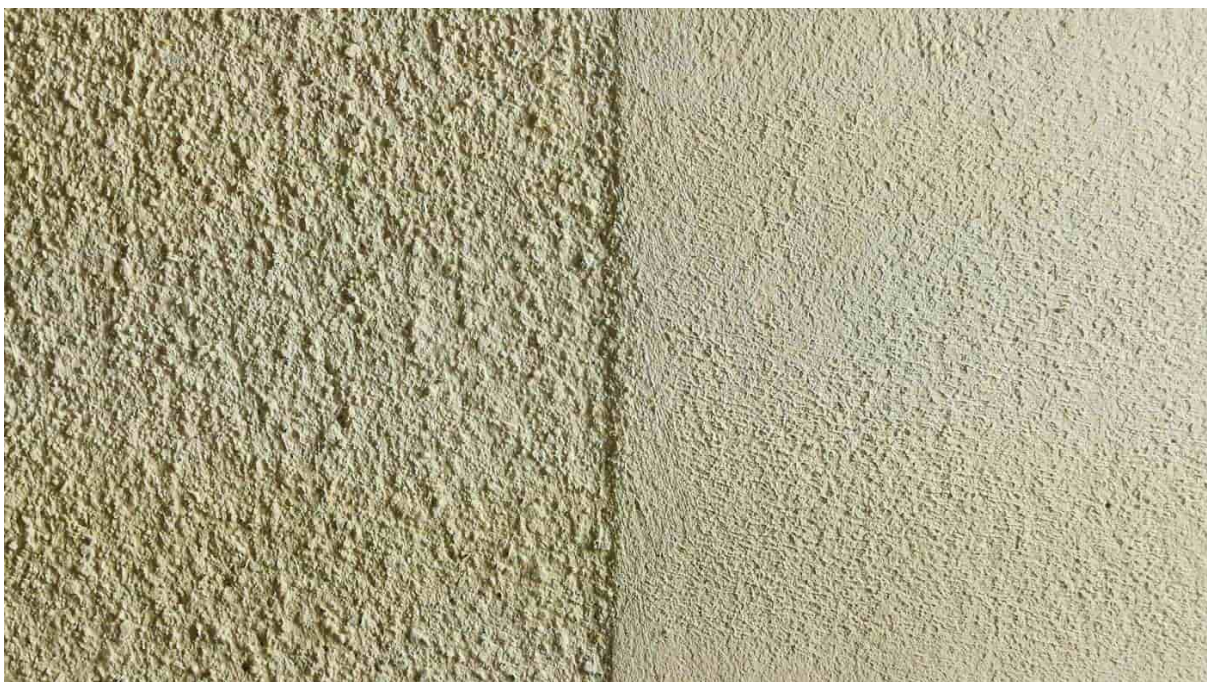
The rendering is available in various colour options (both white and coloured), making possible various type of finishes, smooth or coarse. Coloured renders **do not need maintenance** as they are coloured throughout.

Here is a sample of the **Sanacolor 2000 MGN** render in yellow colour option, with different finishes.

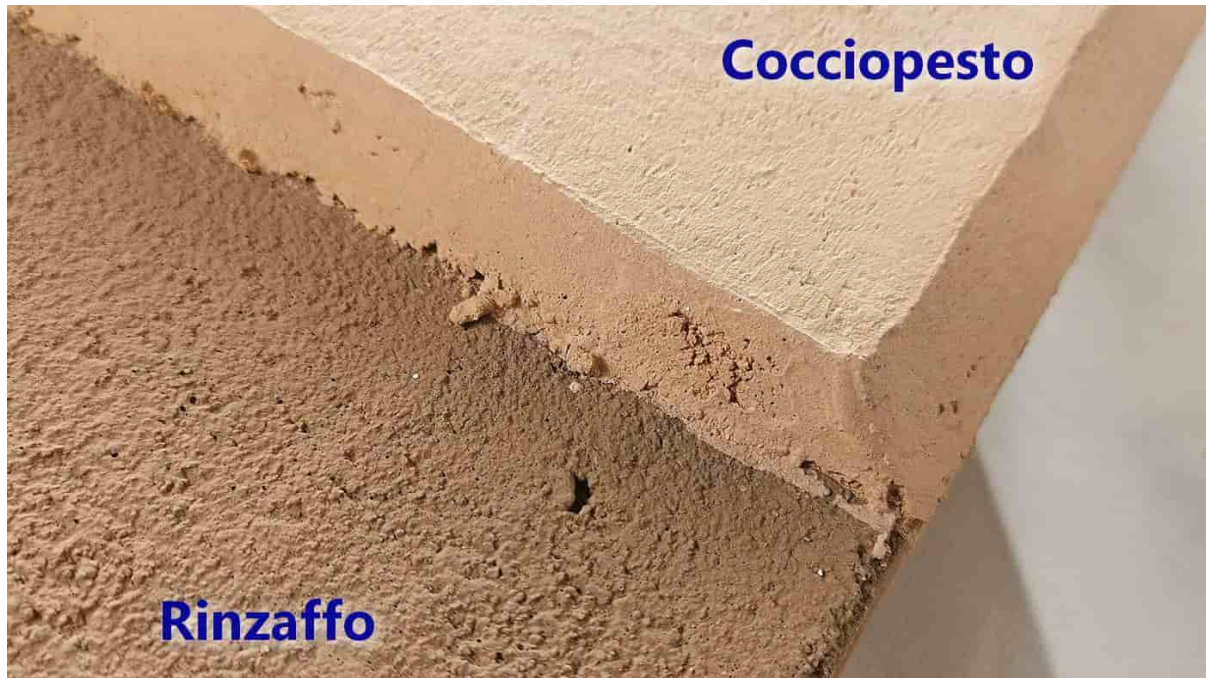
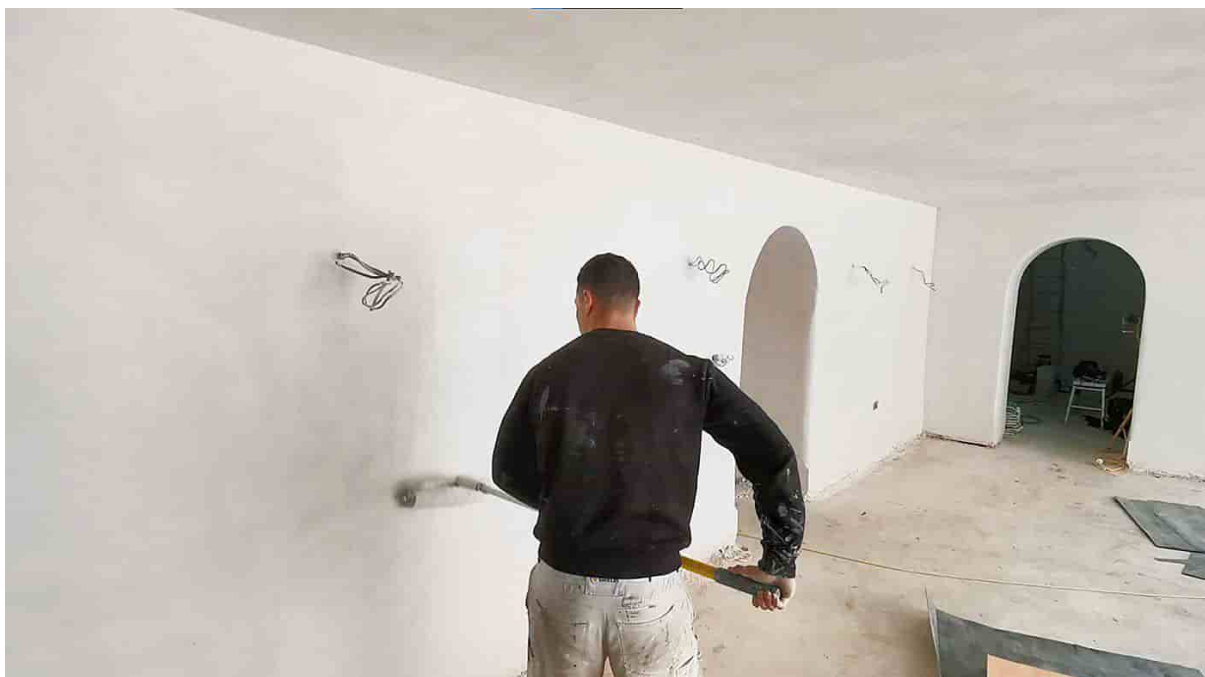
5. Apply 2 x 10 mm coats of the same material onto the walls (and if needed, on the floor).
6. Apply a coat of traditional **Cocciopesto Dehumidificante MGN** brick coloured lime-cocciopesto plaster as the main coat which performs extremely well in damp environments, buffering the excess moisture (absorbs and lets it go).

Here is a photo of both plasters. The Cocciopesto brick coloured main coat can be left on its own (in a cellar) having a nice, brick-coloured look, or finished with a white lime finish (in a converted basement), then painted with a breathable paint to give the walls a nice appearance.
