Dampness Report

Old City Hall

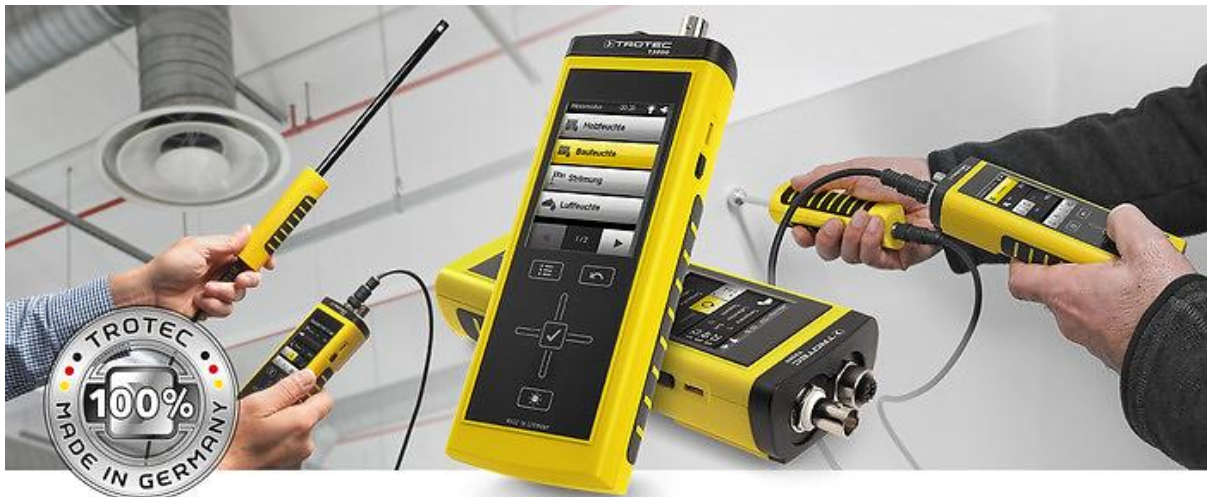
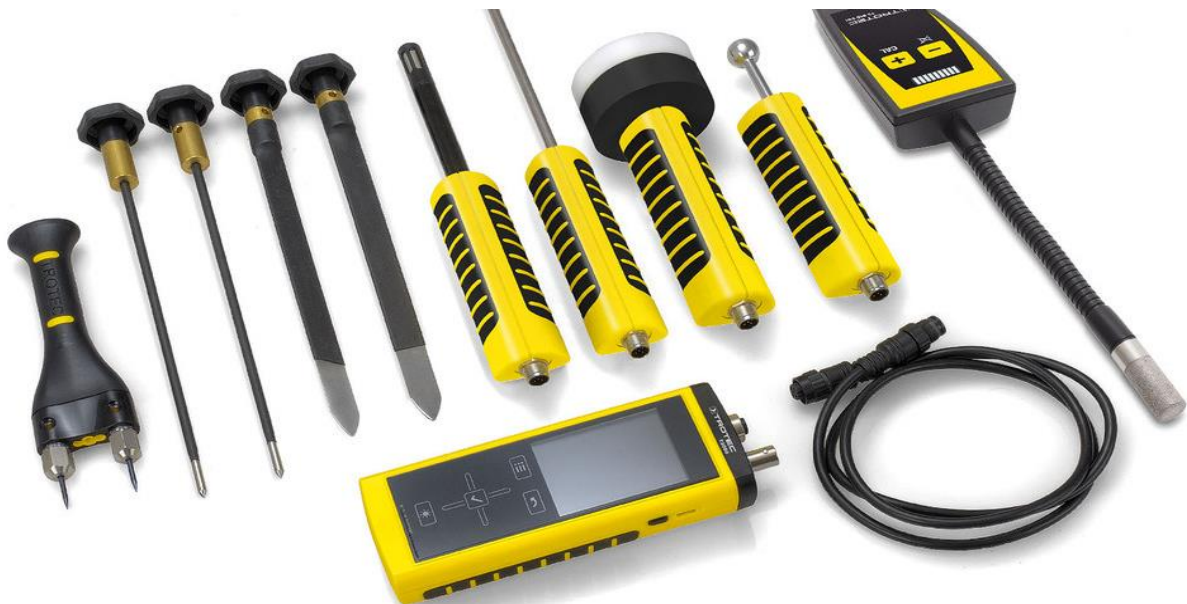
In addition, the moisture content of the walls has been checked using a **Trotec T3000 state-of-the-art microwave moisture meter / digital wall scanner**, made in Germany. This instrument can be interfaced with a range of professional moisture sensors and is capable of detecting moisture up to **30 cm deep**.

Readings over 30 are of concern and need to be addressed.

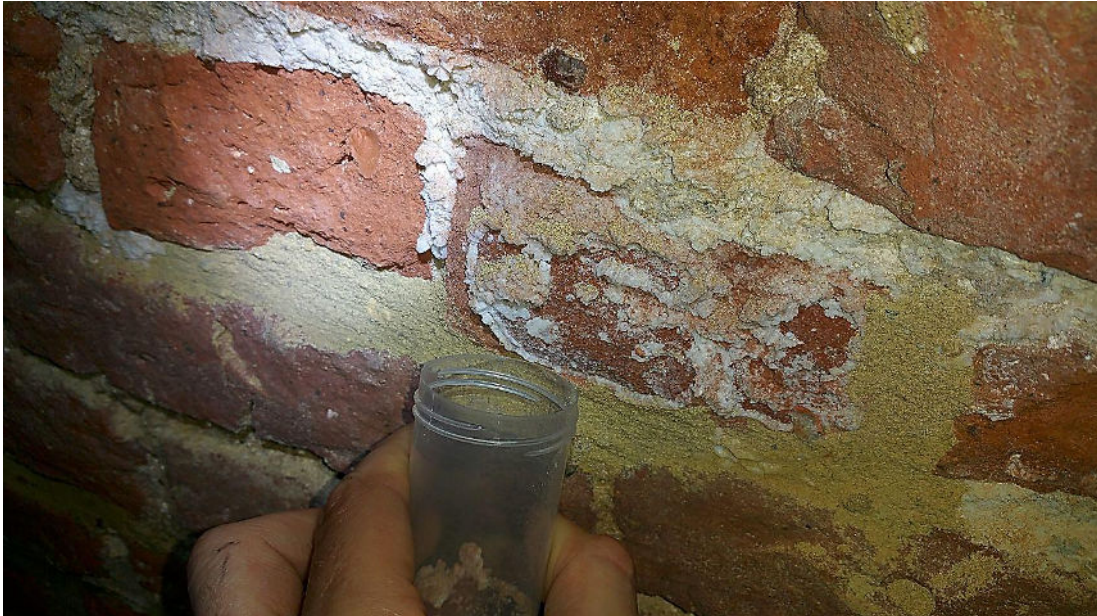
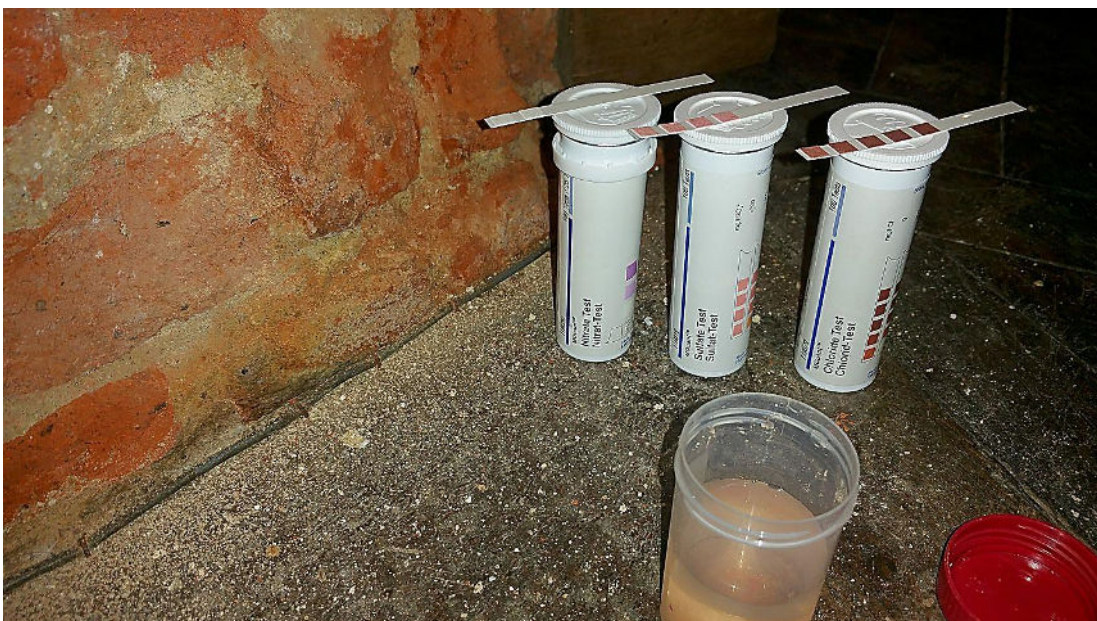
A professional salts analysis has also been performed, and the concentration of **chlorides, nitrates and sulphates** – the most common salt types known to damage the masonry – has been determined using lab grade chemical strips.

Results	pH	Cl ⁻	NO ₃ ⁻	SO ₄ ²⁻
1	Brick wall	6	1.25%	0.00%	0.00%
2

No **nitrates** or **sulphates** were found in the wall fabric.
