Dampness Report

Old Pub Building

3 March 2025

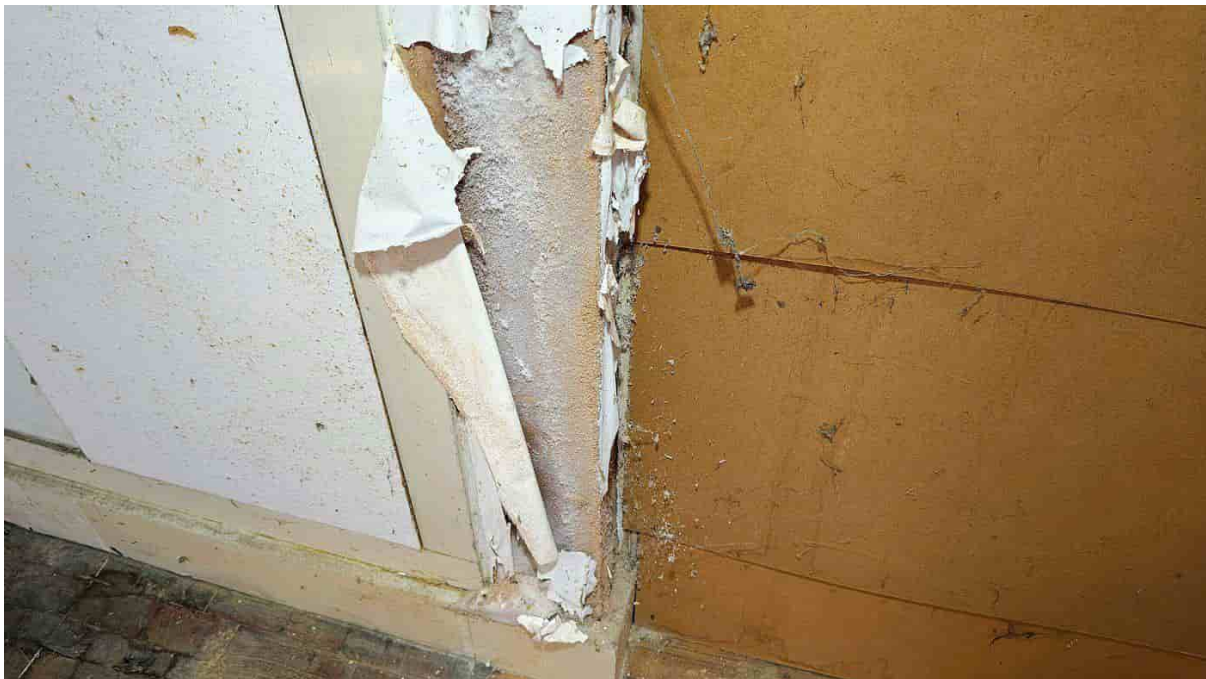
The water evaporates through the plaster and when the growing salt crystals expand in volume (up to 10X), they break down the building fabric, resulting in potential crumbling, peeling and/or damp patches.

There is heavy salt crystallization on some ground floor wall sections.

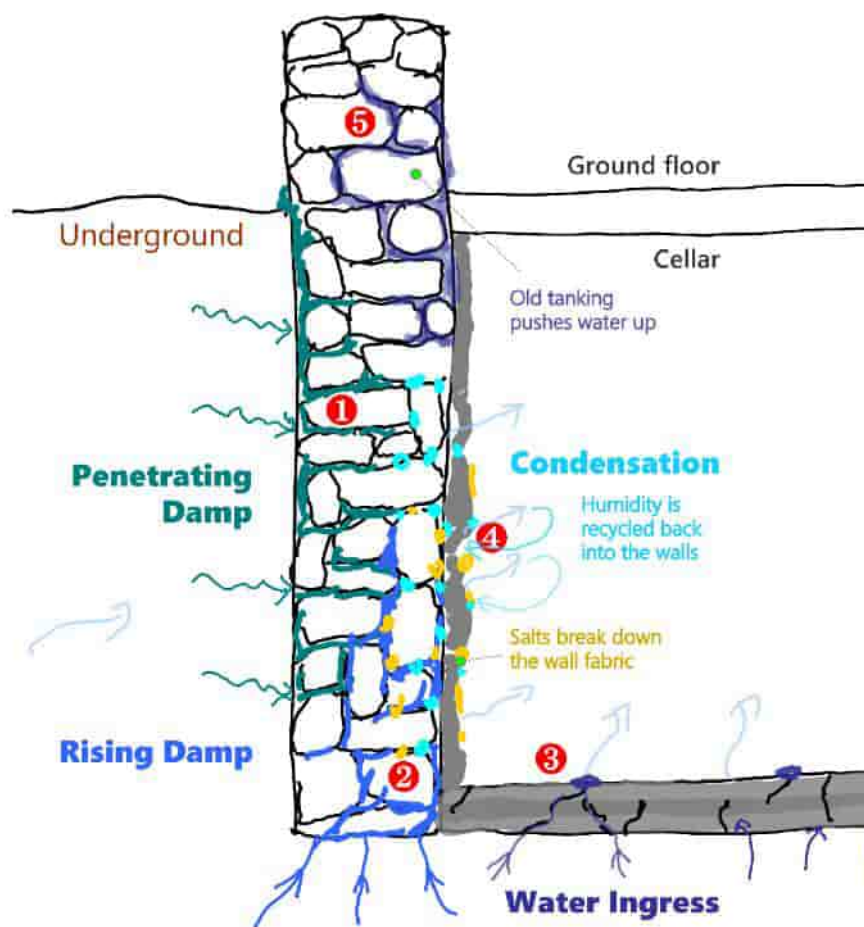
Being a pub, the cellar in the past has been used mainly for storage. To keep the cellar waterproof, it has been tanked with a modern cement plaster then painted with some modern paint. Both the paint and plaster are decaying badly.

The cellar can be made waterproof with the Rinzafo MGN Roman waterproofing mortar by applying 2 x 10 mm coats onto the walls and the floor.

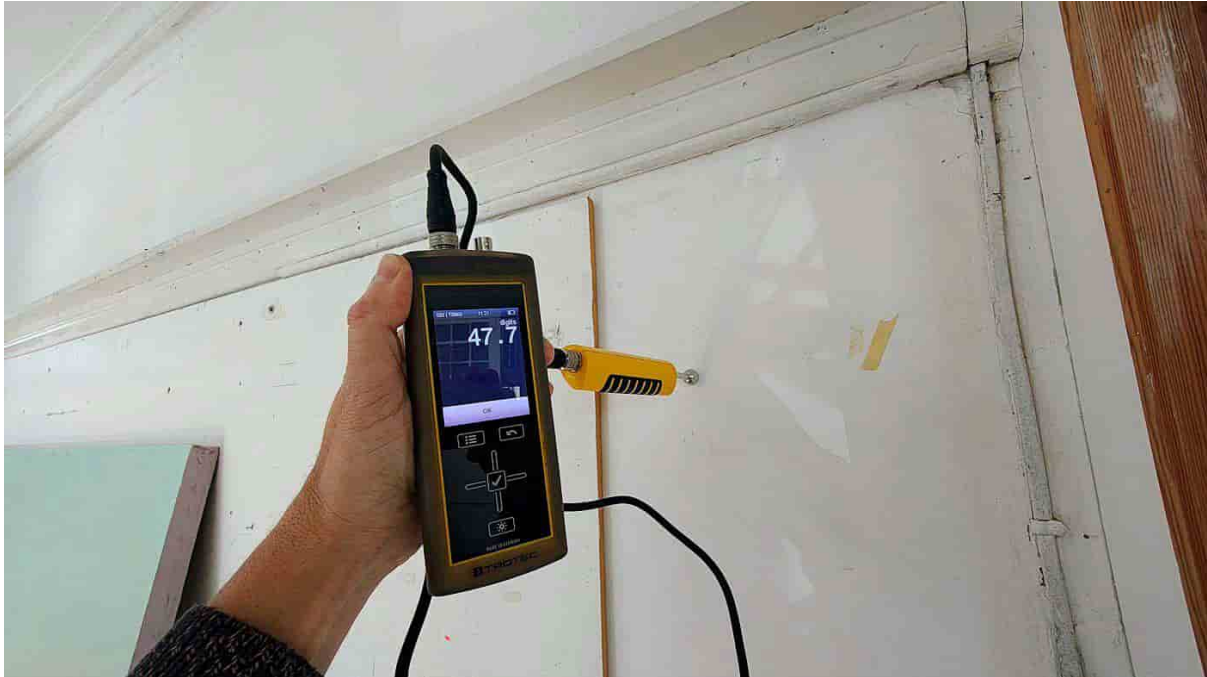
Dampness meter readings confirm this. **Readings over 70 are higher than normal.** There is a significant difference between the upper and lower parts of the walls.

Normal readings on top: 47

Damp values at the bottom: 135

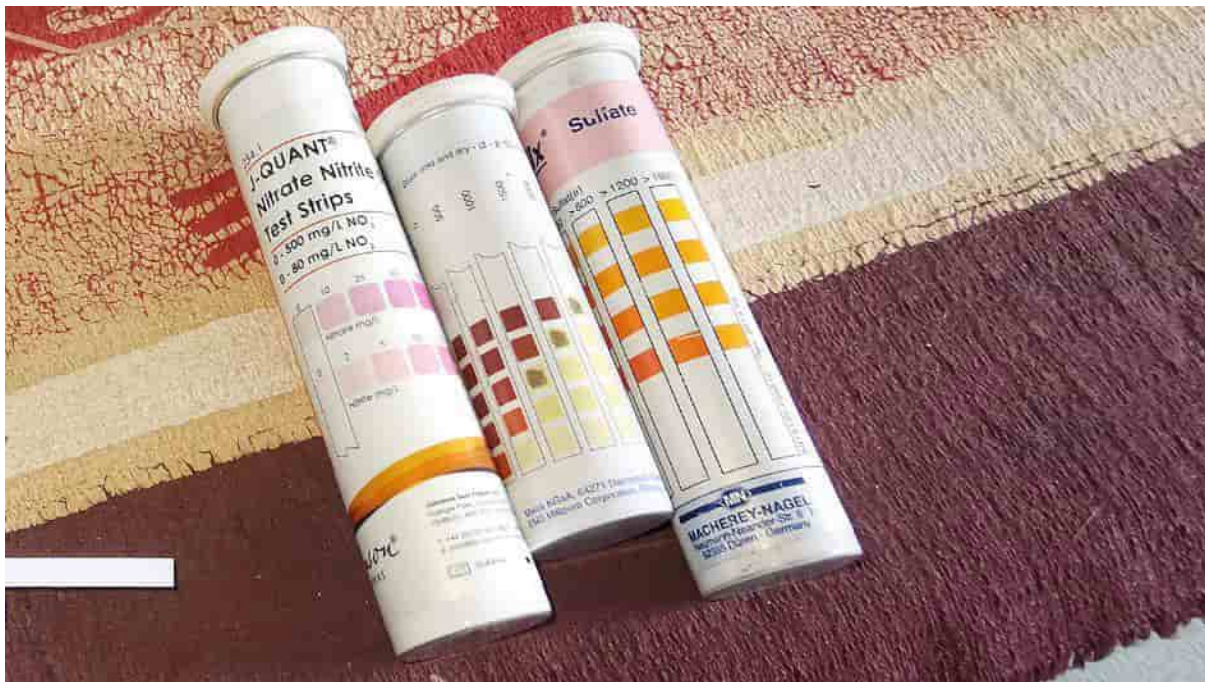
The following salts have been found in your walls:

- **Nitrates** (white to purple): very high concentration, from the ground, as a result of rising damp.
- **Sulphates** (pink to orange): high concentration, can originate from several sources, including the ground or the decaying gypsum plasterboard.
- **Chlorides** (brown to white): none.

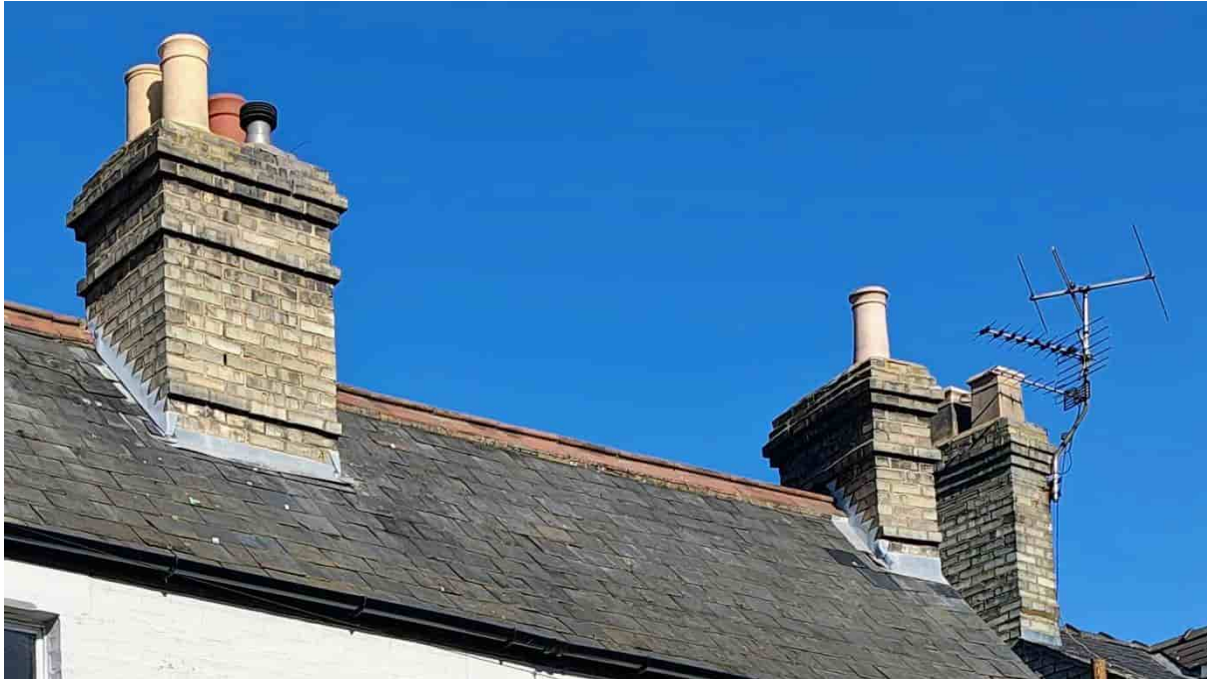
The chimneys in the past have been pointed with cement. The pointing has many cracks which can cause water leaks inside or around the chimneys.

The chimneys **should be inspected for leaks** to ensure that there is no ongoing water ingress. Any pointing of flashing deficiencies found should be remedied, making the chimneys watertight.

The [Rinzaffo MGN Roman lime base coat](#) is recommended to be applied for pointing works around the chimney stack and for the replastering of salt-laden chimney walls – this being a long-lasting, heritage-friendly, sympathetic renovation solution.
