Dampness Report

Clock Tower – Arts Centre

23 February 2025

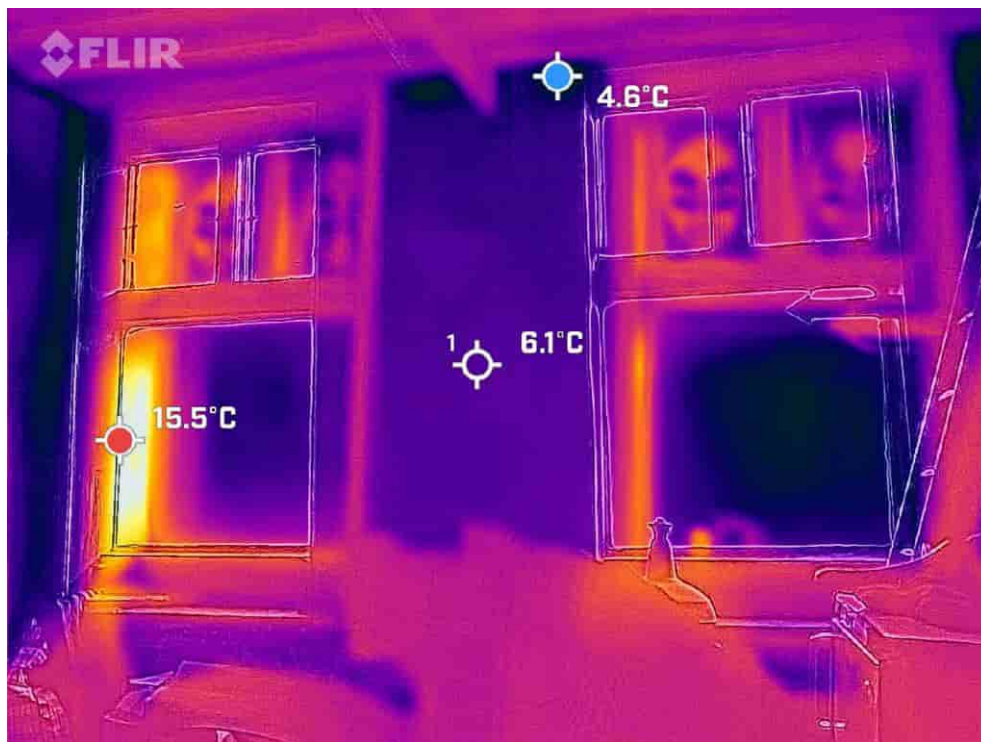
East Wall, mostly internal, except the upper third which is external.

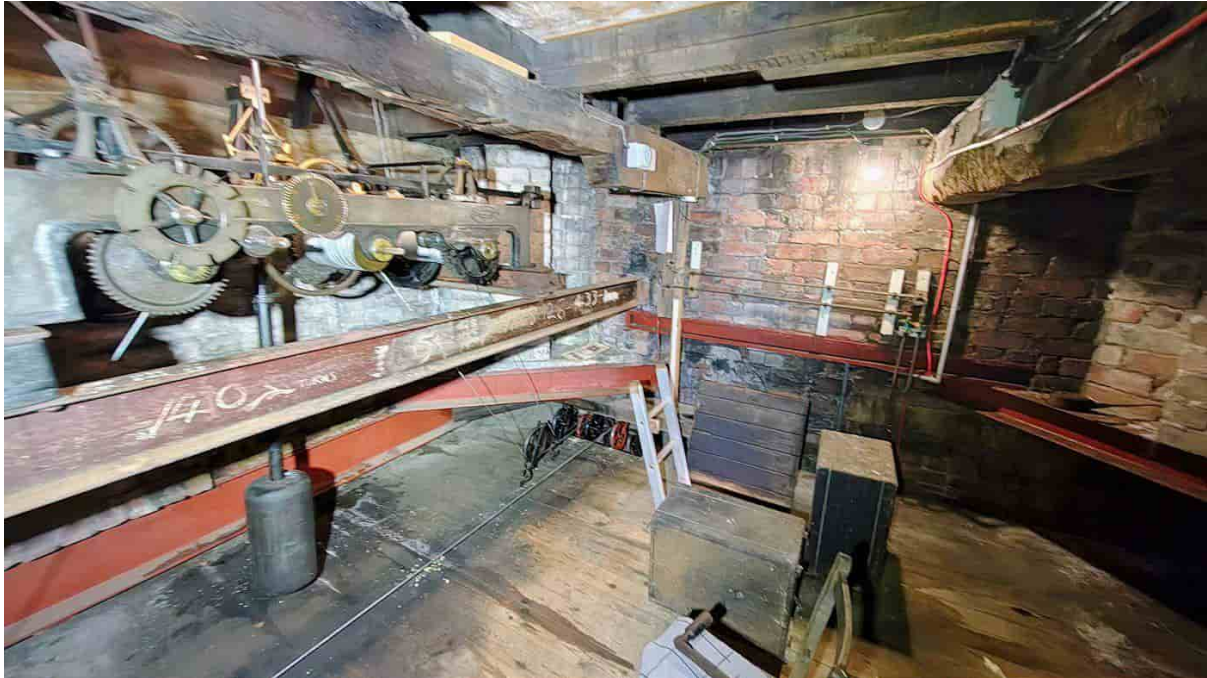
This room has been most probably the subject of some major structural work in the past. Some parts of the tower have been reinforced with steel beams, adding brick reinforcement piers to better support the weight of the cupola.

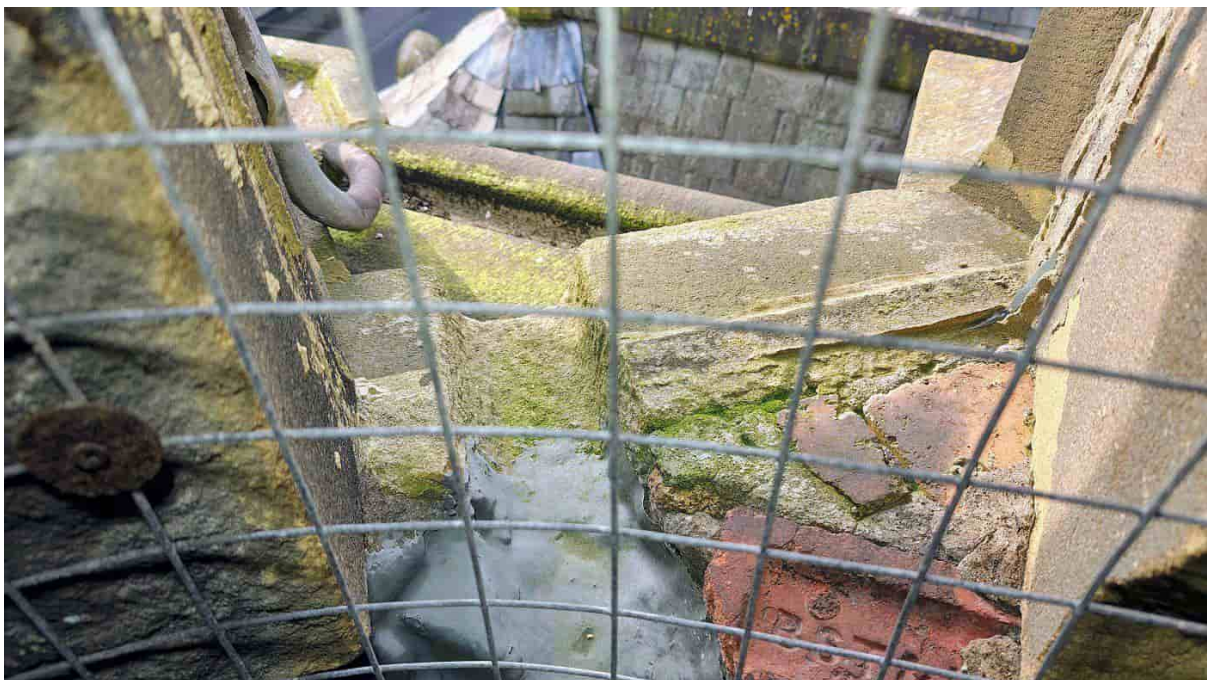
The cupola has 4 round openings. To reduce moisture ingress and to keep the inside of the cupola dry, the four openings are covered by a sheet of glass. Two of these **protective round glasses are missing**, resulting in water ingress on the North and East walls. The walls with water ingress have a distinct green colour as a result of moss growth.

To minimize the ongoing rainwater ingress and keep the inside of the Cupola drier, it is recommended to **refit the two missing glass panes** of the North and East Walls.

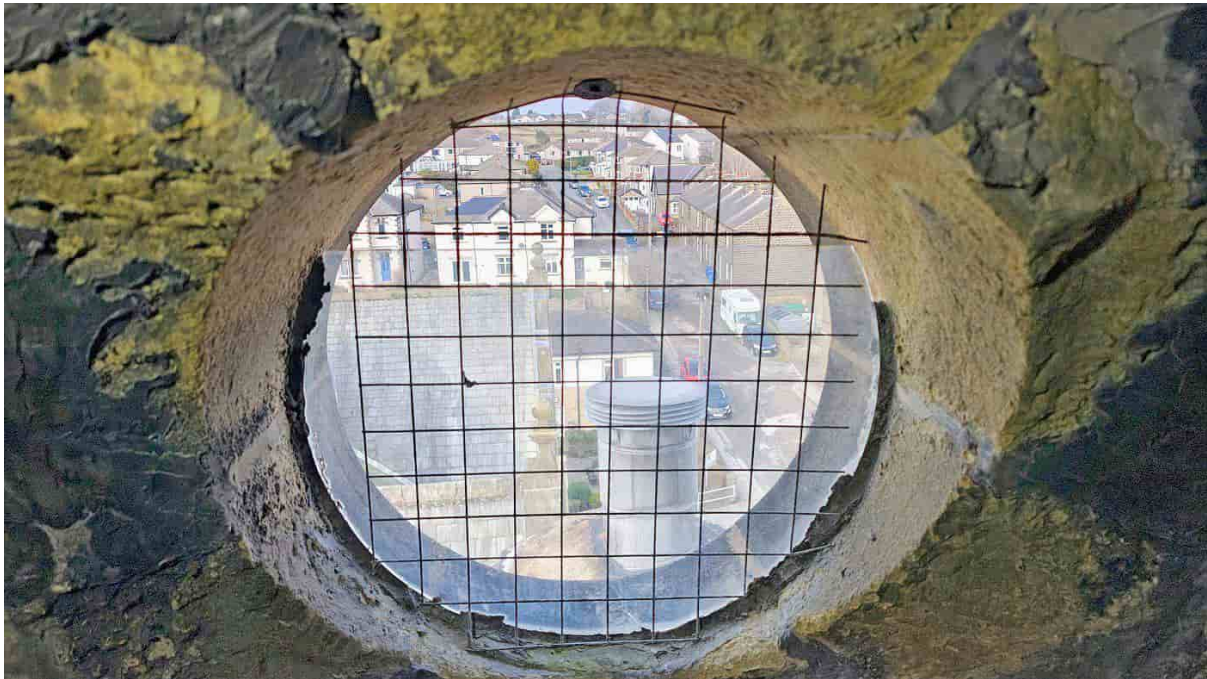
Missing glass along the North Wall – water ingress, green moss growth.

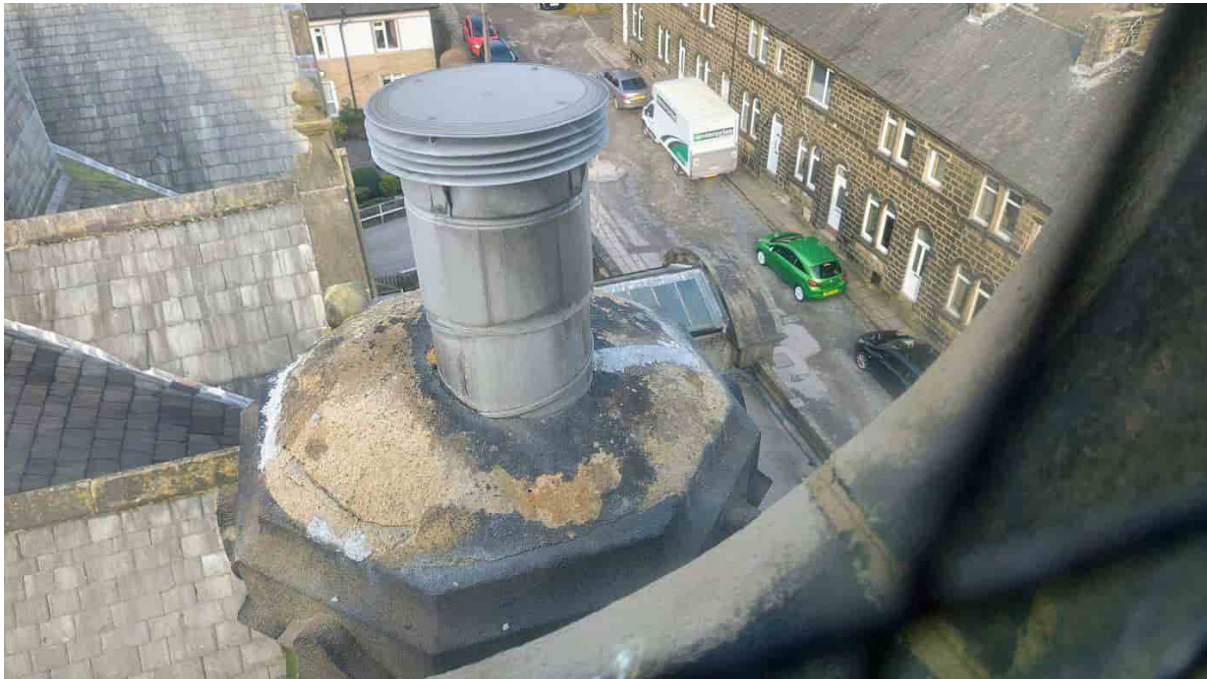
There is an approx. 1 metre **flat roof section** alongside the base of the South Wall.

The roof has also been inspected for leaks and none has been found. This lead covered flat roof with a cement base – reinforcing a wall holding the clock mechanism – is responsible for a significant aspect of condensation of the underlying Storage Room. Both the lead and the cement base are dense cold materials, easily cooled down during the cold season. This creates significant thermal bridging in the internal environment, resulting in heavy condensation.

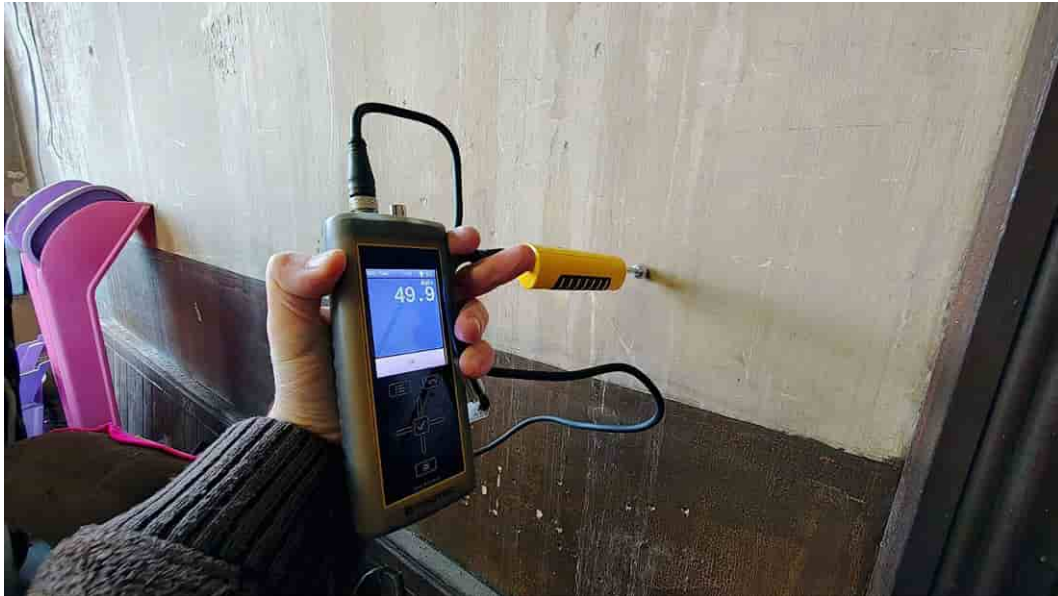
South Wall – plaster, high reading: 160

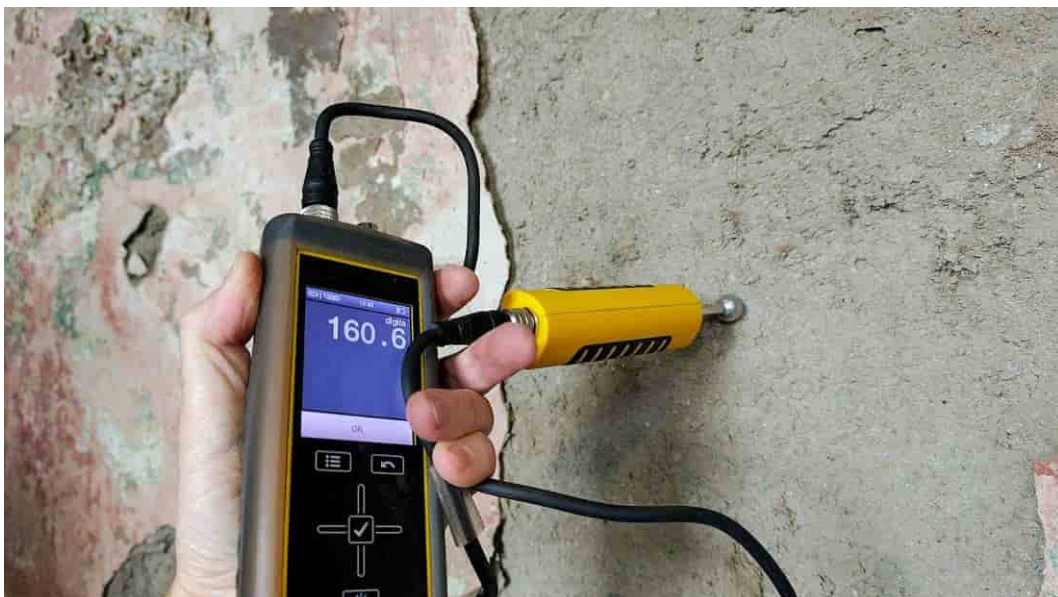
West Wall – plaster high elevation, high reading: 136
